STRUCTURAL HEALTH ASSESSMENT OF TIMBER STRUCTURES

**Proceedings of the International Conference
September 20-22, 2017 Istanbul, Turkey**

SHATIS'17 Structural Health Assessment of Timber Structures
September 2017

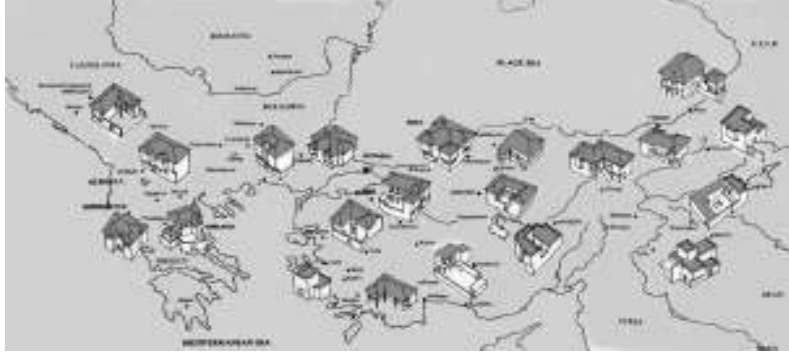
Figure 3: Distribution of the Turkish house in the Balkans and Turkey (Eruzun, C., Interpretation: Dışkaya)

The abundance of material that can easily be found around was one of the most effective factors for determining the traditional structure type as well as the fault lines. The dense forests constitute was an important data for using timber material to construct traditional buildings on the fault lines (Fig. 3) [2].

When the map of the fault lines in Fig.1, forest assets map in Fig. 2 [6] and accordingly the distribution of the traditional buildings map in Fig. 3 [7] are examined, with the relationship between these three concepts may explain the reason for the 75% of traditional buildings are timber and 25% are masonry in Turkey.

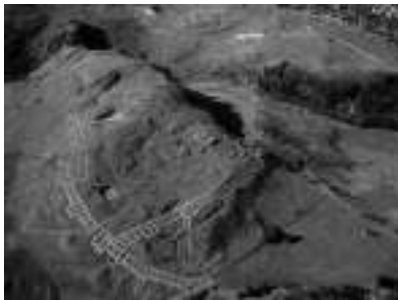
Figure 4: Foundation of fortification walls, (Seeher, 2007)

For example within the scope of experimental archaeology, beside the foundations of the city walls (Figure 4), the descriptions on clay models of Hittite Era (Figure 5) were used in the reconstruction of fortification walls of Hittite capital Hattuša (Figure 6) [8].

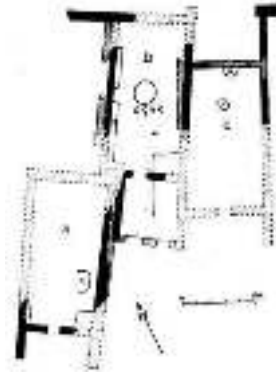
Figure 7: Bronze Age House in Beycesultan (Naumann, R.)

The data of the archaeological excavations could give some important knowledge for clarifying the plan type evolution in Anatolia. The correlation between the plans of early Bronze Age settlements in Beycesultan (Fig.7) [9] and the early 17th Century Halil Ağa Mansion in Bursa-Mudanya (Fig.8) [10] could help to understand the developmental transformation in plan types after approximately 7000 years.

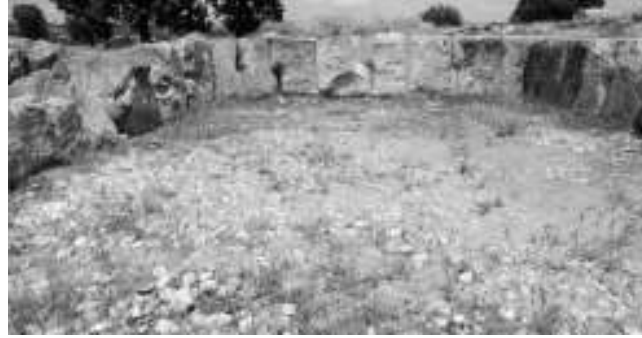
In the formation of foundations the small river stones were used as layers and the orthostatic foundation walls were built on top of them as large cut stones (Figure 9). These cut stones were connected to each other in a unique and intricate way to increase their resistance to horizontal

Figure 9: Section view of a Hittite foundation in Šapinuva B.C. 1500 (Photo: Dışkaya, N.)

The reasons for the use of these layered river stones under the foundation walls can be considered as firstly to prevent the access of the moisture from soil to the building and also to provide the damping of earthquake forces before reaching the structure.

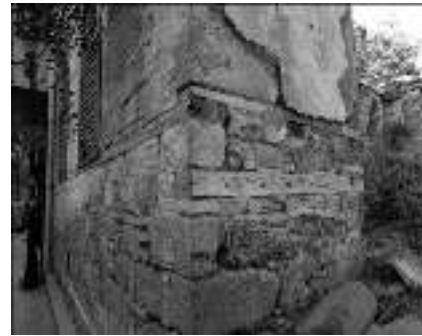
Figure 11: An 18th Century wall detail in Antalya (Photo: Dışkaya, H.)

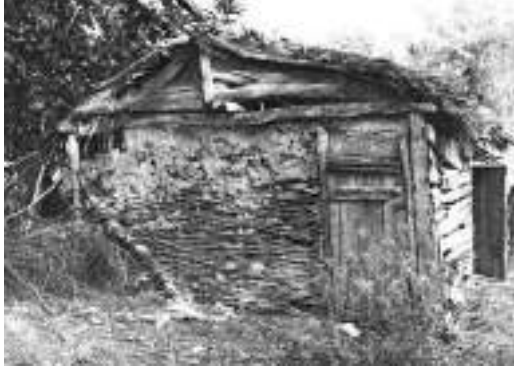
Figure 16: Interlaced twigs on a timber skeleton rural building (Yakar, J., Garson, J. L.)

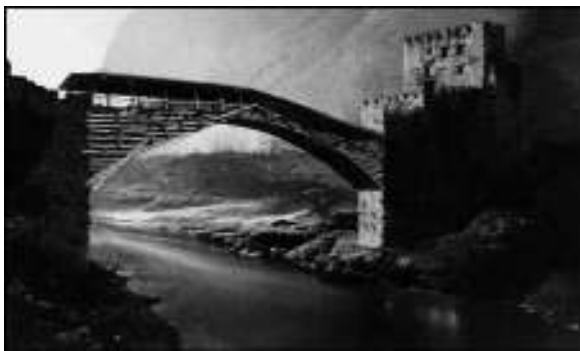
Figure 6: Hypothetical Reconstruction of the Pre-Ottoman Bridge in Mostar [7].

According to the M. Goykoviç, before the Mostar arched stone bridge was constructed, there had been the wooden suspended bridge with span of 35 meter and it was at the altitude of 53.20 m above the sea level, and above the high water level (50.70 above the sea level on this place). His hypothetical reconstruction drawing of the pre-Ottoman bridge in Mostar is shown in Figure 6 [7].

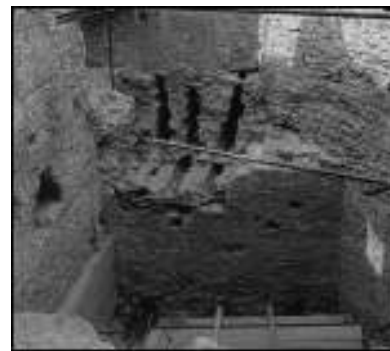
Figure 7: Archeological Investigation Proved Historical Development of The Bridge Site [8].

While the reconstruction of Ottoman Mostar Bridge between 2002-2004, during the excavation works, holes for the placement of timber beam elements and iron nails were found in the bridge site, which verified hypothesis of Goykoviç [8] (Figure 7).

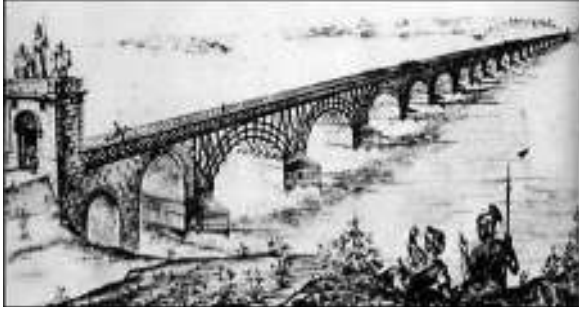
Figure 8: Reconstruction Drawing of Trajan Bridge

During the Roman Period, for the Emperor Trajan, multi arched timber Trajan Bridge was constructed with approx. 1200 m long. Leading to the modern day, Serbian River banks, for more than 1000 years this was the longest arch bridge ever constructed. It carried the Via Flamina, a road that began in Northern Italy and passed the shores of the Adriatic, crossing the Alps. Trajan bridge was depicted on Trajan Column [3]. (Figure 8,9)

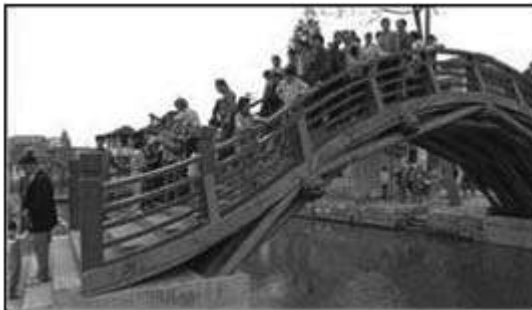
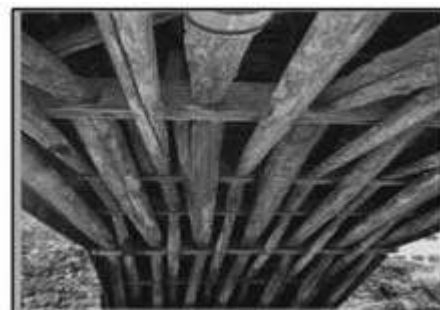
China has a lot of wooden arch bridges that were with unique construction techniques and skills. The use of techniques of beams, tenons and mortises make wooden arch bridges in Fujian Province and Zhejiang Province distinctive and commendable called as rainbow and woven bridges which were constructed by weaving straight logs crisscross together (Figure 10, 11).

Figure 10, Figure 11: Chinese Timber Arch Bridge (Rainbow, Woven Bridge)

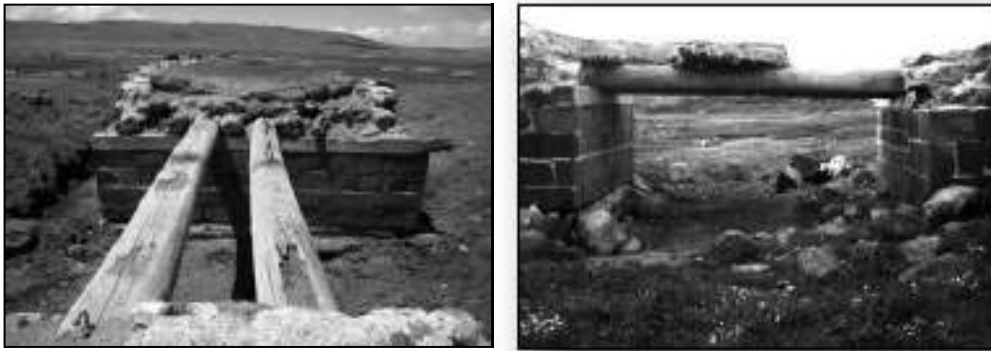
Figure 14, Figure 15: Historical Pular Bridge in Erzurum [12]

Second example from Turkey is Pulur which is also known as Yavuz Sultan Selim Bridge in Figure 14,15. It is located in Erzurum, Pulur Province, on Pulur River. It was constructed 15th century during the Ottoman Period with 135.35 m length and 5.50 m. width with four spans. While its piers were constructed with stone, the superstructure were passed by timber beam structure over it covered by soil covering. Bridge was restored-by General Directorate of Highways between 2010-2012 [12].

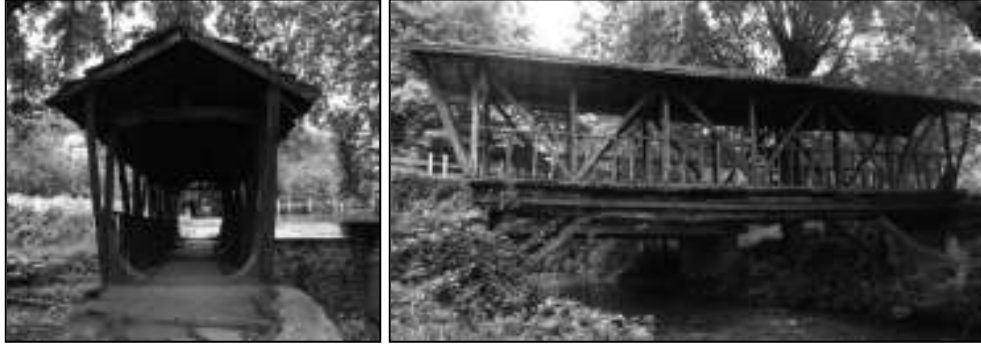
Figure 16, Figure 17: Historical Yakaören Bridge in Kastamonu
(Photographs taken by S.Yılmaz, June 2016)

The third example of a timber beam bridge is Historical Yakaören Bridge in Abana District in Kastamonu from late of 19th century. It is 18.50 m length and 2.80 m in width with one span of 11.52 m. It passes the river with two wooden logs with a 40 cm radius assembled over the stone abutments. The timber beam structure was supported under and over by strutting timber elements shown in Figure 16 and 17. [13].

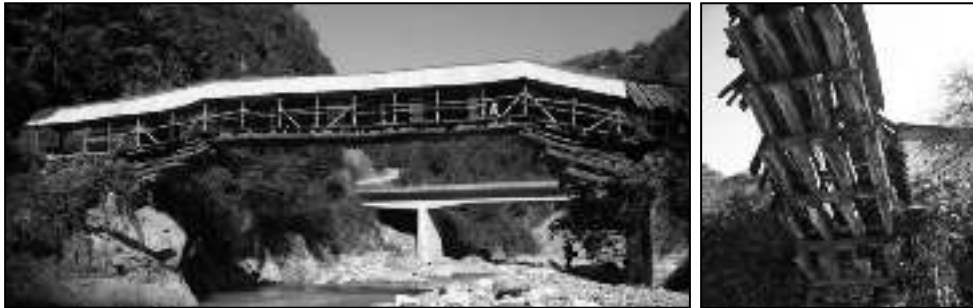
Figure 18, Figure 19: Historical Buzlupınar Bridge in Rize [10].

Historical Buzlupınar Bridge on Madenli Stream in Buzlupınar Village, in Çayeli district of Rize province. The bridge was burned out during a fire in 1906 and reconstructed by the inhabitants after the fire. The bridge is approximately 35 m in length and 2.20 m in width and its 21.80 m span length decreased to 12.50 m by cantilever transverse and longitudinal beams overlapping to each other. Because the superstructure of the bridge was fallen down in 1980s, it was restored by General Directorate of Highways between 2012-2016 [14],[10] (Figure 18,19).

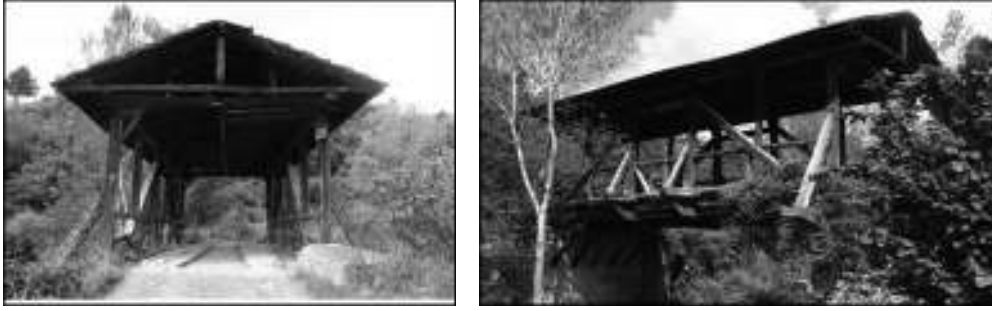
Figure 20, Figure 21: Historical Dörtocak Bridge in Kastamonu
(Photographs taken by S.Yılmaz, June 2016)

Historical Dörtocak Köprüsü is from 19th century in Tosya District in Kastamonu with 11.20m length and 3.90m width. One bridge was constructed over the river spanning 10 m with five wooden beams with a radius of 35 cm assembled on side Stone abutments. The superstructure of the bridge constructed with timber beam logs were hanged by timber elements. On the deck, trail woods were placed along the bridge deck for the easy access of coaches [15] (Figure 20,21).

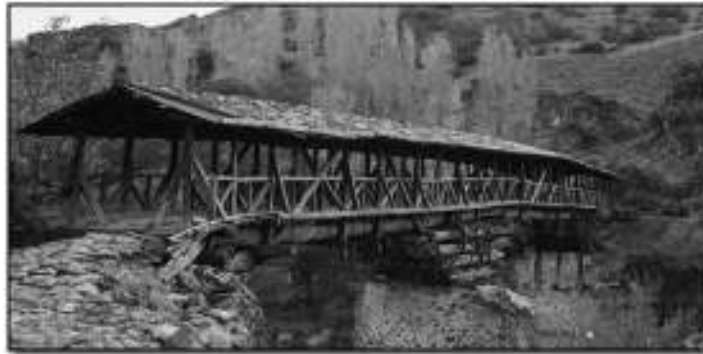
Figure 22: Historical Bayramören Bridge in Çankırı (Before restoration) [16].

The first example is Historical Bayramören Bridge, located on Melan (Soğanlı) Stream in Bayramören Sub-District in Çankırı District, was built in order to provide access between vineyards and truck gardens on the other bank of the stream and the settlement area. It has been rumored that the bridge dates back to 150 years ago. The bridge is approximately 64.80 m in length and 4.00 m in width with double spanned of 12.21m and 17.03m.

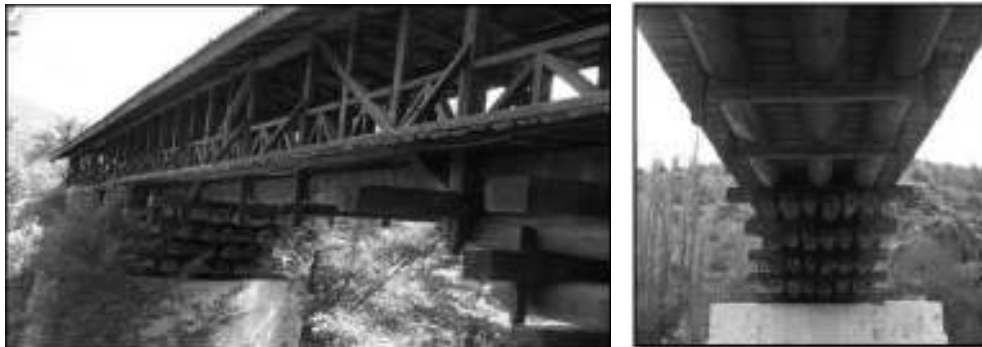
Figure 23,24: Historical Bayramören Bridge in Çankırı (After restoration)[16].

The bridge has constructed with hybrid system which combines cantilever and suspension structural systems together. That is, the main timber girders were supported by the cantilever system established through overlapping and locking transverse and longitudinal beams on the stone piers and also the main timber girders were hanged by suspension timber elements at the same time. (Figure 22). The bridge floors were formed on the main girders at a height of 9.00 m from the base level and trail woods were placed along the bridge floors. Bridge was reconstructed by General Directorate of Highways between 2000-2001. (Figure 23, Figure 24) [16].

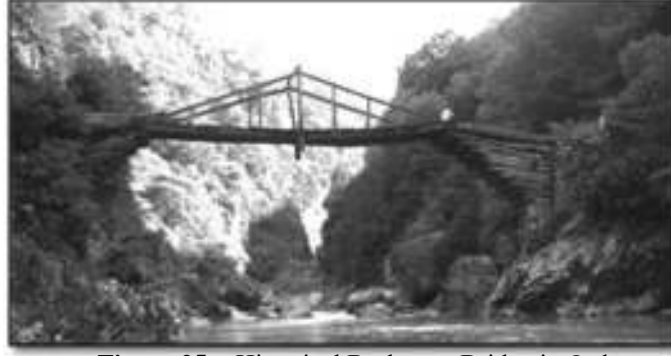
Figure 25: Historical Başkotanı Bridge in Ordu constructed with hybrid system[17]

The second example is Historical Başkotanı Bridge located in Kabadüz District in Ordu. Bridge was constructed in 19th century with approximately 30 m length and 2m width with one span of 18 m. The bridge has constructed with hybrid system that the main timber girders were supported by the cantilever system established through overlapping and locking transverse and longitudinal beams and also the main timber girders were hanged by suspension timber elements at the same time (Figure 25), [17].

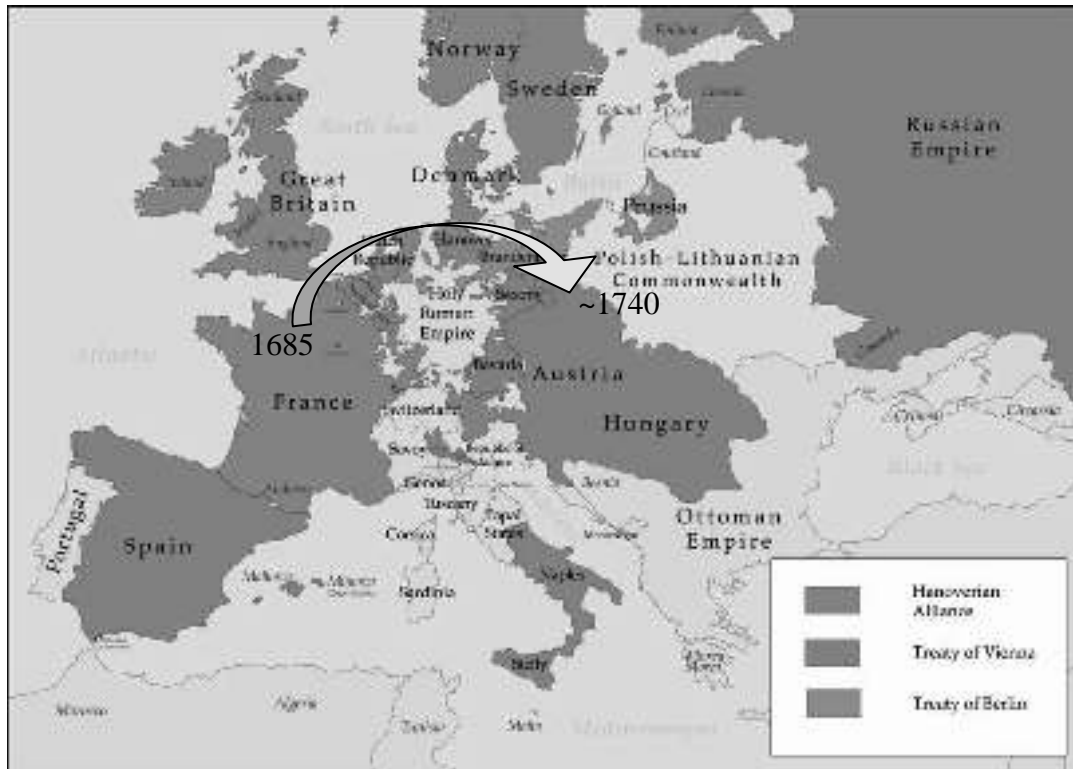
Figure 2: The development of rafter framing in Europe

Despite the fact that the timber roof structures, which evolved in the Baroque period to take the form of a mansard roof, are in principle analogous throughout Europe, when analyzing the described structures situated south and west of Silesia [4, 5], one may arrive at the conclusion that at least with reference to this analysis, the most crucial are those studies which refer to the description of the development of timber roof structures in German-speaking territories [6, 7].

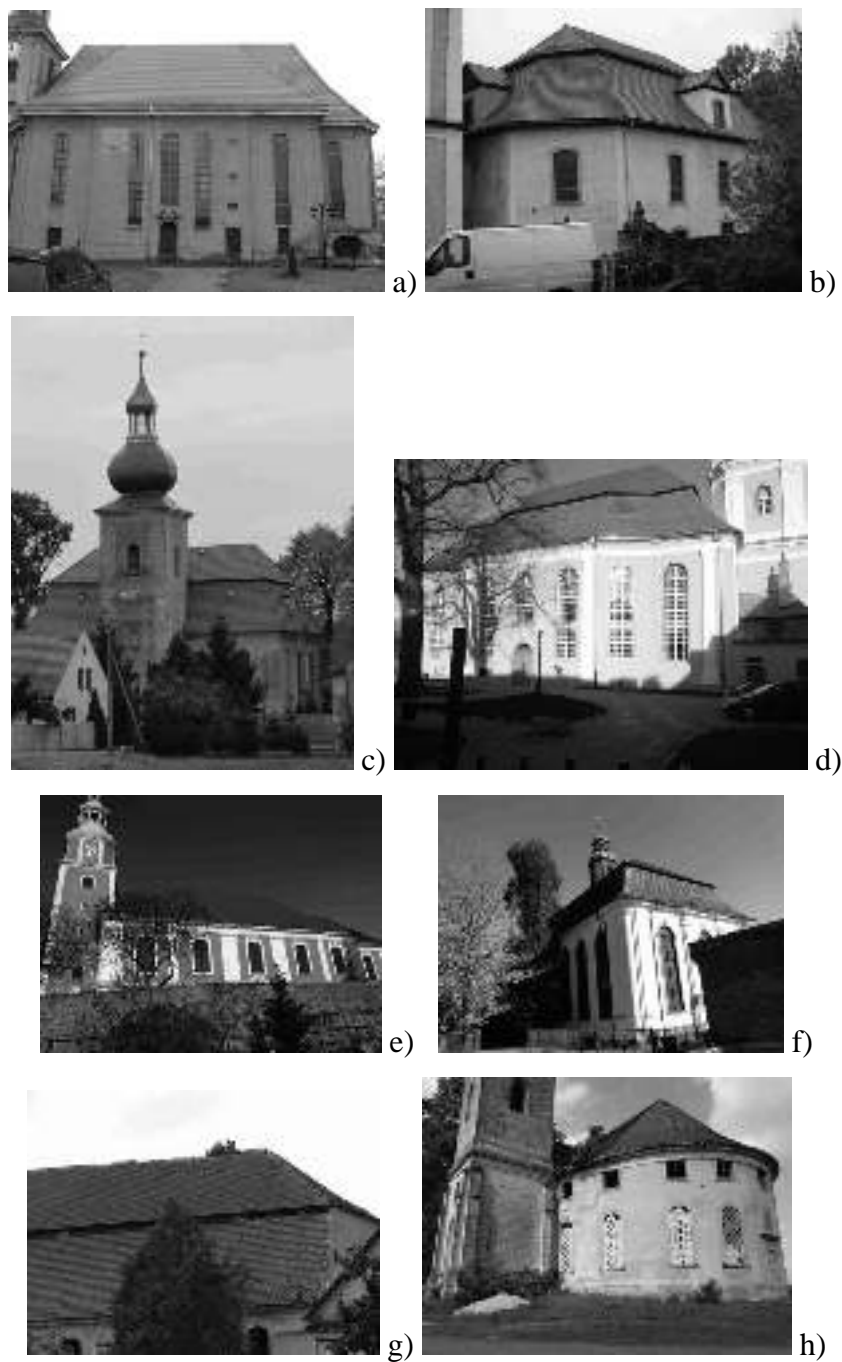
Figure 10: Selected churches from the Table 1. a) Iłowa, b) Nowy Kościół c) Kosiska, d) Cieplice, e) Pławna Dolna, f) Siedlęcin, g) Ocice, h) Żeliszów

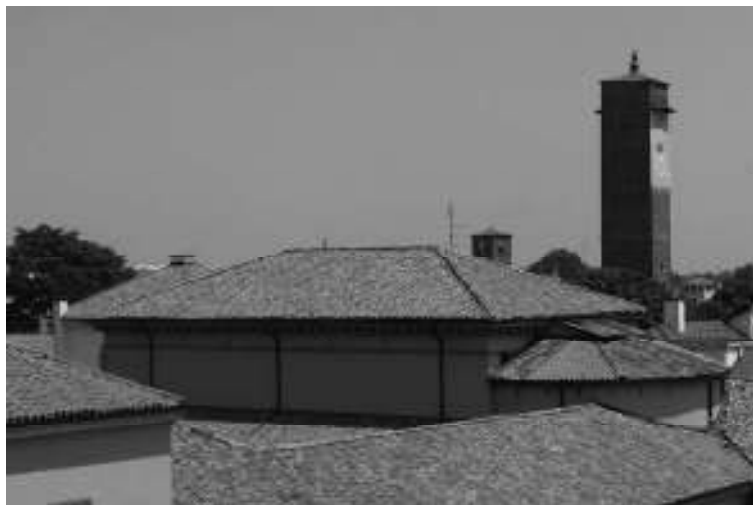
Figure 2: The Great Hall photographed from south-west. We can see the hipped roof of the hall and the roof of the apse shaped as a truncated cone with a single pitch covering the former skylight (photo by E. Zamperini).

The pronaos has an autonomous gable roof; the apse has a semi truncated conical roof ending at the top with a skylight now covered with a single pitch with curved tiles; the lateral bodies are single pitched, in the back of the hall they are connected to the roof of the rest of the building, in the front they end with a hip; the roof above the properly called hall is a hipped roof. Since the other parts of the roof are not accessible and of minor constructive importance, the paper will focus on the hipped roof of the hall.

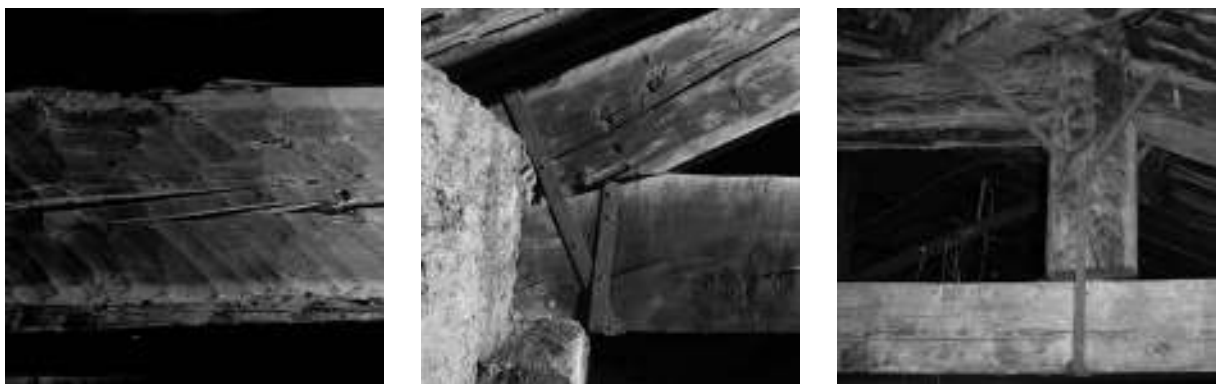
Figure 5: On the left: traces of hand working with the hatchet that can be seen with raking light.

In the middle: iron strap bandaging the tie-beam rafter joint of truss 5.

All the joints between rafters and tie-beams are reinforced with one big wrought iron nail and a bandage made with a thin iron strap, this probably originally put in place after heating (fig. 5 in the middle). All trusses are “open-joint” trusses, i.e. each post is raised from the tie-beam and jointed to it with an iron stirrup strap [7]. In queen post trusses, stirrup straps are Y shaped, that means that each end of the strap is bifurcated to connect also the rafter and the straining beam in addition to the post (fig. 5 on the right, 6 and 7).

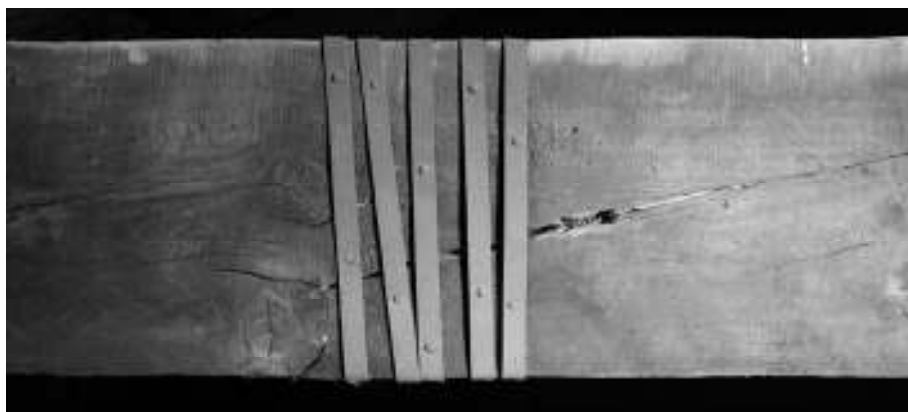
The tie-beams of truss 2, 4 and 5 have some big knots next to each other. This concentration of knots gives timber high local grain deviations, leading to the opening of cracks that weaken the resistance of the tie-beam, particularly to bending moment. The three tie beams have been repaired during time; probably truss 4 was repaired during building works, since the materials used are similar to those used for joints between rafters and tie-beams (fig. 5 in the middle and 8). Tie-beams of trusses 2 and 5 have been strengthened with a different system: a pair of iron bars approximately 1.5 cm thick, 5 cm wide and 170 cm long are placed below the tie-beam in correspondence of the damage and they are kept in place with a couple of iron stirrups tightened with a screw and nut system. Stirrups pressing the iron bars against timber generate a high friction that makes strengthening system effective (fig. 9).

Figure 8: System used for the strengthening of the tie-beam of truss 5 (photo by E. Zamperini).

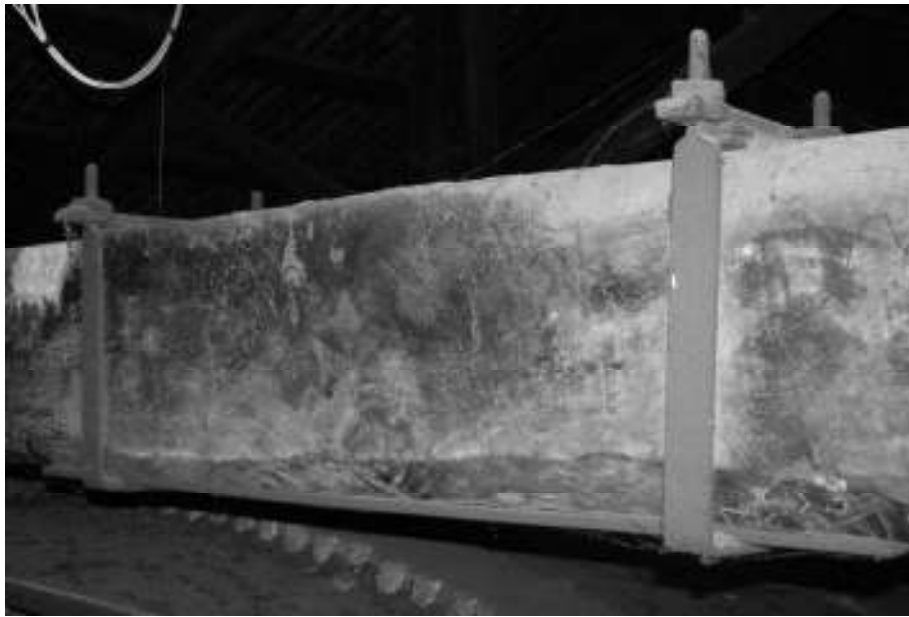
Figure 9: System used for the strengthening of the tie-beams of truss 2 and 4 (photo by E. Zamperini).

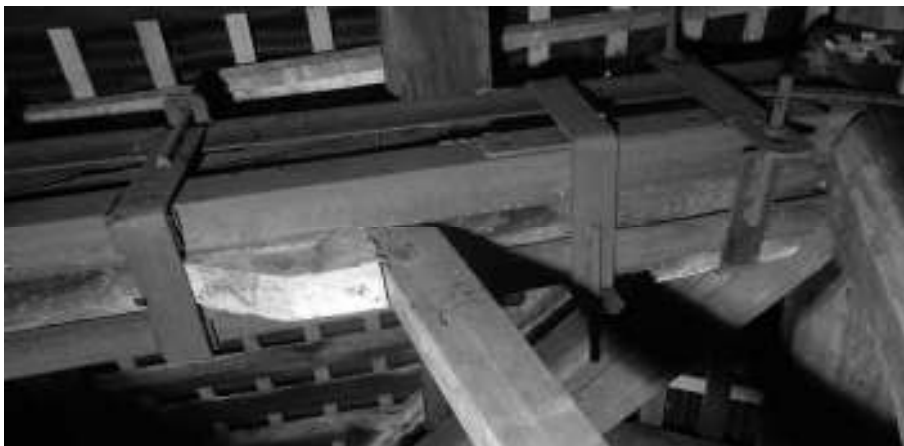
Truss 5 has an additional peculiarity: one of the rafters has been strengthened in its upper part with four laminated steel L section bars fixed to the timber rafter with four stirrup straps. The stirrups are made of a flat laminated steel bar bent to form a U (to enclose the rafter) at whose ends short threaded rod pieces are roughly welded, and of another flat bar with a hole at each end in which threaded rod are inserted, and finally a pair of nuts to tighten (fig. 14). Simultaneously, two other struts were added in place higher than that of the original struts.

Figure 14: Strengthening system for the rafter of truss 5 (photo by M. Bosi, A. Cernuschi, E. Doria, P. Pilan).

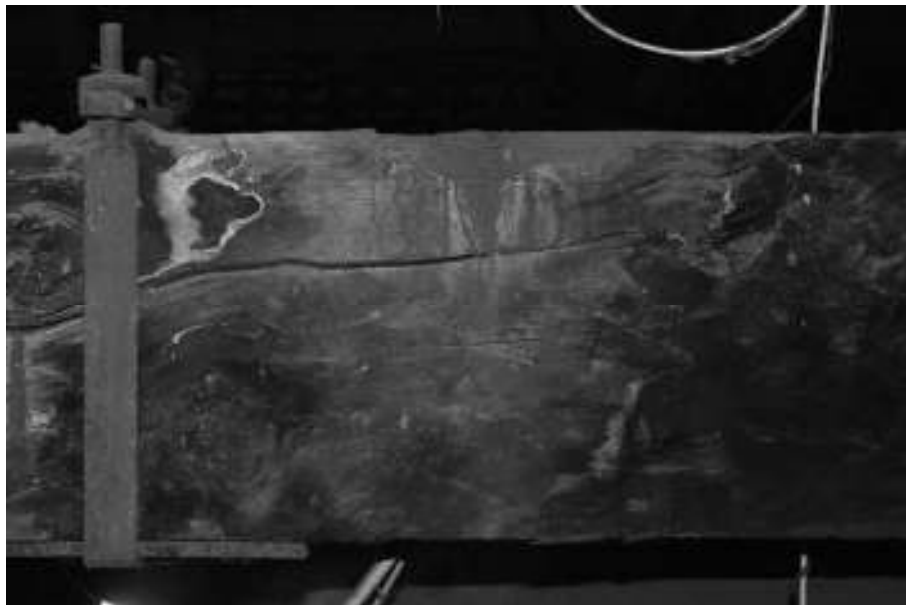
Although tie-beam is made of larch timber (quite resistant to biotic decay) and the attic is quite well aerated due to the presence of many small arrowslit-shaped windows, water leaking from the roof remains on wood long enough to make decay progress. It's therefore necessary a urgent intervention to stop leakage and prevent the progress of decay.

Figure 15: Incipient biotic decay phenomena in the tie-beam of truss 2
(photo by M. Canestrà, R. De Marco, R. Delogu, G. Godio).

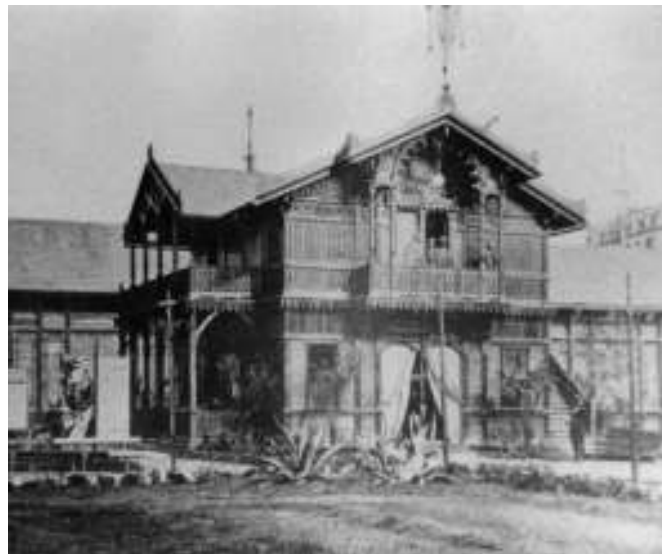
Figure 1: The Columbian Exposition at Genoa, 1892. Chalet Rinaldo Piaggio (arch. Riccardo Haupt).

In this context, the chalet of the *Rinaldo Piaggio & C.* at Sestri Ponente, designed by the arch. Riccardo Haupt in 1892 for the Columbian Exposition, is paradigmatic. The structure of this building, as an “archetypal architecture”, is realized integrally in pitch-pine. Wooden vertical studs and joints on the ground floor; exterior walls with boards spiked horizontal frame on the upper floor. This structure is inspired by the American model of the balloon frame, according to a manufacturing process which is based on technical standardization [3].

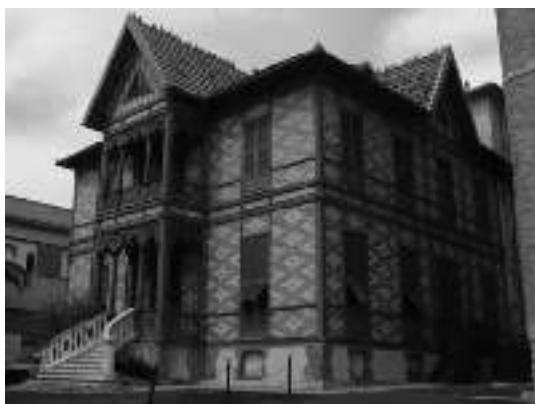
Figure 2: Parish rectory of Cristo Re, Imperia

We defined 4 categories: *residential buildings* [4], made up by two floors in eclectically style with the timber frame that pointed out thanks to the different materials used for the external walls (Figure.2); *bathing establishment*, very simple buildings with an unique and open space covered by a four pitch roof. The perfect conservation of these manufactures, constantly exposed to seawater and sand, is made possible by a constant and periodic maintenance of the timber wood; *public infrastructures*, located alongside the railway, like big warehouse, funicular terminus (Figure 3) or waiting rooms made by a simple frame structure; *industrial plants*, big warehouse used for defendant aims, for example the last Genovese timber frame shipyard perfectly conserved. The cataloguing of these structures, based on an experimental sheet, is very important because it allows to know where the case studies are located and consequently to preserve, maintain and enhancing their value.

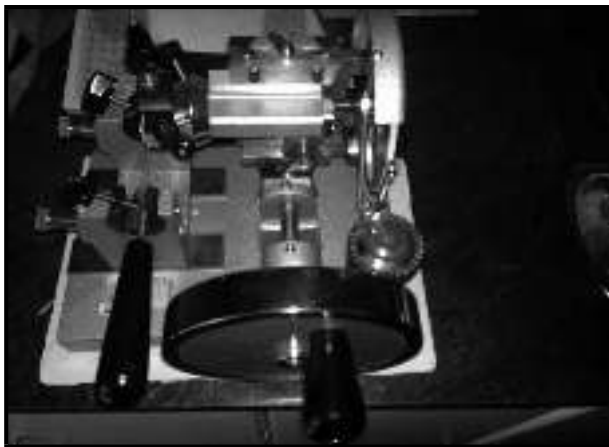
Figure 5:Microtome used to cut extremely thin slices

To understand the wood species, we used macroscopic and microscopic analysis with precision instruments that analyze wood cores and slices samples parallel or perpendicular to grain as the UNI 11118 suggests.[8](Figure 5-6)

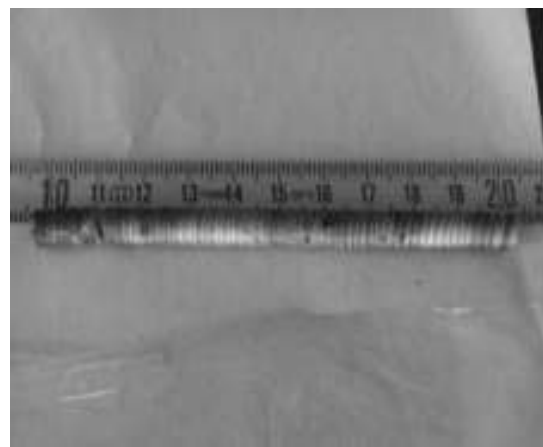
Figure 6: Wood core extracted from a beam.

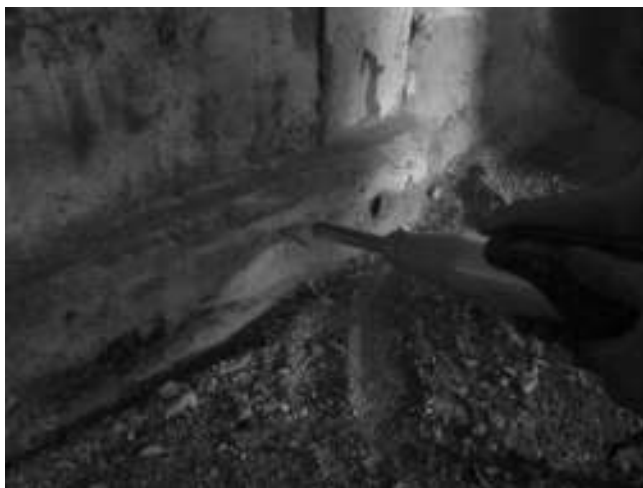
Figure 7: Mechanical Sclerometer Pylodyn

The assessment of density was carried out using the sclerometer Pilodyn (Figure 7) or the Mechanical DRC Wood Pecker, in some cases incremented with an experimental sclerometer with an elliptical nail. This mechanical test is limited cause the nail is 5 cm long and can't evaluate the whole section of the beam.

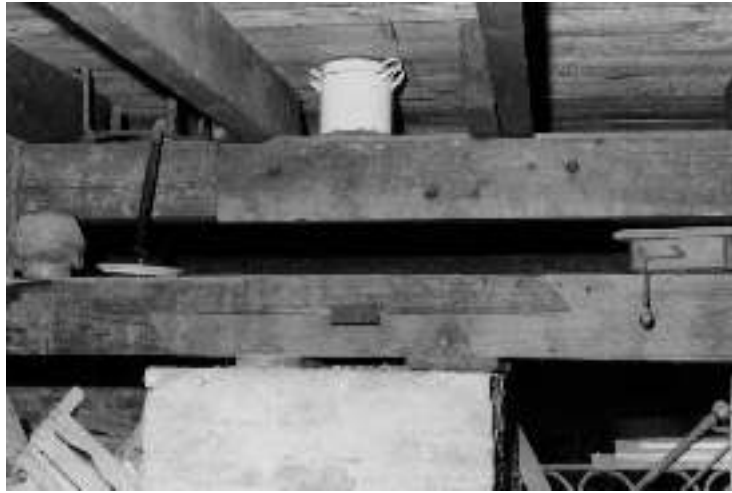
Figure 9: “stop-splayed scarf with key” joint that connect two sleeper in the foundation. San Sperato House (Reggio Calabria); similar to the one of Cav. Ferruccio Gay at the beginning of ‘900.

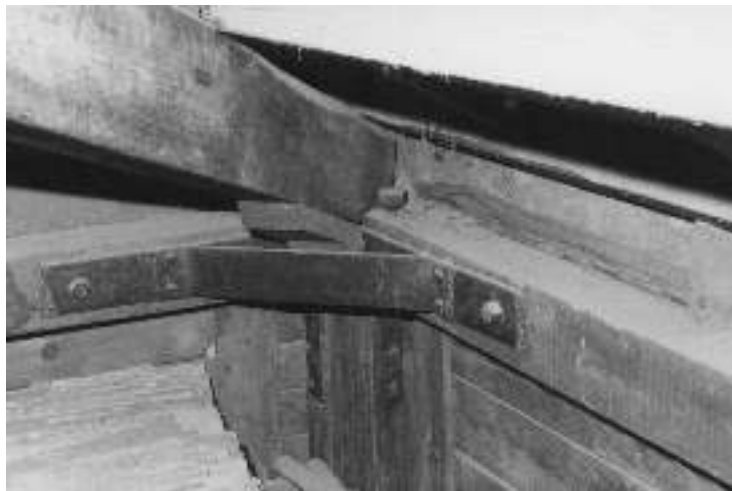
Figure 10: Metallic handmade elements to stiff and reinforce angle beams in the upper part of the structure. San Sperato House (Reggio Calabria); similari to the one of Cav. Ferruccio Gay at the beginning of ‘900.

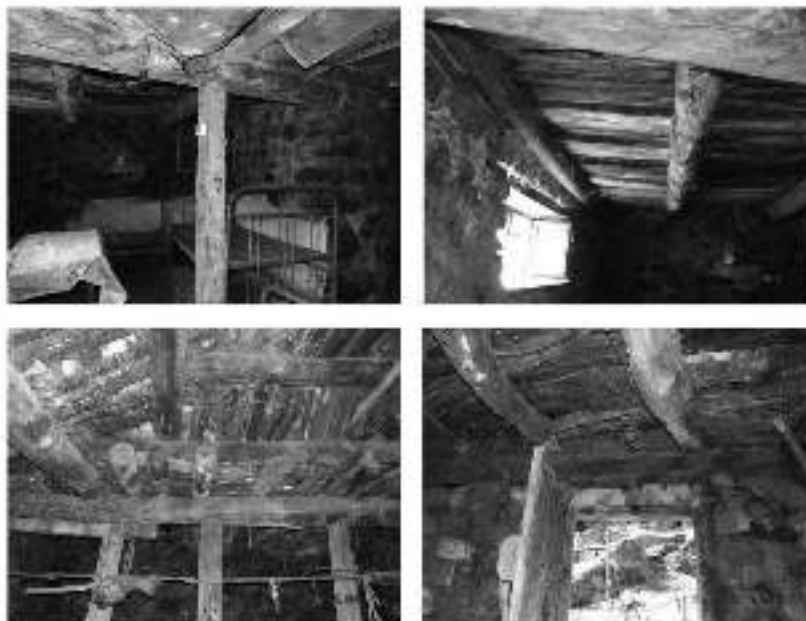
Figure 2: Photos of Tchatchkari dwellings. Medieval log and timber ceiling constructions.

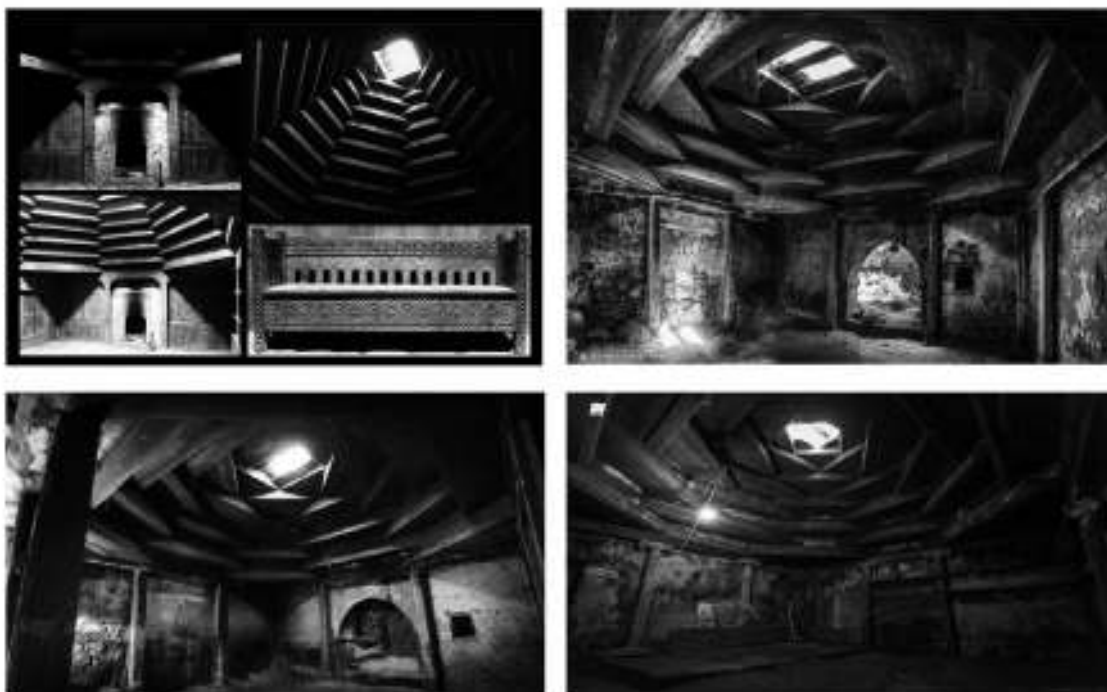
Figure 5: Meskhetian Darbazi Types [4,5]

Darbazis are really fascinating due to their original construction. From three sides building Darbazi is under the ground, similar to Daranis, and only entrance is free.

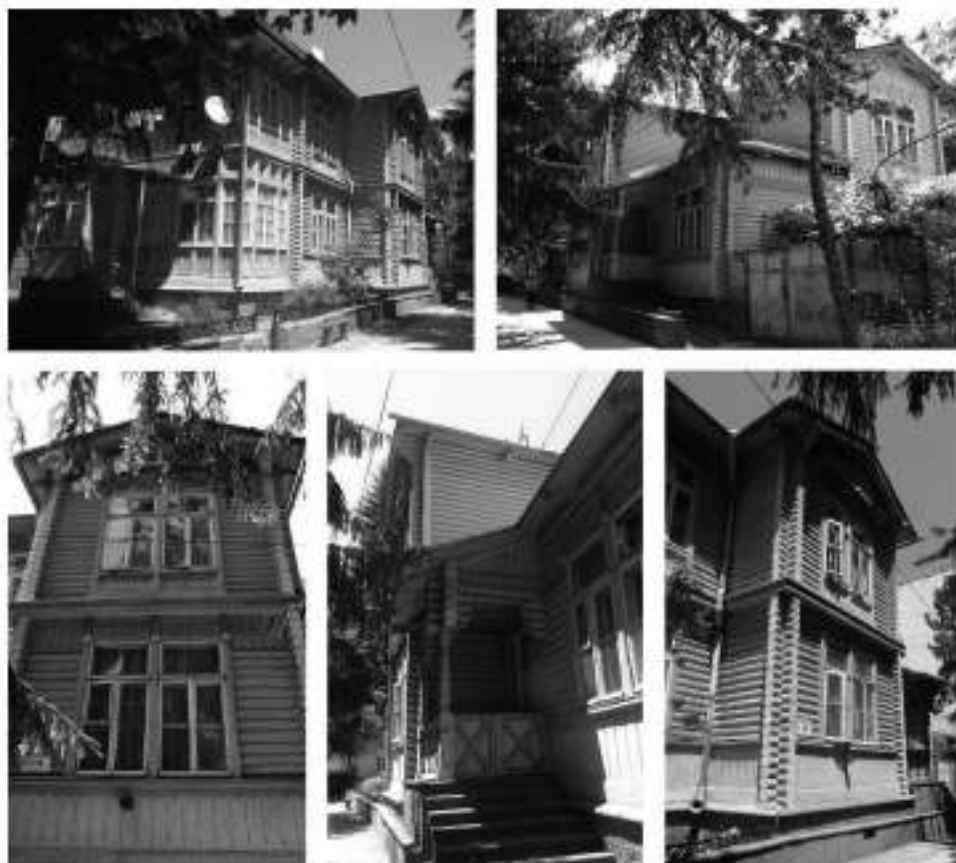
Figure 7: Log house. Rustaveli str. 117, Borjomi

These buildings are outstanding with their construction and decorative tiles. Log construction is one of the widely spreaded types of living houses of the beginning of 20th century, such as this beautiful living house in Borjomi, Rustaveli str. 117, called “Hunter’s house”.

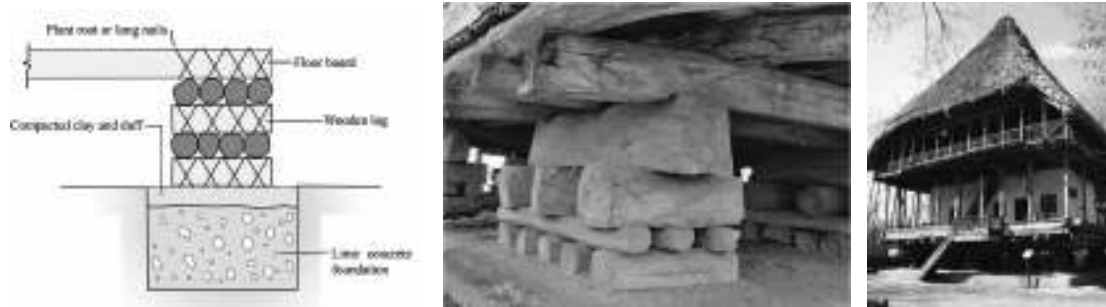
In moist ground, a *zogali* foundation is constructed, of which a part is outside the ground. A hole with a section of 150 cm square is excavated in the ground. It is filled with lime concrete and is covered with a waterproof layer of compacted clay and duff. A number of logs with a diameter of 30 to 40 cm and a length of 100 cm are bonded by plant root or long nails and placed on the lime concrete foundation. The next sets of bonded logs are laid on the top and perpendicular to the previous set of logs to reach the required height (Figure 2).

Figure 2: Zogali foundation

A stoneware pipe is inserted in the foundation for each wooden column. The diameter of the pipe is a few centimetres larger than that of the column. The lower part of the column is tarred and placed inside the pipe. The clearance of the column inside the pipe lets the column move during the earthquake and dissipates the earthquake energy (Figure 10). *Zogali* foundation is also capable of dissipate the energy of the earthquake transmitted from the ground to the buildings (Figure 2).

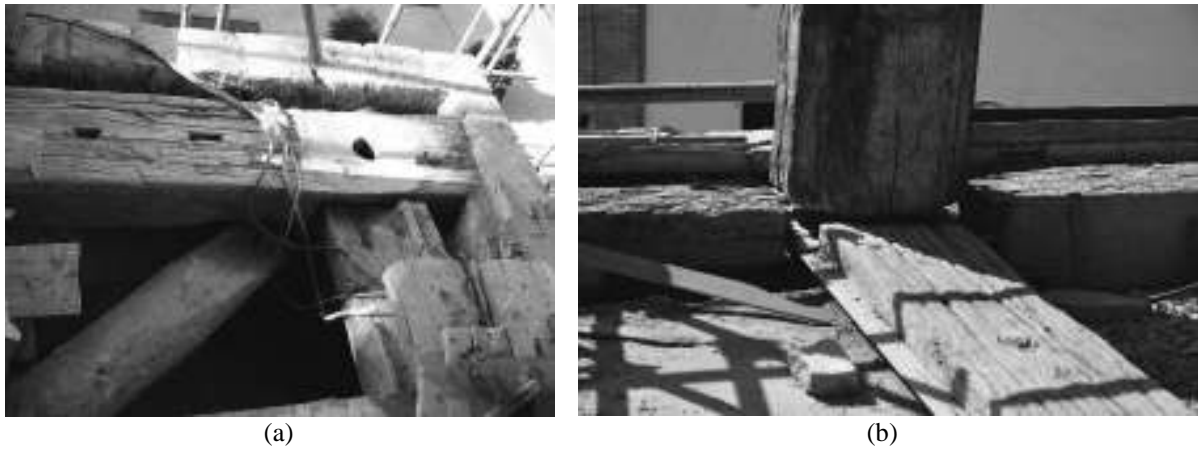
Figure 13: Floor ties between the columns: (a) corner, (b) strengthened with steel profiles

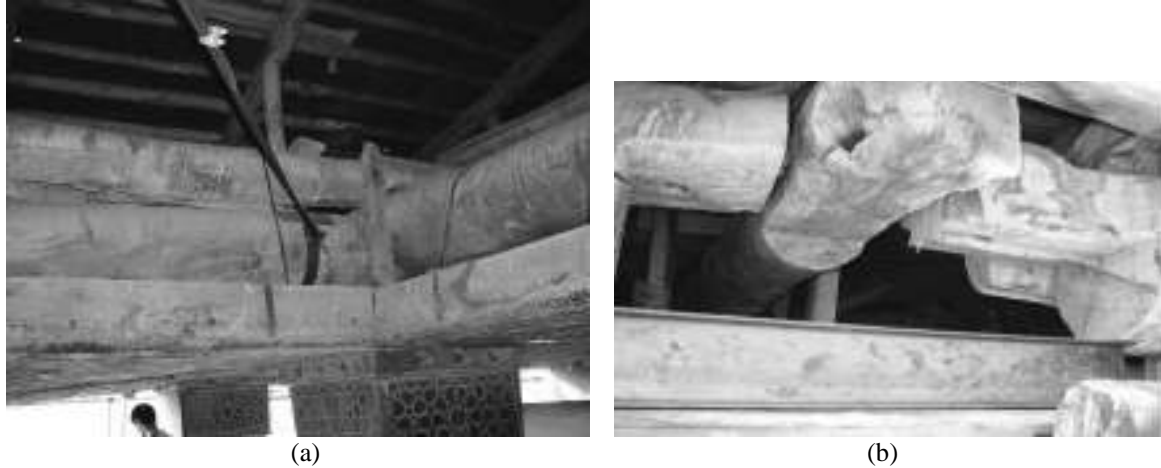
Long wooden main beams, three in longitudinal direction and six in transverse direction, are connected to the top of the columns by long iron nails; hence, making a simple connection capable of small rotation (Figure 16(a)). There is a secondary beam located at a small distance over each main beam (Figures 12(b) and 17(a)). Secondary beams support the weight of the top planks.

In some parts, wooden beams have been strengthened with steel profiles (Figure 17(b)).

Figure 17: (a) Secondary beam over the main beam over the column with a steel cable lateral bracing attached to the main beam, (b) a steel profile for strengthening the wooden beam

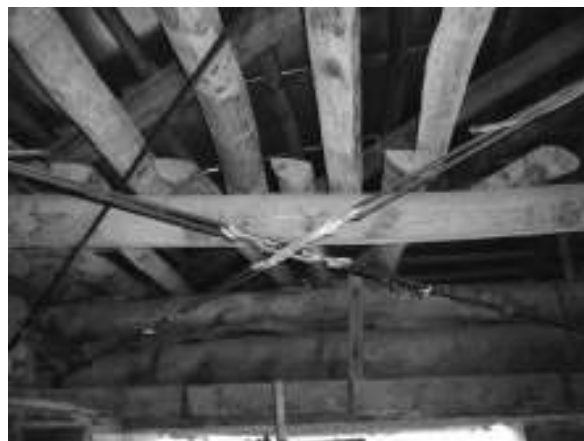
Figure 18: Wooden horizontal bracing system replaced by a steel cable bracing system that is too stiff

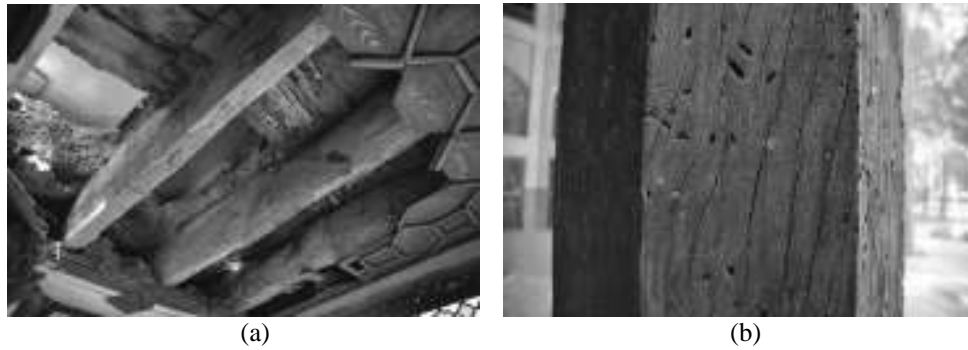
Different insects such as termites and beetles have widely damaged wooden elements in different regions in Iran (Figure 20). Termites have devastating effects on the structural strength of the wooden elements. There is not adequate information on the exact types of the insects and applicable methods of tackling them in Iran.

Figure 20: (a) Termite attack, Mosavver-al-Mulki house, Isfahan, eighteenth century A.D., (b) beetle holes, Hasht-Behesht building, Isfahan, 1897 A.D.

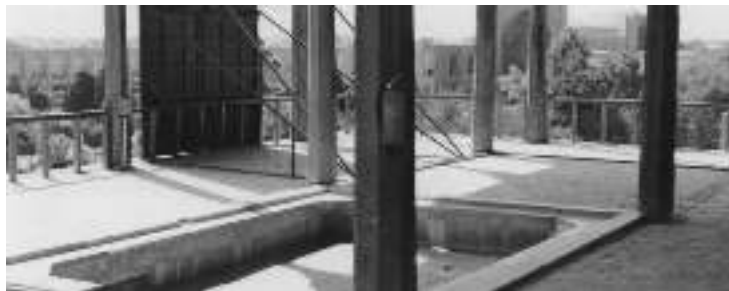
Fire is a potential high risk to most of wooden buildings in Iran. Usually there is not a proper design and adequate installation for fire distinguishing instruments (Figure 21).

Figure 21: Inadequate fire distinguishing system, Ali Qapu building, Isfahan, 1597-1668 A.D.

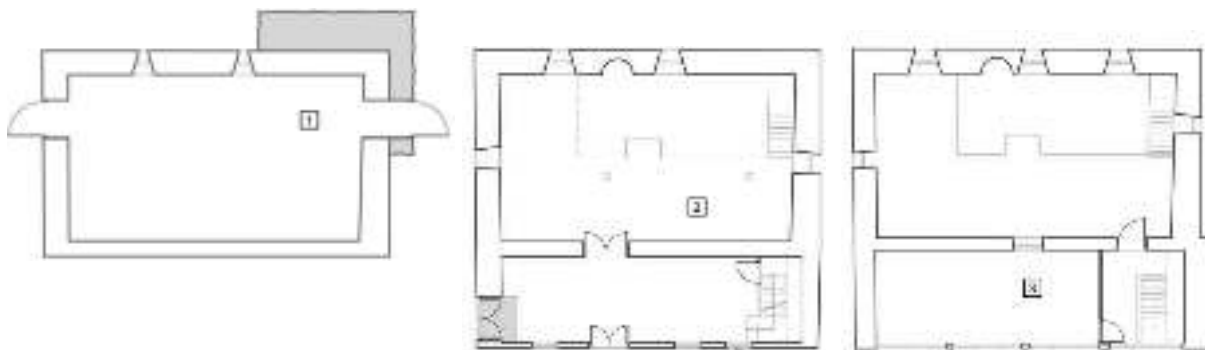
Figure 2: Plan of basement (1), ground floor (2) and the first floor (3) of Kučanska Mosque

The north-eastern part of the harem (adjacent to the building) is closed, with metal structure and glass (visible on the left side of frontal façade and on the right side of rear façade, Figure 3), thereby forming a new pre-space i.e. the side entrance to the Mosque (yellow shaded in Figure 2), and putting out of function the original front entrance. As a result, side passage to the remaining part of the Mosque courtyard covering an area close to the shore of the river Ibar is closed, while the visual aspect of the street façade has been disturbed (Figure 3).
