STRUCTURAL HEALTH ASSESSMENT OF TIMBER STRUCTURES

**Proceedings of the International Conference
September 20-22, 2017 Istanbul, Turkey**

SHATIS'17 Structural Health Assessment of Timber Structures
September 2017

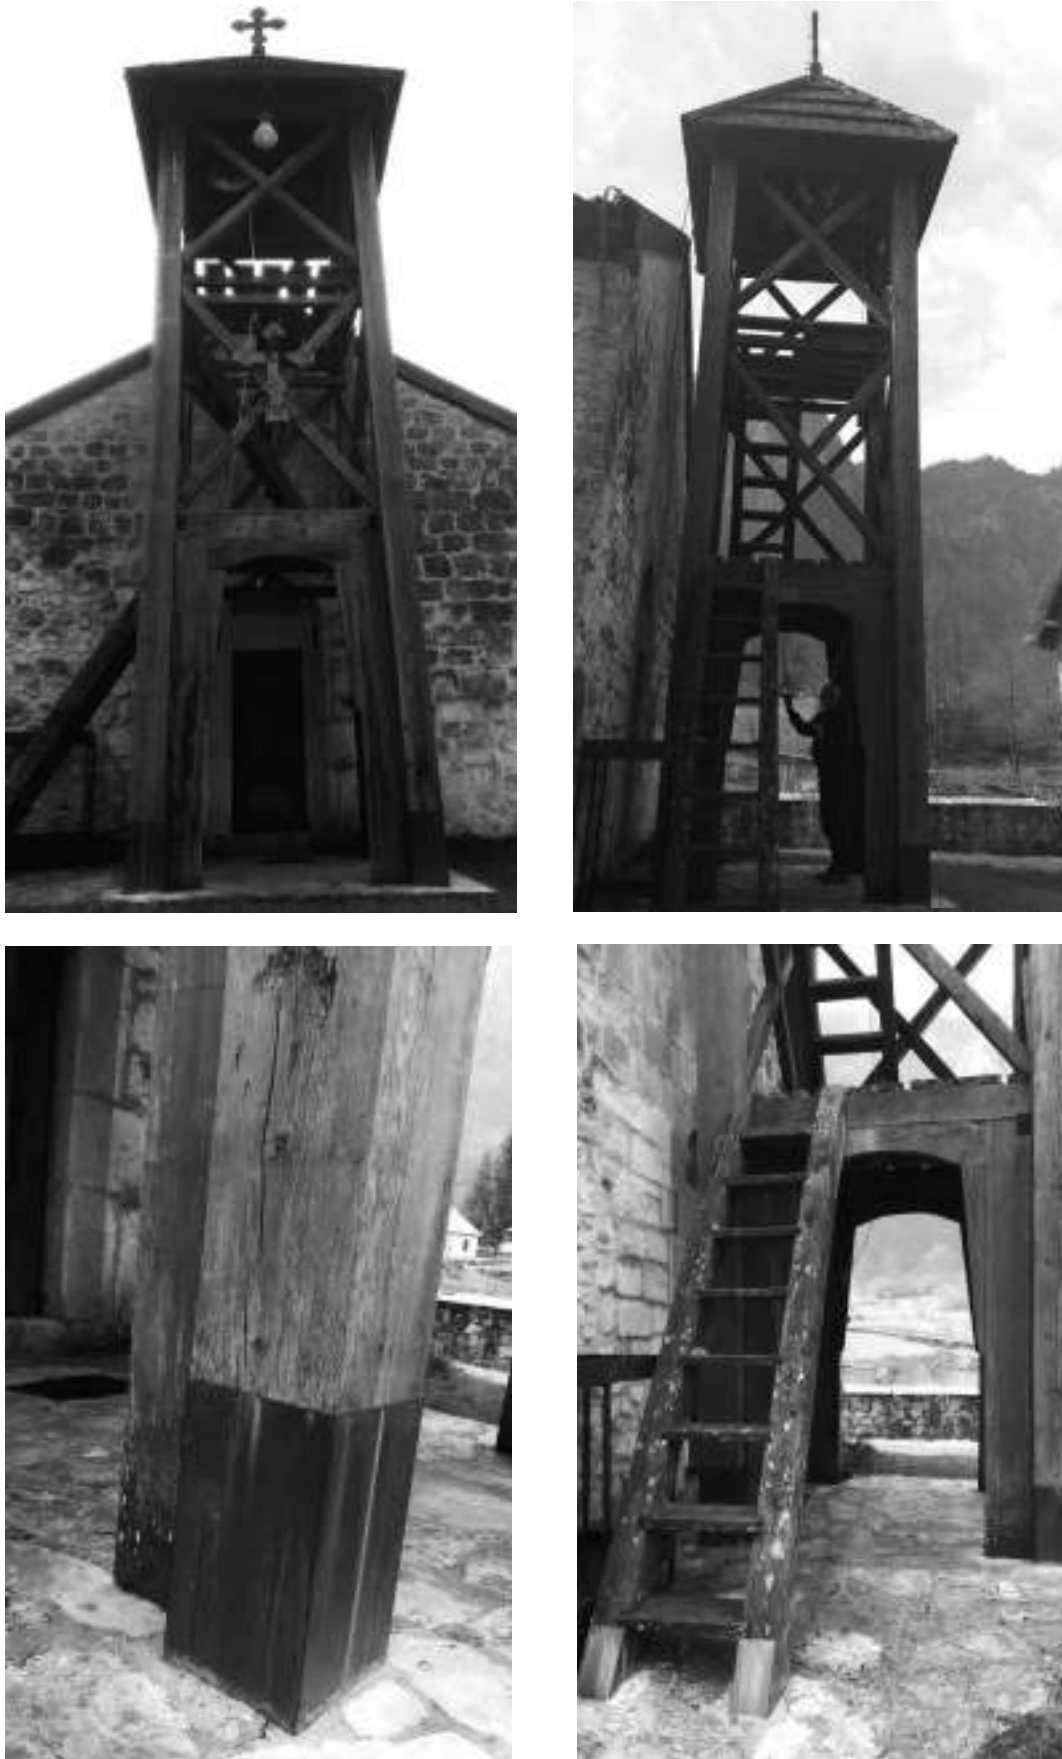
A high wooden bell tower has a hipped roof covered with properly sliced wooden shingles. The lower part of the bell tower is built in the form of an open portico (Figure 7).

Figure 7: Wooden bell tower of Monastery Dobrilovina

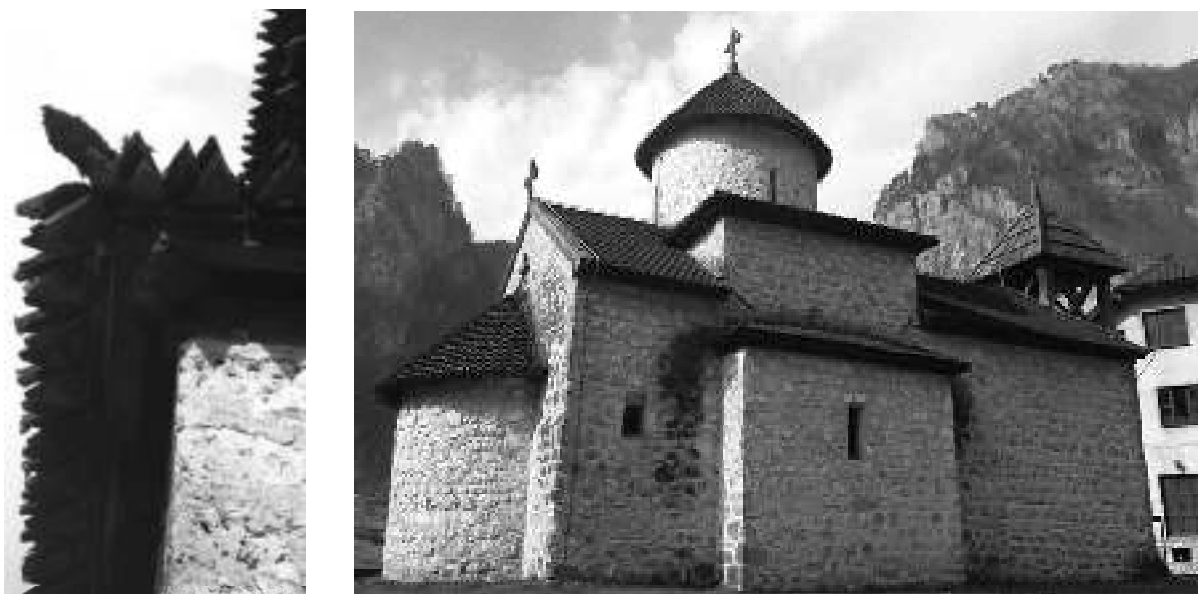
Figure 8: Details of roof cladding decay and rain water traces on walls of Monastery Dobrilovina

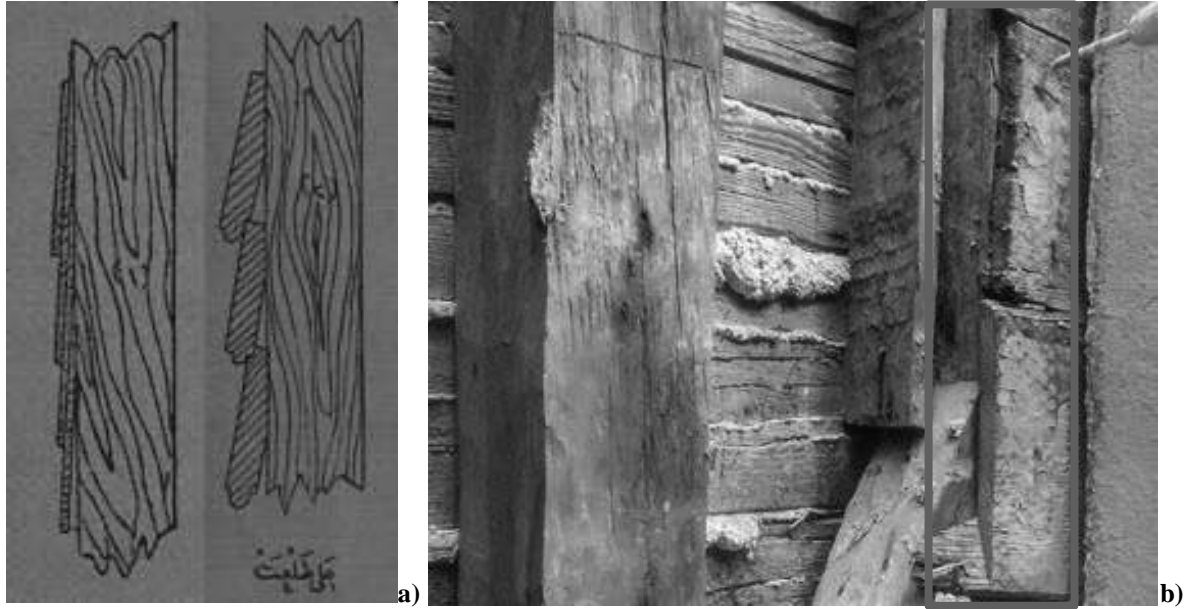
The covering of outer walls with timber boards started in the first half of eighteenth century in Istanbul, however timber boards were used only to cover the sea facing façades of *yalis* on the Bosphorus, while other *hımış* residential buildings had clay or lime plasters. In the period between late eighteenth century and early nineteenth century outer façades were covered with hand-cut timber boards. (Fig.1) The boards were nailed towards the upper edge, just below the joint where they overlap (Fig.3a) or they were nailed on both upper and lower edges,

which were inclined so as to prevent the water leakage into the building. (**Fig.3b**) The second half of the nineteenth century witnessed the emergence of timber boards with tenon-mortise or half-grooved connections. These timber boards became factory-shaped at the end of the nineteenth century with the establishment of Ahırkapı Timber Factory in Istanbul [2]. (**Fig.4**)

Figure 3. Timber façade covering boards from **a)** Ali Talat drawings [3] and **b)** Tuzcuğlu House at Beylerbeyi [4]

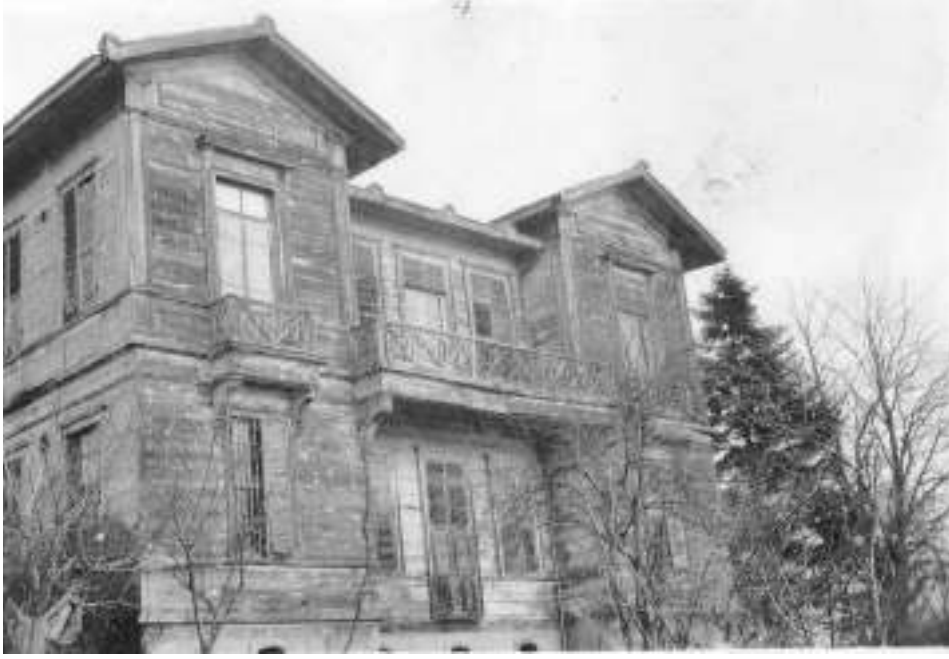
Surface coatings applied on the façade of a prefabricated timber framed house built at the end of the nineteenth century for Prince Vahdettin were recorded in a contract prepared by Imperial Building Department (*Ebniye-i Seniyye Anbarı*) before the construction of the house [15]. (**Fig. 5**) The contract includes detailed descriptions of all sub-systems (foundation, timber frame, roof, finishings and exterior coatings) of the building. All the coating layers listed in **Table 1** are briefly mentioned in the contract and the technical specifications notify that “Marseilles (French) lead white” and American and Marseilles turpentine oil had to be used in the paint layers as the best quality coating materials. Similar to Prince Vahdettin’s timber house, nineteenth century building cost-estimates reveal that most of the timber buildings built for the imperial family members were coated with linseed oil-lead paste and paints.

Figure 5: Prefabricated timber house constructed for Prince Vahdettin in Çengelköy (Istanbul Protection Board, Encümen Archive, 1955)

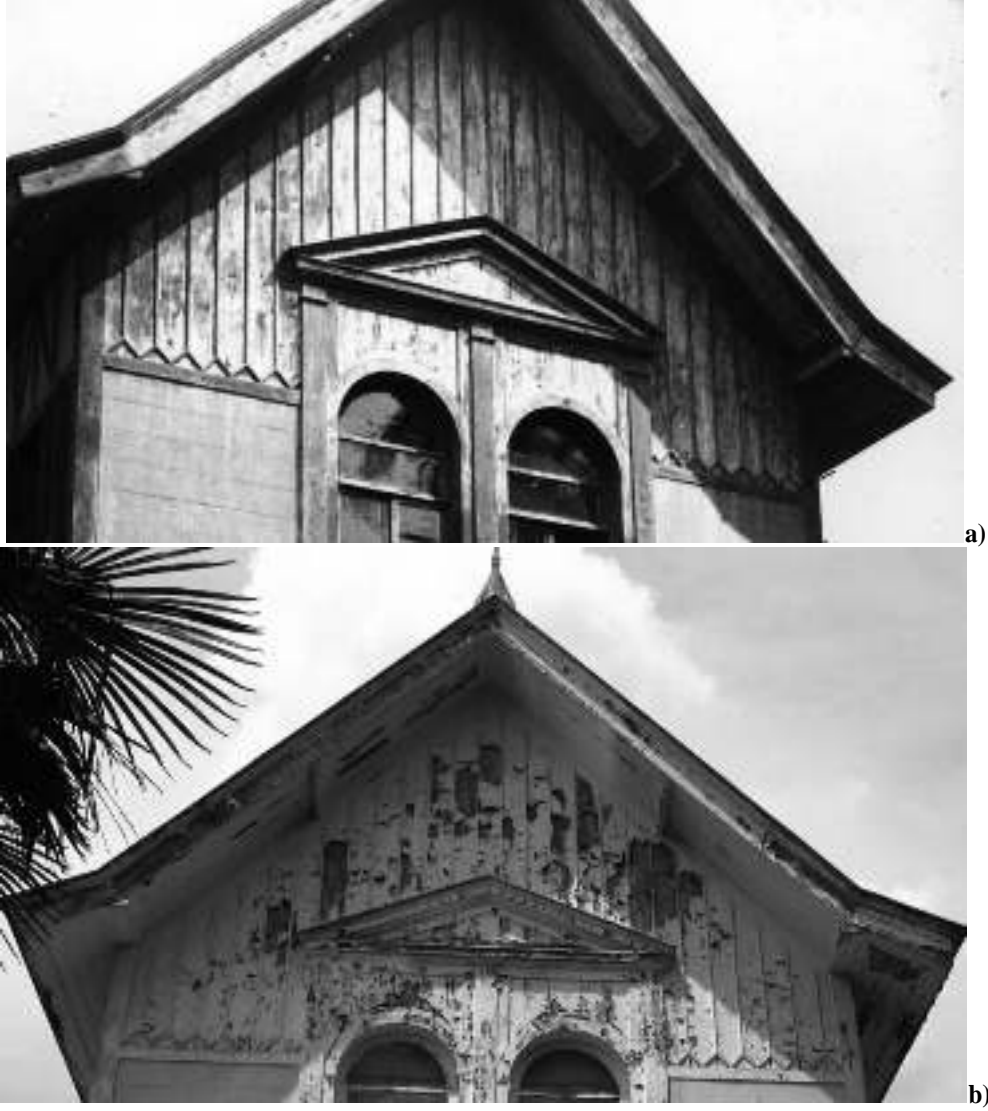
weather in a characteristic way, rather than become brittle and cracking, the paint gradually ‘chalk’ away to a matt surface. (**Fig. 6**) Weathered surface could be easily recoated after a few years without removing any rest paint from the surface. The texture and surface of weathered historic buildings significantly influence the public attitude towards timber heritage.

Figure 6: Roof forefront of Prince Kemaleddin's house in Dolmabahçe Palace showing the aging of **a)** linseed oil paint (1966 – Turkish National Palaces Archive) and **b)** modern plastic paint (2008 – D.Acar)

Apart from the damages to texture, the brittle and unflexible film layer formed by modern plastic paints tends to crack and enclose the rainwater under the detached paint layers. The rainwater that cannot evaporate from the surface triggers the activity of wood decaying fungi, which leads to fast deterioration of authentic timber covering planks and the structural timber elements. Moreover, one has to remove all the plastic paint from the surface of the timber before recoating, which is time consuming and threatens the integrity and texture of the surface.

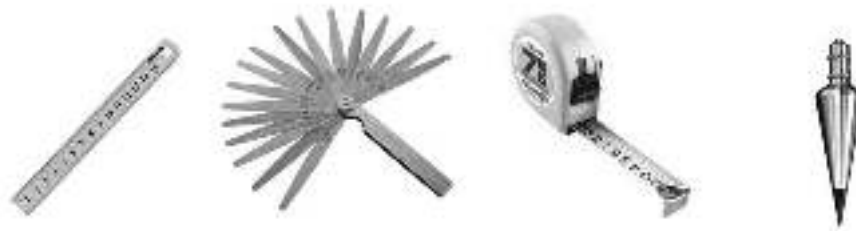
Figure 6: Straight ruler, feeler, box ruler and plumb

survey and assessment process including ruler, feeler, box ruler, plumb and so on shown in Figure 6.

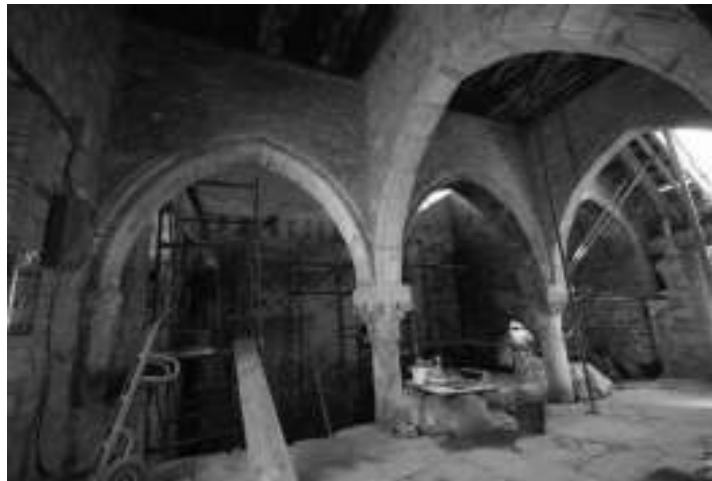
Figure 2. The gothic Venetian loggia looking from the north, during restoration work. The two transversal arches are Ottoman era additions. The transversal Ottoman-era wall within the loggia has already been removed

building (Fig.1). Upon entering the building, looking to the left, one can see a colonnade consisting of two reused palaeochristian Corinthian columns supporting three ogival gothic arches (Fig.2). It used to be a loggia open to public space in Venetian times, before the Ottoman extension enclosed it. In fact, the surviving part of the building was itself a *public loggia*, a civic building comprising a covered open space on the ground floor, where various administrative functions, such as tribunals and public announcements took place, and a large hall on the first floor, where councils convened [5]. The Ottoman extension of the building, to the north, consists of a stone masonry ground floor and a mixed masonry and timber-framed- wall first floor (Fig.1a) with timber floors and roof, that together with the older Venetian wing constituted a stately residence [6]. (From now on, when referring to *the building*, what is meant will be the Venetian wing of the “Bailo building”, except if otherwise stated).

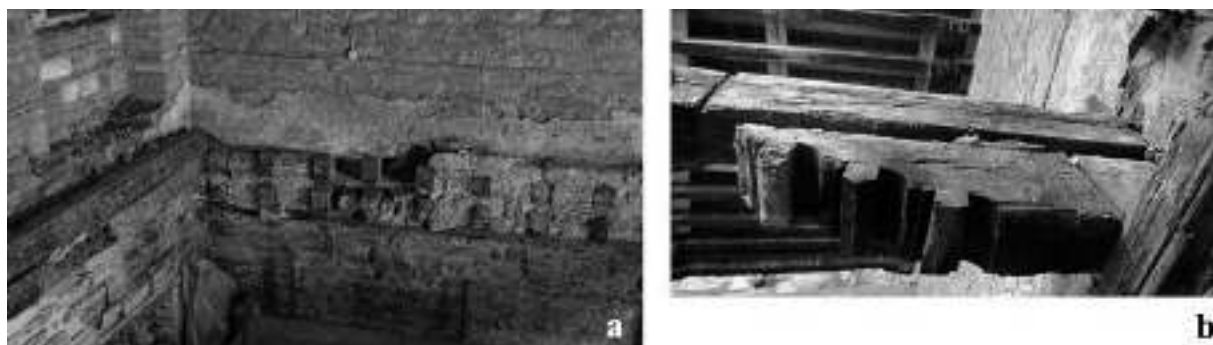
Figure 4. **a.** The remains of the original timber 1st floor, trapped inside the southern wall. To the left, the in situ 1st beam (with another beam placed over it, probably during the Ottoman period). **b.** The remains of the 12th beam, with its southern corbel and underlying cornice/tie beam

The only visible surviving elements of the original floor were one timber beam adjacent to the eastern wall, and underneath its northern end, a wooden corbel. This type of corbels, feature a typical sculpted profile, and are known in the Venetian dialect as *barbacani*. On the southern wall, one could easily discern, still encased within the masonry, the wooden remnants of the original timber beams of the floor and their corresponding corbels, which had been sawn-off at some point in the past (Fig.4a). On the northern wall, only the gaps of the timber elements were discernible.

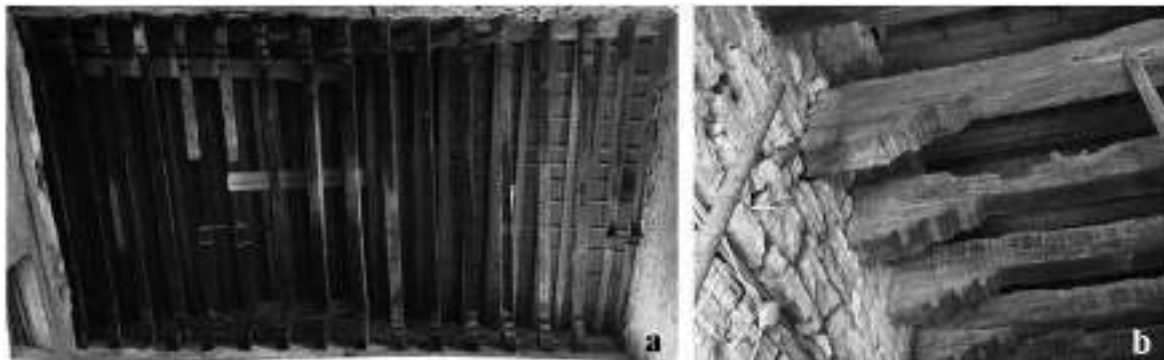
Figure 5. a. The second floor remains, underneath the modern roof. b. Closeup of some of the second-floor beams and corbels, before restoration began

On the second-floor level, there was a full set of 17 timber beams, with their respective corbels, all in place (Fig.5a). As already mentioned, in this case the corbel cantilevers provided a support for the beams, as they were in full contact. The form of the corbels was similar to the ones of the first floor. However, both beams and corbels of the second floor had larger cross-sections, probably because they belonged to a horizontal roof (terrace) of which the dead loads were much greater than the ones of the floor underneath. On the first floor, both beams and corbels had a cross section of 15 cm x 20 cm, whereas in the second floor, the respective dimensions were 17cm x 22 cm. Beams and corbels of the second floor had no grooves. As already noted by architect Nikos Delinikolas, who had studied these remains, small recesses (5 cm x 1.5 cm) were visible, cut out at regular intervals along the edges of these beams on their upper surface. Delinikolas had identified these recesses as shallow cuttings for the positioning of timber covers for the longitudinal joints of the overlying boarding. These joint covers were placed transversally to the beams' direction, whereas others ran parallel to the beams, resulting in the creation of a coffered ceiling. The joint covers formed the coffer frame, while the floor boarding planks formed the background.

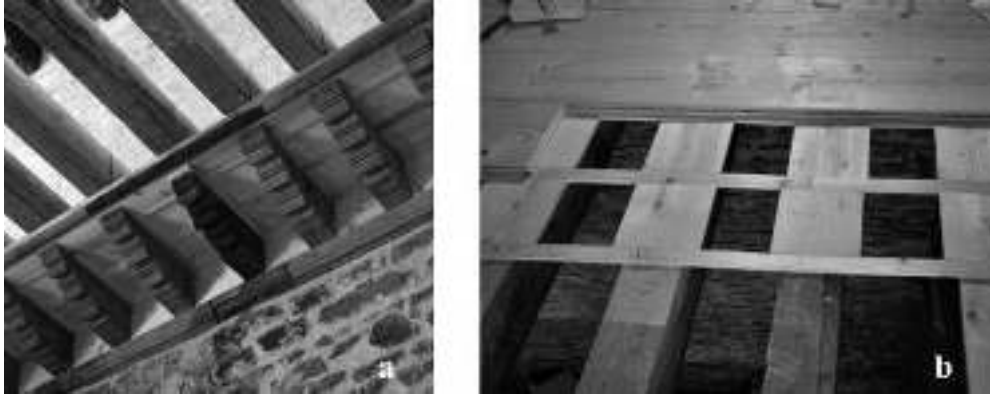
Figure 10. **a.** The in situ remaining original 12th corbel and underlying cornice, with the new corbels and beams. The lower coffered ceiling between corbels and beams is already in place. Discernible is the original braid element, that was found reused in the Ottoman wing by chance. **b.** Constructing the coffered ceiling over the beams. The *cantinelle* running transversally to the beams are made of strips as original, whereas the ones parallel to the beams are made of planks projecting over the edges of the beams, ensuring full contact of floor boarding and beams. Note some *tongue and groove* boarding planks that have already been screwed into place

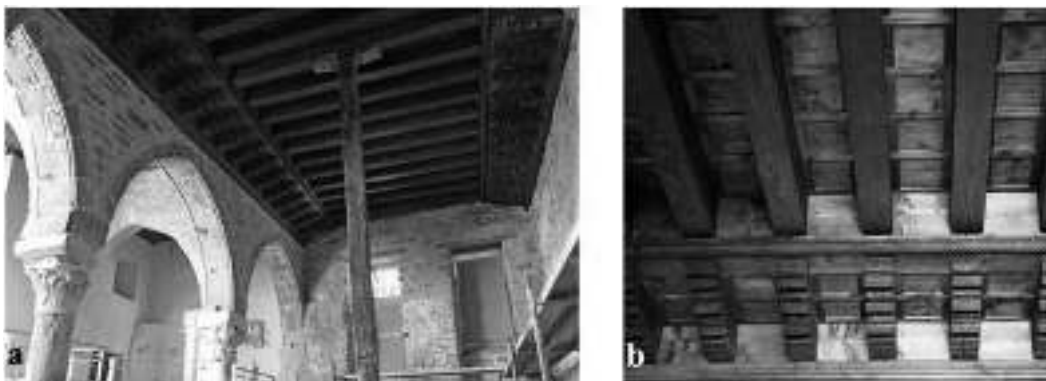
Figure 11. **a.** The reconstructed floor. The Ottoman era support column made of a reused Venetian beam was put back into place, as an important testimony of the building’s construction history. **b.** Closeup of ceiling

For the 12th beam, it was decided for extra security, that it be moved to the vacant westernmost position, where it would have to withstand half the loads than in its original one. However, its corbel and adjacent cornice were never moved, they remained and were conserved in situ (Fig.10a). It was decided that the other beam that had been reused in Ottoman times as a column be placed in its original position, under the new 12th beam, as an important element of the building's construction history [Fig.11a].

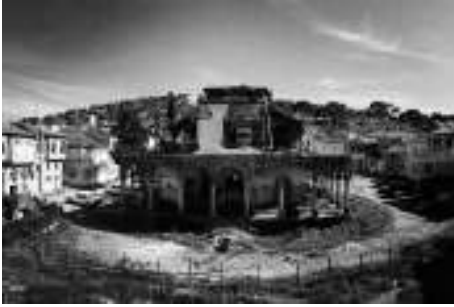
Figure 3 Hagia Triada Church Front Façade

Today, Hagia Triada is highly demolished and each day climatic conditions and misuse is increasing the degree of the damage.(Figure 3) To take urgent action; documentation and analyzing the building is very significant. Which has been used for a long time, caused structural and material deterioration and destruction of the structure. In this case, the structural system, construction technique and details of the structure could be easily analyzed. Furtherly this paper is going to give this deeper analysis of Hagia Triada especially its construction system.

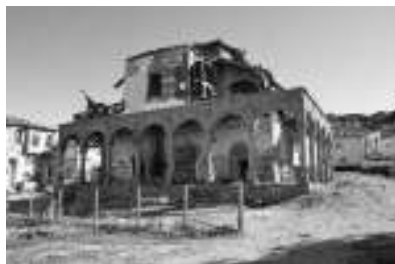
Figure 6.(Right) The aspect of Hagia Triada Church from 13 Nisan Street

The building has a composite structure that is used together with stone masonry and timber frame. The *narthex* was built with a stone arch system between cut stone columns while the main walls of the church were built as masonry rubble stones.(Figure 6) Several techniques have been used in the church as wall-forming forms.(Figure 7) This diversity observed in the walls is discussed in detail in the part of vertical elements. At the western of the church, on the narthex, there is a *gallery* built with a timber frame system. The three naves main space, wooden, one-piece columns that separate naves from each other, also carry the roof at the same time. The columns and walls are connected to each other by tie bar. The tie bars are fixed with clamps from outside of the main walls and ring-shaped fasteners on the columns. Openings between wooden columns, passed by diagonal timbers that forms arches. (Figure 5) Originally, the *apse* had a half-dome but today a large part of the *apse* is in ruins. All ceiling cover and roof system except the *apse* are built with wooden construction techniques.
