STUDIES in ANCIENT STRUCTURES

**Proceedings
of the 2nd
International
Congress**

**Proceedings of the 2nd International Congress
July 9- 13, 2001 İstanbul, Turkey**

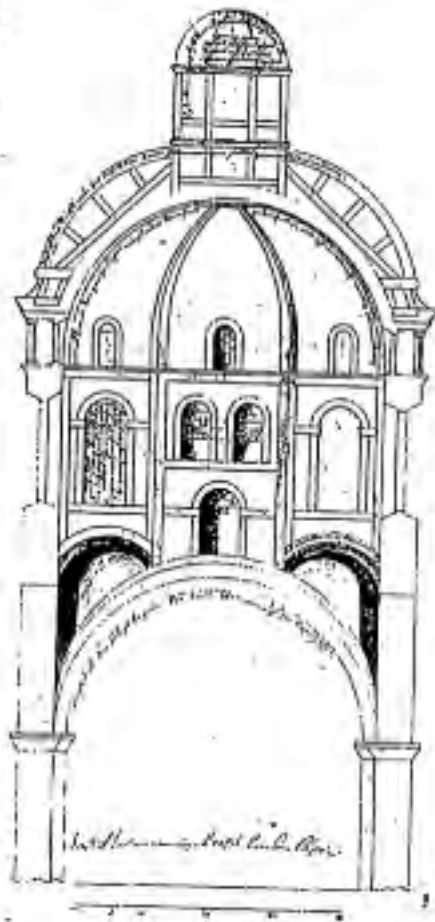
Fig. 4. : A "damage assessment" carried out in 1699 : The Domes of Speyer after a fire [4]

d) The cupola of the medieval Speyer Dome (Germany) (Fig.4) was damaged during a big fire taken place in the years of 1689. Much later (1893) in a complete monograph on the monument, W. Meyer-Schwartaus published an interesting sketch drafted ten years after the fire. (“Das ist das Profil inwendig von der Cupelwie jetzt noch stehet“). This finding, together with some (apparently contradictory) repair proposals (1699) (Abb.5), animated lot of later research and interpretations [3], before the final restoration, which took place much later, during the years 1970.

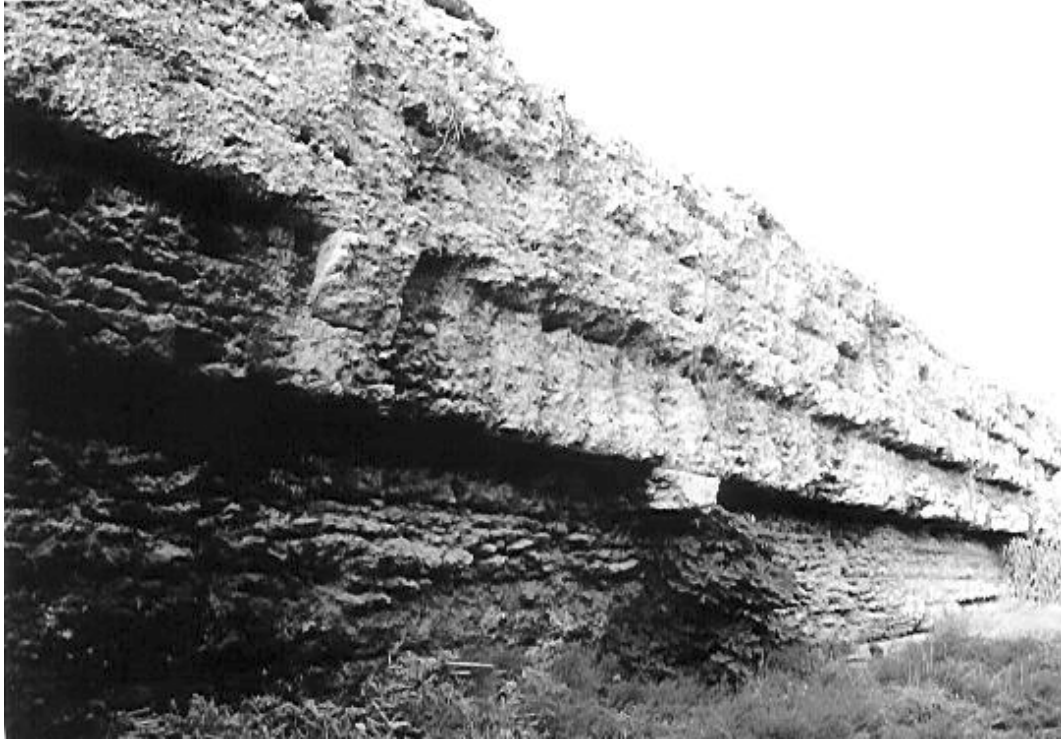
Figure 3: The stepped external surface of Block G

The building blocks rise over the stone blocks laid on a ~40 cm thick concrete floor. The building blocks, which still exist today, were made of Roman concrete in which pieces of stone and conglomerate of various sizes were used as aggregate and cast in place in the form of strata. As this method was used widely, there is the cast concrete section that serves as the core between the walls. The interior and exterior surfaces of walls are made of plain hewn stones without mortar [1, p.42]. At Donuktaş, the inner face of the stone wall which does not exist today was stepped inward to the core, ensure that the concrete section adhered to the stone face. By taking up the stones, the external surfaces of the concrete section appeared stepped (Figure 3) [1, p.45]. Unfortunately during the excavation no evidence related to the existence of a wall on the inner face was found.

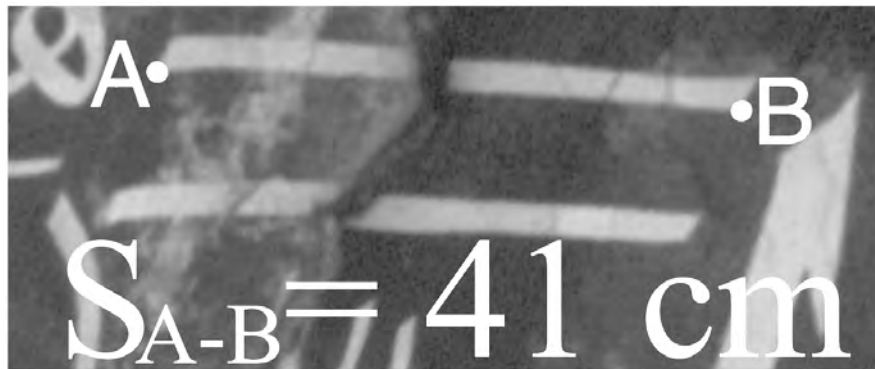
Figure 6
Width of the crack C1

Next we want to look at some selected cracks (C1,C2,C3) in the building. The locations are marked in figure 3. The crack C1 can be identified in some prepared images taken in the last 100 years, figure 8. The first image was taken between 1885 and 1908. At this time the mosque was renovated. In the years later the crack appeared. We know that the drum of the dome was plastered in the year 1955 and later on the same crack was visible at the outside. So we can say that crack C1 occurred in the last 100 years, the width of the crack is about 2 cm, compare figure 6. We think that crack C1 is very important because the pillar P1 is affected.

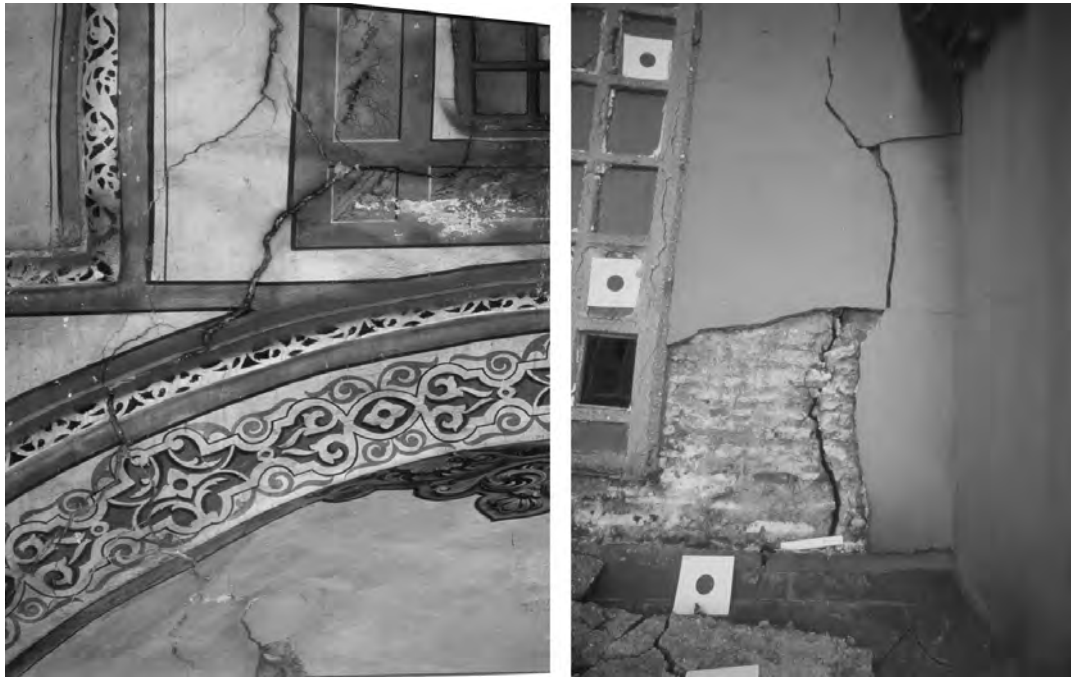
Figure 7
Crack C2 inside and outside
after the earthquake from August 17th, 1999

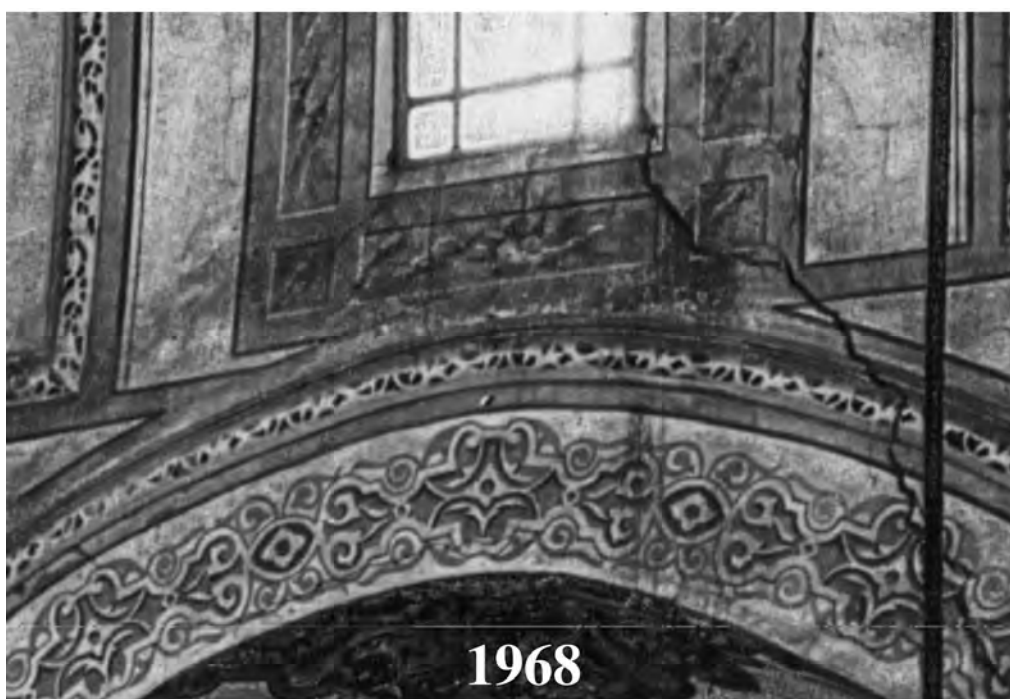
Figure 11
Crack C3, images of the years 1968 and 2000
(The image of the year 1968 is rectified to the image of the year 2000.)

Let's look at figure 11: in the year 1968 crack C3 was in a symmetric situation to crack C2. At the moment crack C3 is plastered. We know from other images, that it was also plastered in the year 1979. Therefore we can conclude, that the movement at crack C2 is bigger than the movement at crack C3.

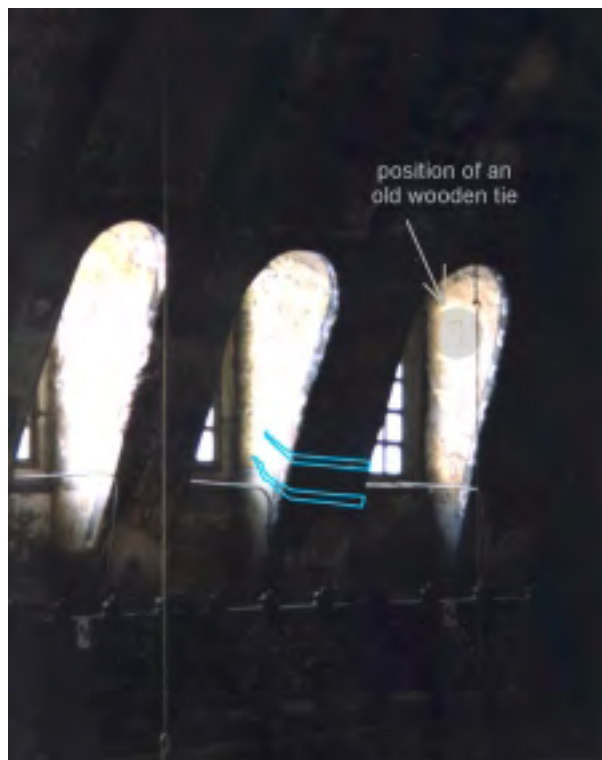
Figure 9. Photo of the windows at the base of the dome. The cracks on the ribs and the position of the old wooden ties are clearly shown.

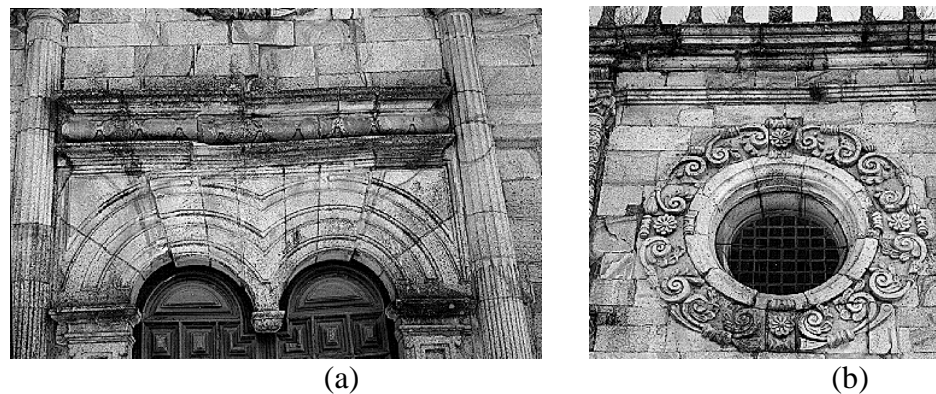
Figure 3 – Damage in the façade: (a) twin arch and (b) opening

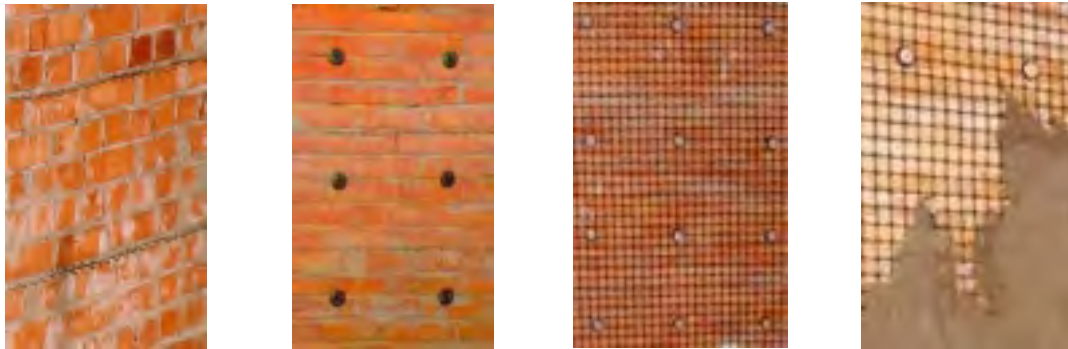
Figure 14 Horizontal and vertical reinforcement
