STUDIES in ANCIENT STRUCTURES

**Proceedings
of the 2nd
International
Congress**

**Proceedings of the 2nd International Congress
July 9- 13, 2001 İstanbul, Turkey**

Edited by
Dr. Görün ARUN
and
Dr. Nadide SEÇKİN

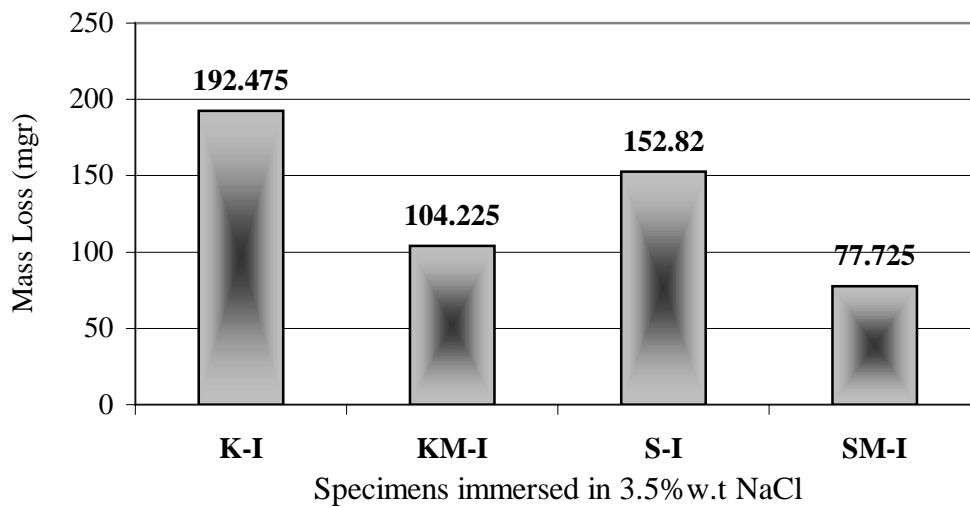
Figure 3: Mass loss measurements of lightweight and common mortars after 12 months of partially immerse to NaCl 3.5% w.t.

The results of mass loss measurements of reinforcing steel, after twelve months of exposure in chlorides solution are given in figure 3. It is obvious that mass loss differences are higher when lightweight mortars are compared to common mortars that contain as aggregate sand. From these results, the improvement of the mortars properties and consequently of the corrosion performance of steel rebars when the aminobased corrosion inhibitor added is evident. The INHIB-M, lowering the steel rebar mass loss after twelve months of exposed by about 45% in lightweight mortar and 50% in common mortar specimens.

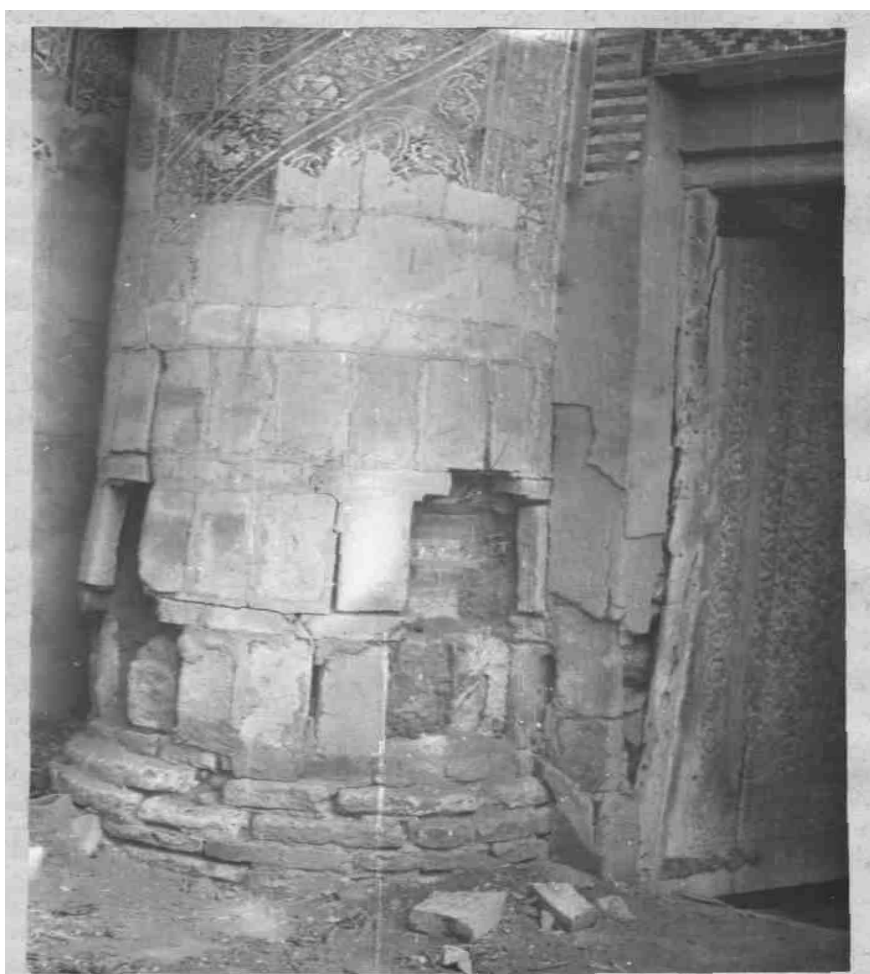
Figure 1. Destruction of the basement of a column as result of lixiviation of salts breaking stability of monuments (Tash-Hauli)

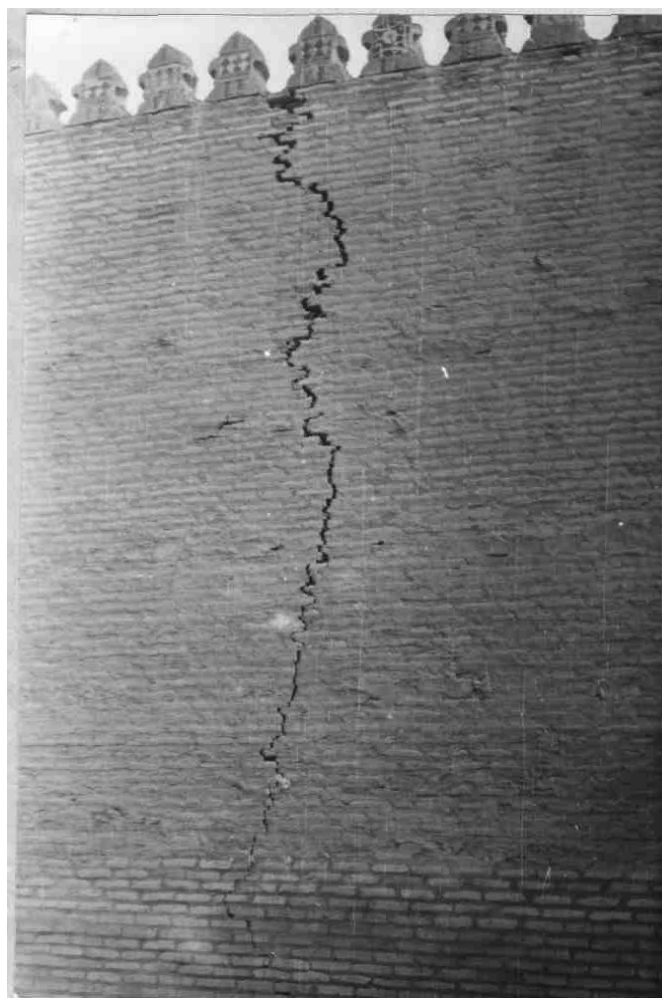
Figure 4. Cracks in the wall of caravan-saray of the complex Alla-Kuli-khan

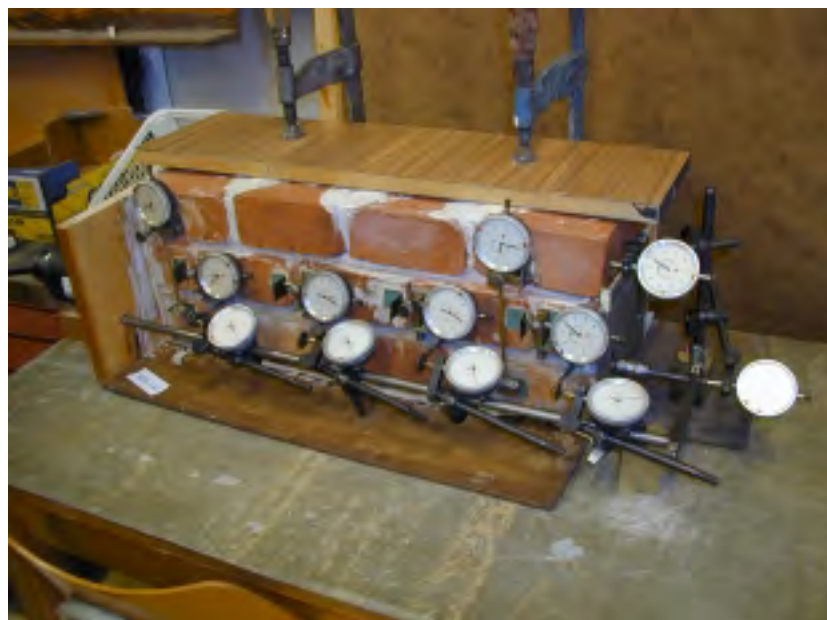
Fig. 7: Scheme of tests arrangement within the reinforcement anchorage in masonry
