STUDIES on HISTORICAL HERITAGE

Proceedings
of the
International
Symposium

Antalya, Turkey
September 17-21, 2007

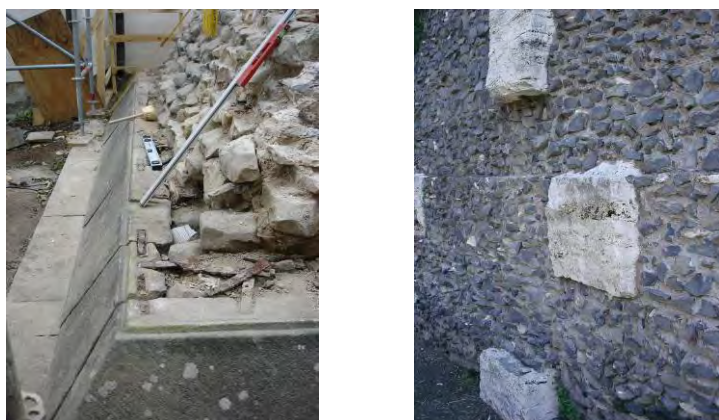
Figure 3: To the left the first course of casing at the Järfälla pyramid with leaded iron cramps along the sides and iron bars running transversely into the concrete core. To the right the base of the tomb of Cecilia Metella at Via Appia with concrete courses with heights corresponding to the remains of the headers.
(photos M Traung)

When the work to dismantle the casing stones had started an additional vault above the grave chambers cloister vault were discovered. The function of this upper vault is believed to be twofold A) to relieve the chambers vault of load and B) to act as a ventilation chamber which with its four ventilation exit shafts on each side gives the self draught an extra push. The incoming air comes through ventilation shaft in the foundation walls. To withstand the horizontal thrust from the vaults heavily dimensioned tension bars of square iron 50 x 50mm had been imbedded in the concrete

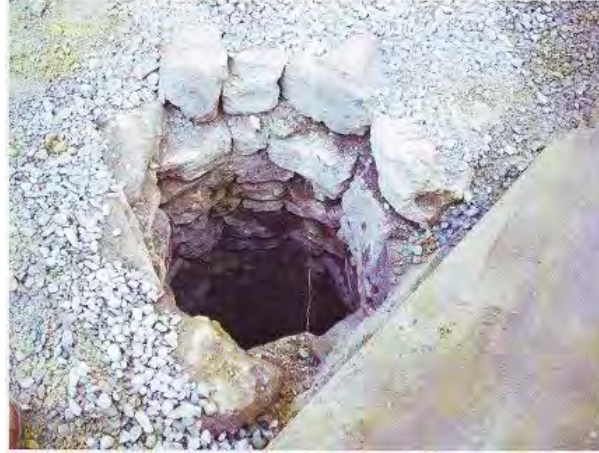
Figure 2: The well of 30 meter deep under the foundation of a two storey small wooden building in Fatih district, Istanbul.

The aim of having wells underneath the foundation was to collect underground water so that the building doesn't get moisture (Figure 2). These wells under the foundation were interconnected to each other from top with small gates (tunnels or galleries) and then are opened to air from side of the land as chimneys or connected to other wells of neighbor's lands, which later they go to open air. This way taking of moisture from ground to the walls or ground floors was prevented.

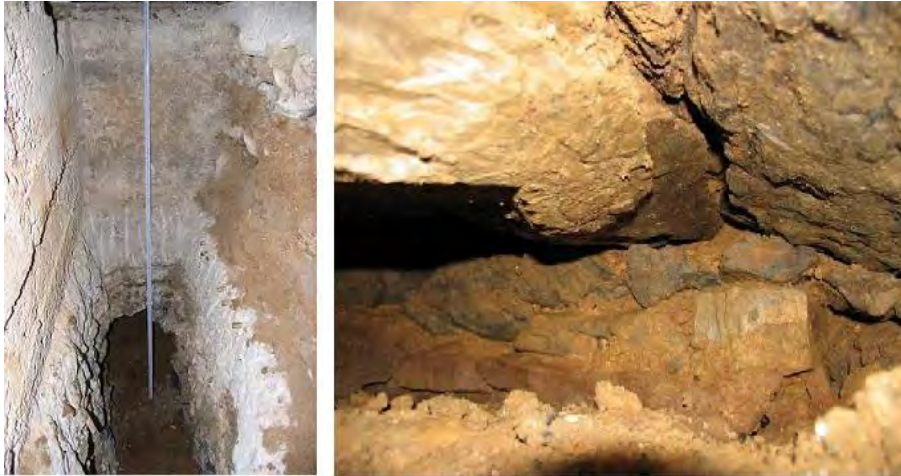
Figure 3: The Galleries or underground gates below the mat foundation (left). The gallery that is filled with soil about 80% during 2 centuries (right)

The size of galleries where wells are connected to each other varies from 30-40cm to 1-2.5m depending on the size of the building. These are generally constructed of stones or bricks with mortar binding (Figure 3). If these gates or wells are closed, moisture will penetrate the building as capillary force and disintegrate the mortar and spoil brick.

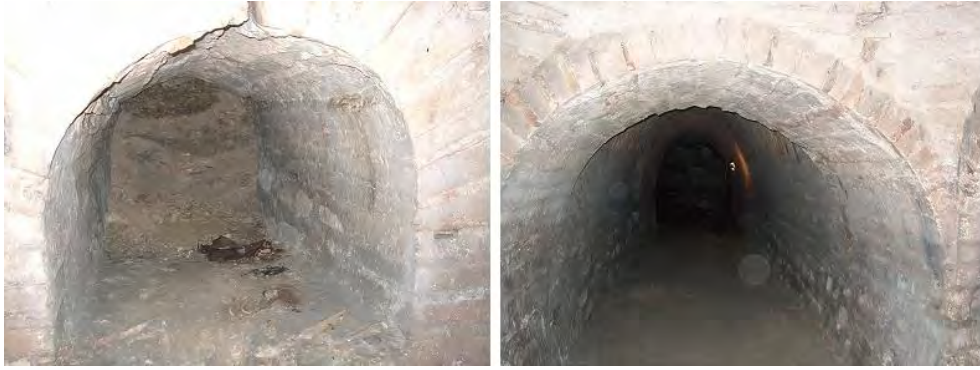
Figure 4: The gates under the Sultan Selim Mosque in Fatih, Istanbul

The gates or tunnels where the galleries open were constructed mostly within the foundations i.e. just below the foot touch (Figure 4). These tunnels served to keep the structure warm in the winter and cold in the summer and also removed the moisture from underground water. The size and length of these gates varied according to the need and size of structure and air ventilation of structure. Some of these exceeded several times of length of foundations out of the building. For example the galleries under Hagia Sophia extended several meters outside of

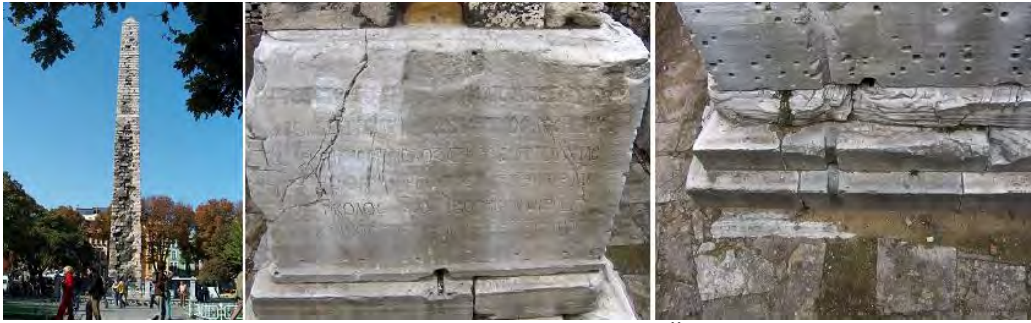
The Örmetaş Obelisk is placed on a marble base over three layers of orthostat stones. In 1856, the soil filling the area around orthostat stone layer in due time was opened by C.T. Newton [3].

The diffraction of earthquake waves under the ground and come up with inclined or vertical direction and hit on ground surface has a complicated mechanism when arrives at orthostat stones. These three layers of orthostat stones serve to absorb the earthquake waves, which are concentrated at the primary time causing less movement to be transferred to the superstructure.

Figure 6: The orthostat stone layers of Örmetas Obelisk

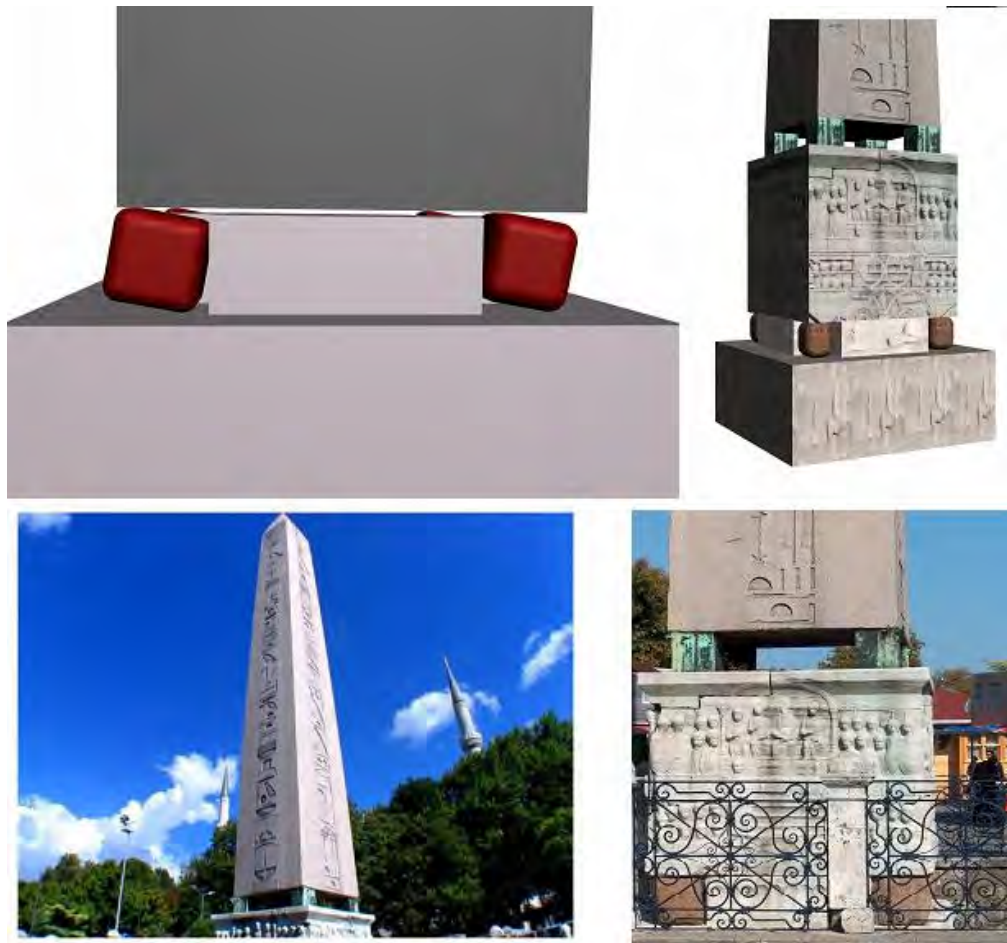
Figure 7: The base isolation of Dikilitas Obelisk

When earthquake hits the marble orthostat layer, these granite stones can slightly rotate causing a slight rising of the base and stop the shock of earthquake (Figure 7). Otherwise how these structures that must have experienced many earthquakes could stand without any failure for more than 16 centuries.

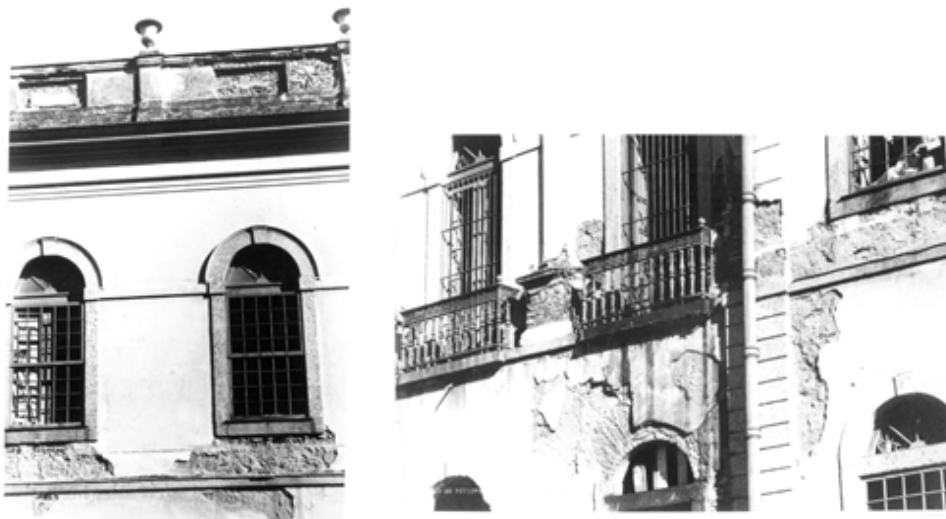
Figure 2: Breastwork window and balcony window with rails, c.1948.

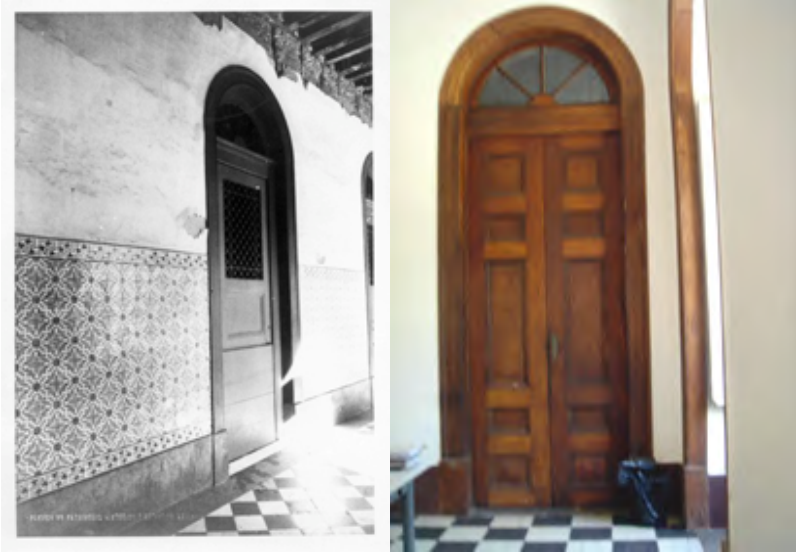
The single wooden wing type, that gave access from the patients' wards to the ground floor galleries was discontinued and replaced by a double wing model (Figure 4). By the time the building function became the University, this swap was justified, the reason being to allow the creation of further space to the classrooms furniture.

Nevertheless, in general terms, the lack of registering in historical edifications hinders the understanding of the model replacements. The mortises of the discontinued panel doors were substituted by a less elaborated system, consisting of juxtaposed frames. When opting for a simpler procedure, budget curtailing might have challenged the rectory. The alternative could be new and less refined execution types, aiming to making them stand out from the primitive patterns.

Figure 4: Extinct door (left), 1946 and existing replacing pattern, 2007.

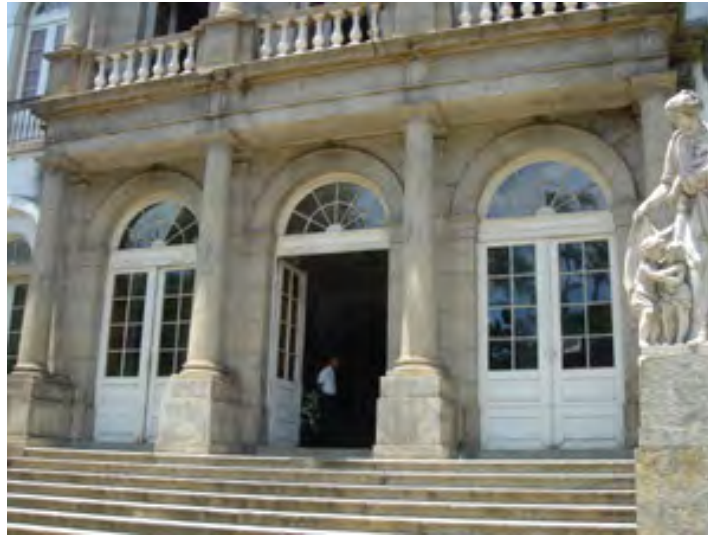
The original doors are sturdier and more refined than the newer ones in this neoclassic heritage. A set is comprised by the three most important samples of the edification (Figure 5). It is located in the porch, allowing access to the atrium. These are luxury doors, a feature of 19th century constructions in Brazil, whose techniques embraces wood-framed glass on the top and the blending of panels and skirting boards in the bottom and upper wing. These doors are protected by oil paint on the outside and varnish on the inner side.

Figura 5: Portas do pórtico central, 2007.

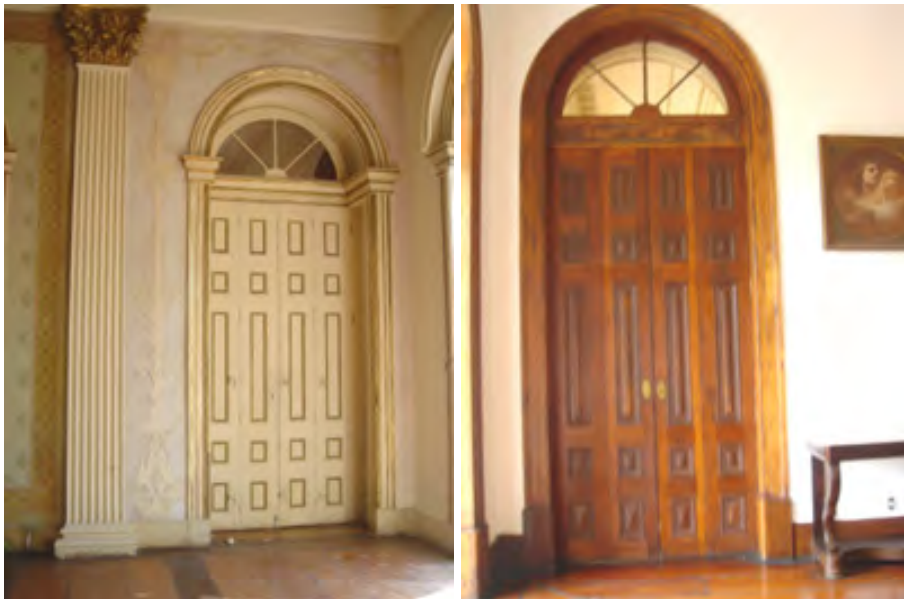
Figure 6: Golden Room door (left), Red Room door (right), 2007.

The Red and Golden Rooms, so named for their furniture colors, intercommunicate by a conspicuous door. Figure 6 shows its two surfaces, whereof two vertical boards form each wing and six crossbars are inserted in the same lower level. Not even contemporary Brazilian luxury constructions, described by Bellegarde (1848, p.107), exhibit so much tastefulness: one most commonly comes across with doors with at most three crossbars. Overlooking the Golden Room (left), the most refined doorframe linings stand out; rims, frames and cornices compose with the door decoration. On the Red Room side, its door skirting is formally simplified.

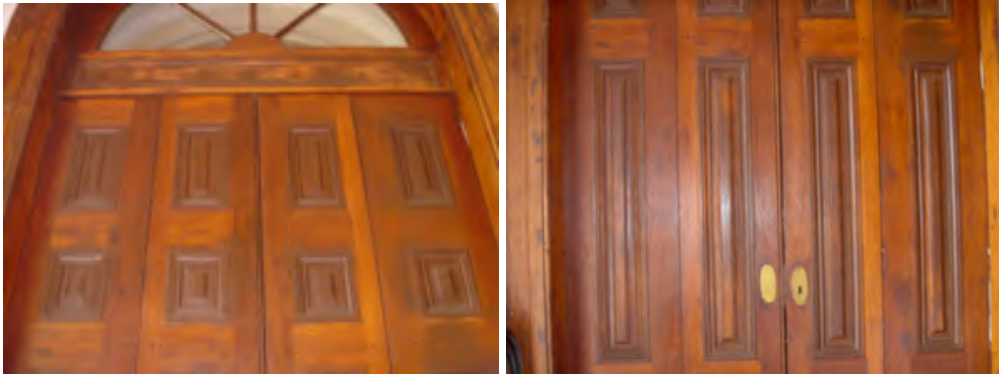
Figure 7: Red Room door: detail of friezes, raised and fielded panels and frames, 2007.

The Red Room door panels are the raised and fielded pattern, inserted by mortises and decorated with frames in either cannelures or fillets finishing, aiming to impart additional relief and refinement, underlining the building sumptuousness (Figure 7, right and left). Details providing high technical and decorative standards are friezes over frames and raised panels superimposed over each other.

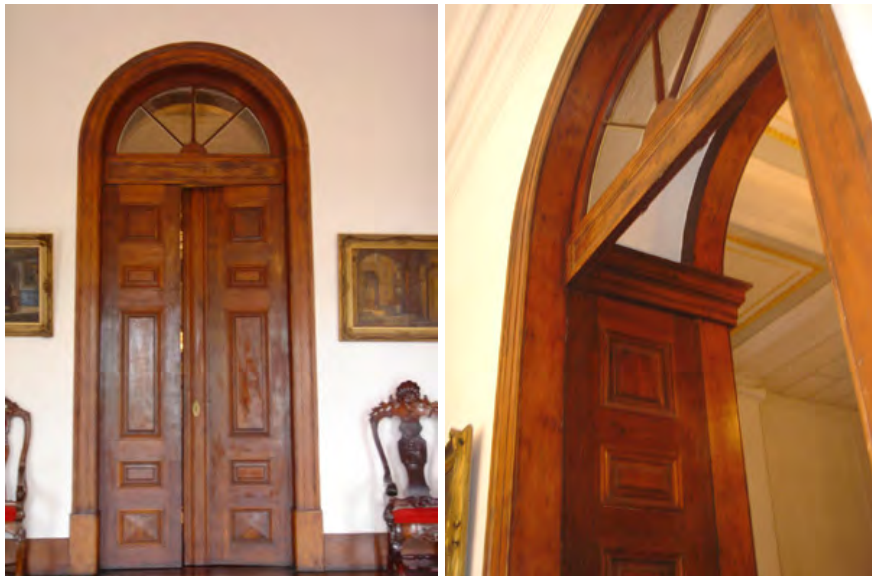
Figure 8: Closed (left) and opened door, embedded in the wall depth, 2007.

Sometimes the original doors are embedded in the walls, creating staves in the interspaces (Figure 8); one of these connects the Red Room to a corridor. When opened, it is hardly noticed, forming an extra frame.

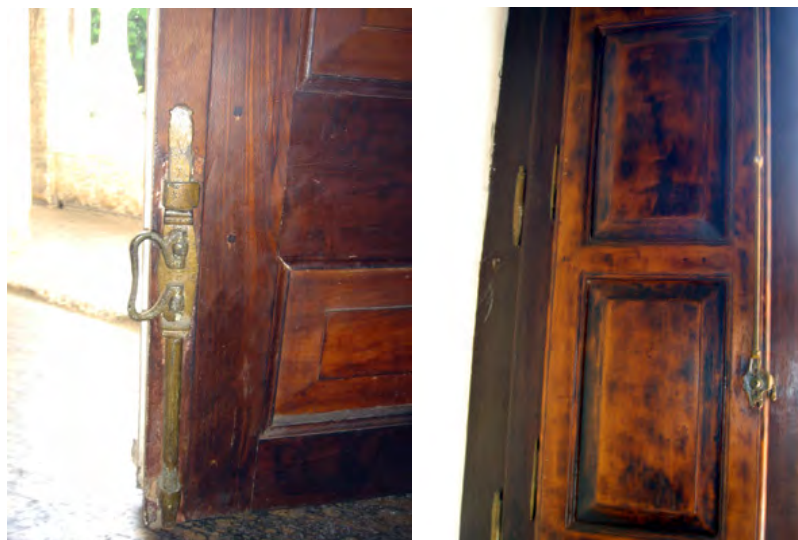
Figure 10: Locks, hinges and copper bars, 2007.

Tough locks, hinges and copper molten bars are present in the former windows and door models (Figure 10), aiding in the original types identification. This is due to their robustness and high welding standards. They are only found in the building original samples.

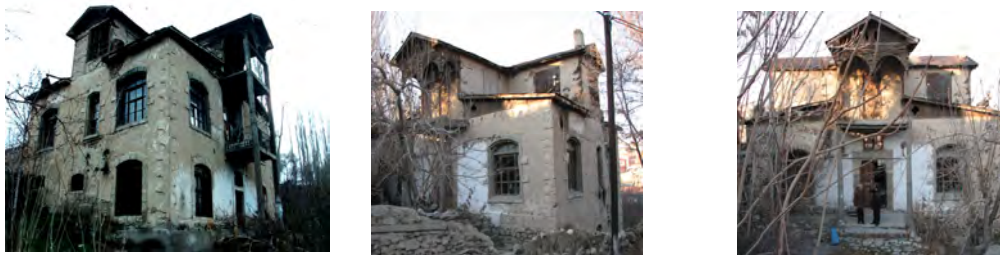
Located in Dink parish, Blind Ismail Mosque Side Road, the structure consisting of a basement floor, ground floor, and a penthouse has corners, windows sides made of cut stone and rubble masonry walls coated with mud plaster (figure 2).

Figure 2 A Typical House from 19th Century late Ottoman

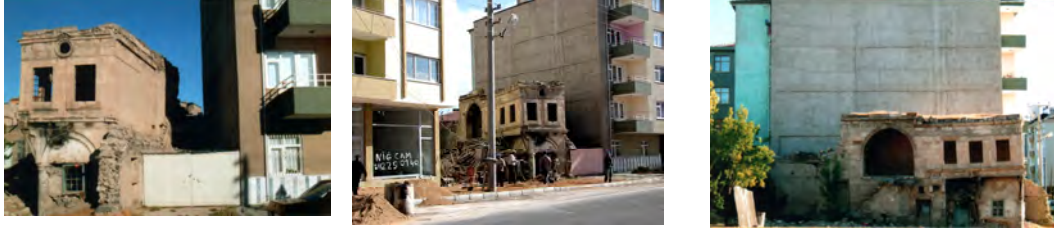
Located in Sokubasi parish, Kunkbasi road, the structure known as priest house is attached to the church behind it. The building contained in courtyard has a hall type plan. Two-floor house was plated with local stone, and in the first floor, horizontally located there exist a stone jamb surrounding the building. Penthouse in the up stare contains three rail windows (figure 3).

Figure 3 Remnant of a Church Premises (Priest house)

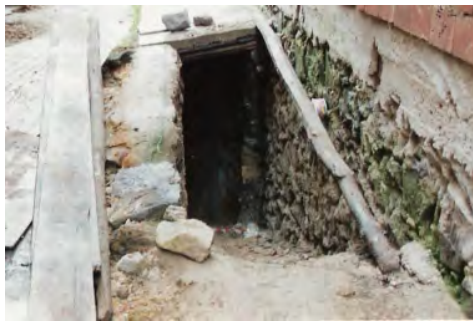
Located in the courtyard of a house in Orta (Middle) parish, Guyer road, the chapel consisting of two parts can be accessed through rectangular opening.

In one of the two parts there is a well, in the other, a niche of abscissa and a candle niche (figure 7).

Figure 7 A Typical Chapel Enternence

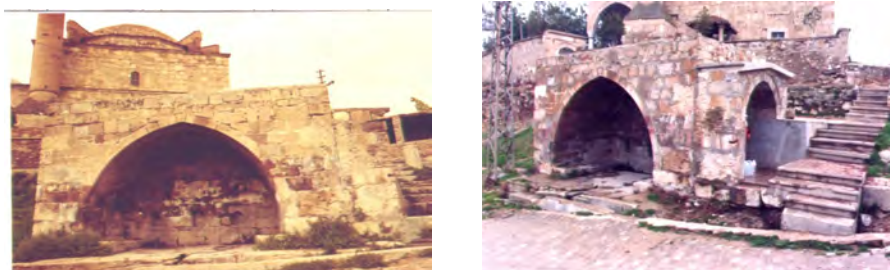
As another example, located Kale (castle) parish, kale steep, the fountain founded in 1558 constructed with cut stones. It has a iwan shape, and on the inside of the iwan part there are three mug niches with jamb made of pointed arc shaped stone. There are two gutters around the left one of which there is a plant patterned stone (figure 8).

Figure 8 A Typical Arc Shape Covered Fountain

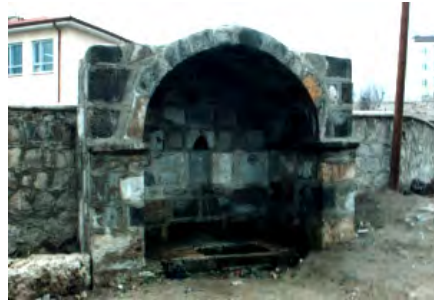
Finally, located in Cumhuriyet parish, Acipinar Road, a fountain has two side arc shaped covered with cartridge belt. In its epigraph, 1218 is read (figure 9).

Figure 9 A typical Fountain

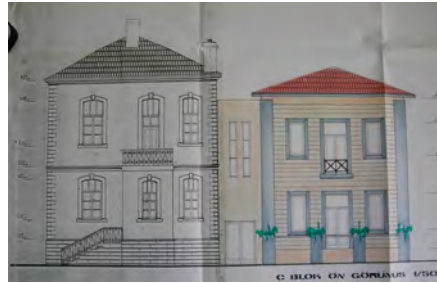
Figure 2. The first proposal for the new addition.

Concerning the relation of two façades, in the first proposal, the façade order and façade components of the new addition are similar to the old building's (Figure: 2). The articulations of historic components are eliminated for abstraction. As respect to historic building, the dimension of the new mass is reduced and a small connection part is designed in between the old building and the new one, which also serves as an interior corridor between the two buildings.

Assessment of façades: The entrance façade of the main building and the new addition are not facing each other and front façades comprise a silhouette. The problem of establishing harmony in between the old building and the new addition can be understood by the examination of proposals for the addition to B. The proposals of the architect show that it is difficult to balance the harmony and differentiation at the same time.

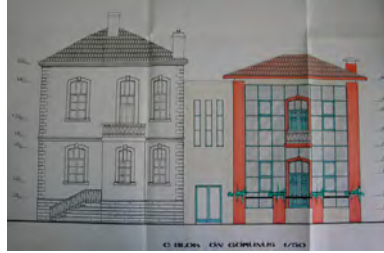
Figure 3. The second proposal for the new addition.
(Source: İzmir 1st Numbered Regional Council for Immovable Cultural and Natural Properties)

In the second proposal the connection part is enlarged and the façade of the new addition is rearranged to look more “contemporary” (Figure: 3). However, the historic details, which are designed in order to establish a harmony with the old building, are exaggerated and false selections. Thus, the end product resulted in a maladjusted new addition: neither a good imitation, nor a contemporary design (Figure: 4).

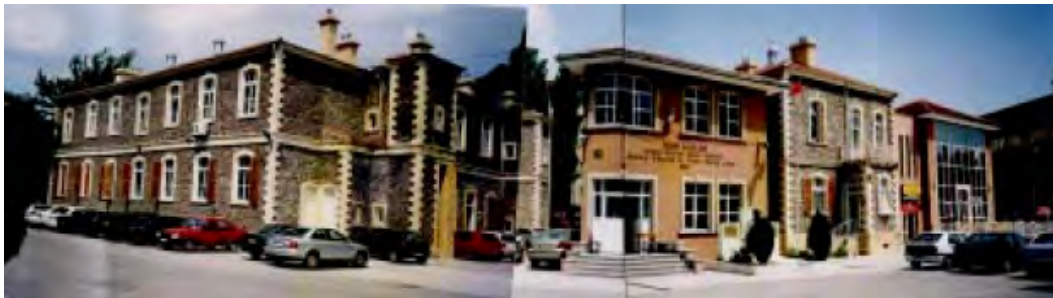
Figure 4. Existing situation of the building. The new addition is on the right end.

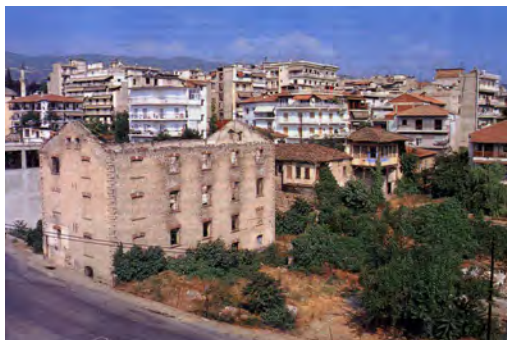
Figure 1. The watermill before the restoration works

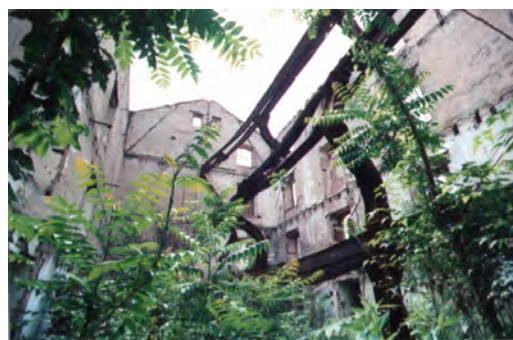
Figure 2. The internal space before the restoration works

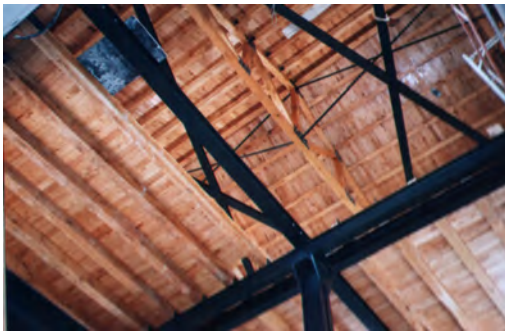
The values of the building, together with the reliable reconstruction drawings, lead to the decision to rebuild the carrying system of the construction, in simpler form and details, so that at short distance the contemporary of the construction is distinguished (Figure: 3). In that way the material evidence of the innovating technology of the period is preserved and highlighted. Small parts of the original iron construction are displayed at the courtyard of the museum.

Figure 3 Reconstruction of metal carrying system, timber floors and roof

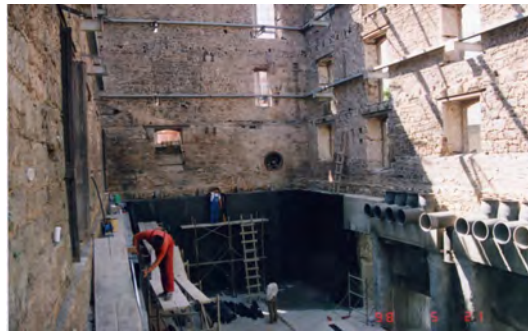
Figure 4 The construction of a basement in the mill

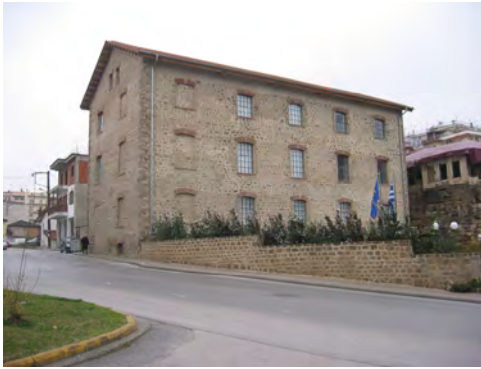
Figure 6 The transformed mill to a museum

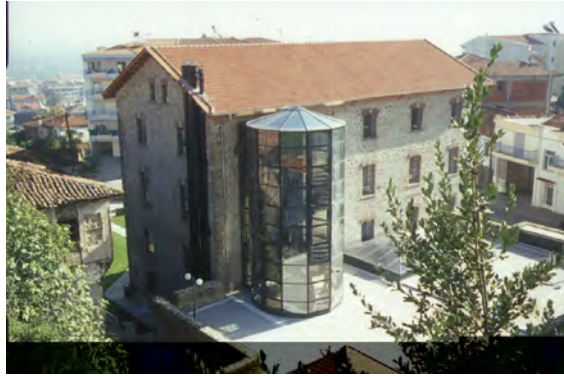
Figure 7 The external staircases and the roof of the atrium

The size of the mill was not enough to house the additional functions of a museum, such as laboratories, training rooms, storerooms, offices, boilers, etc. To face this necessity, the building was extended to new constructions. Taking advantage of the inclination of the ground, a new building was inserted on a level with the ground, invisible from the road side due to this inclination, with a two-storey basement (Figure: 5). This building was built in touch with the mill at the position of two later storehouses of minor importance. The visible part of the façade at this level was kept visible by positioning a covered atrium. The laboratories were located at the ground level of the extension. The visitors, through windows of the mill, have the image of the laboratories. A basement was also added under the mill for multiple uses, such as, temporal exhibitions and training programs. The construction of these extensions was based on advanced technology (Figure: 4), to ensure the safeguard of the old building and to be clearly differentiated from the old construction. Finally an external staircase was added to the mill for security reasons. This staircase, as well as the roof of the atrium, the only actually visible parts of the extensions, was constructed by iron and glass to match the building materials of the mill (Figure: 7). Furthermore, the use of glass permitted the view of the city walls at this position, behind it. The

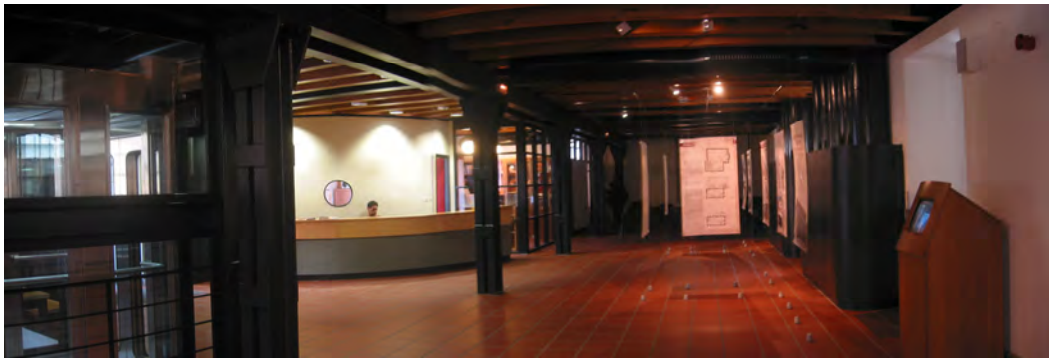
Figure 8 Ground floor, after the restoration works

The internal space of the mill, after the restoration works, was imposing (Figure: 8). Therefore, the exhibition design had additional difficulties. It should respond to the demands of a museum exhibition where the focus is on the exhibits, to the display of the building itself as a reminder of the later history of the city and to the museology study, which entailed the division of the space. The aim of the plan was to get on a balance with different levels of view. The exhibits should gather the concentration of the visitor, so planning should focus on them, highlighting their importance and the scenario of the museology study. At a second level, the visitor should have the image of the internal space of the old factory, after its restoration. Therefore, all the constructions for the division of the space should have the minimal dimensions to correspond to their role. At a third level, the constructions themselves and all exhibition equipment should be elegant, equivalent to the qualities of the building and the excellent art of the exhibits.

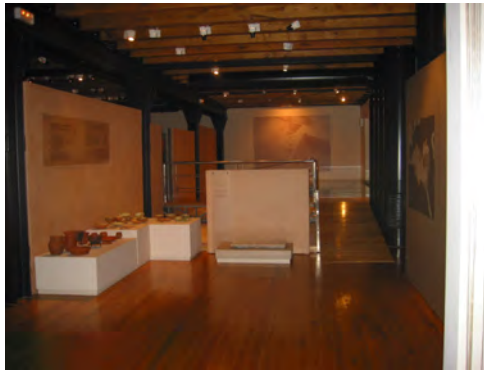
Figure 9 Exhibition area

Within this frame, all the partitions were plain, following clear geometrical forms, creating slots between them to leave fragmentary views, at a limited

number, the necessary one to define units, with maximum height 2,20m. Double face icons were supported by simple metal stands, while show cases have minimal dimensions and simple forms. In addition, a glass corridor was positioned over a part of a mosaic to permit its view. Glass, iron, mortar or smooth plasters were used to fit to the building materials of the museum (Figures: 9, 10). The final result, according to public and experts opinion was quite successful, accomplishing the aims of the architectural plans [1].

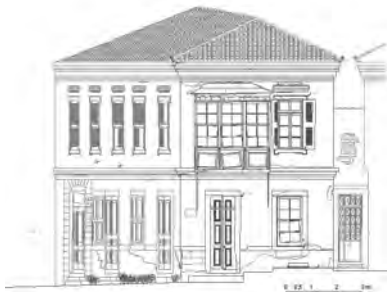
Two of the exterior façades facing Mithatpaşa and Hacı Memiş Streets have preserved the design characteristics of the 19th century such as doors and windows with casings, wooden shutters, bay window and cornices (Figure 2). Because of the interventions made by the inhabitants of the house, the courtyard façade has lost its original characteristics (Figure 3).

Figure 2 Northeast Elevation
(Documented with photographic methods)

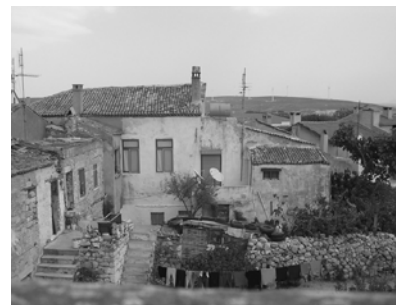
Figure 3 Courtyard Façade

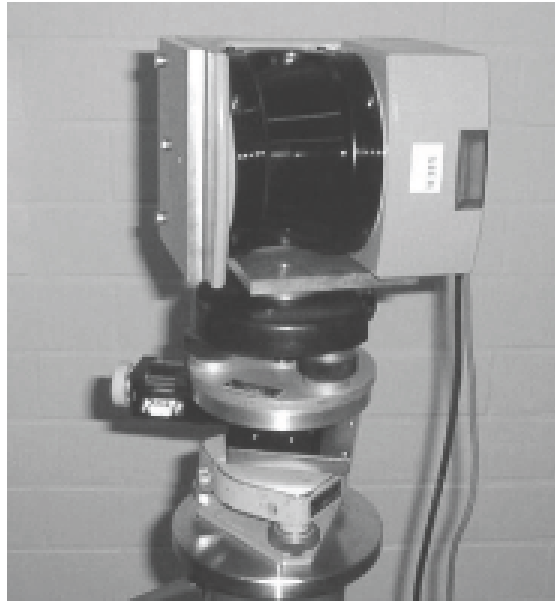
Figure 2: Photo of the 3dLMS laser scanner [6]

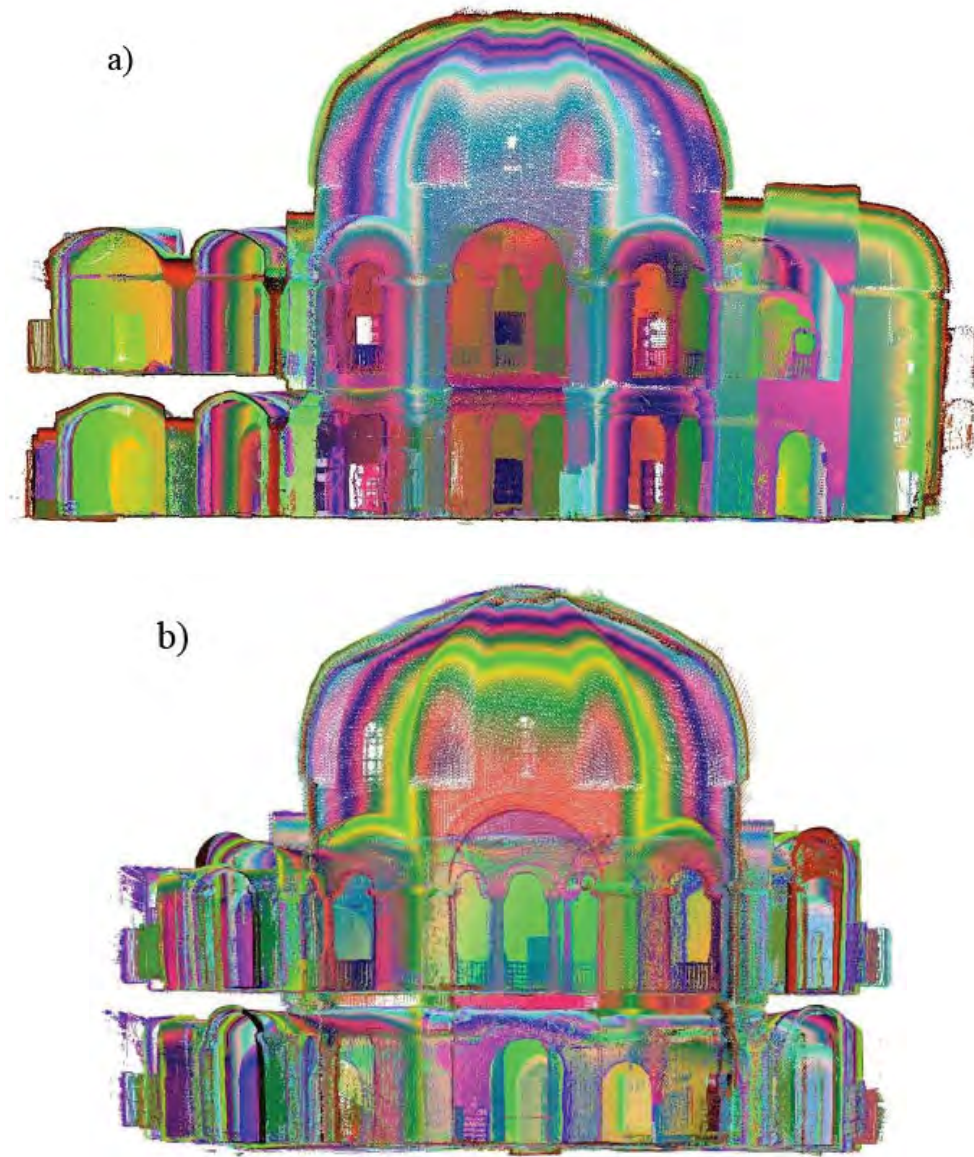
Figure 8: Vertical cuts through Küçük Aya Sofya mosque from laser scanner data:
8a: cut in West – East direction; 8b: cut in North- South direction;

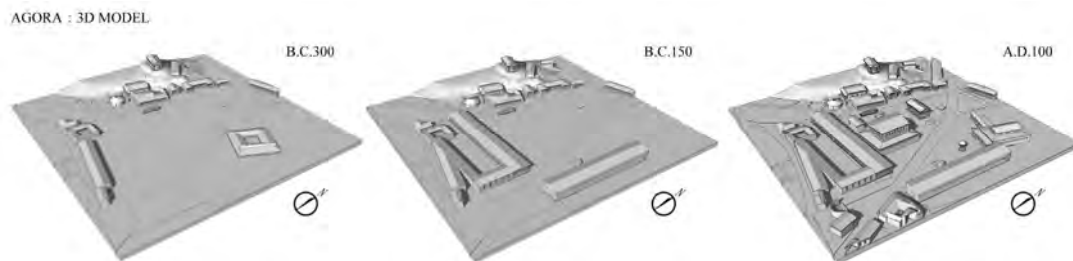
1. The floor plan and elevation plan were imported as graphics data into CAD and converted into vector data.
2. The height of the architectural structures, etc., were measured according to references 1-14 and the fact-finding data. The vector data was opened with CAD.
3. Three-dimensional computer model was used to read and place the data on a site map drawn by three-dimensional computer model.

Fig.3 3D Model (B.C.500-A.C.100)

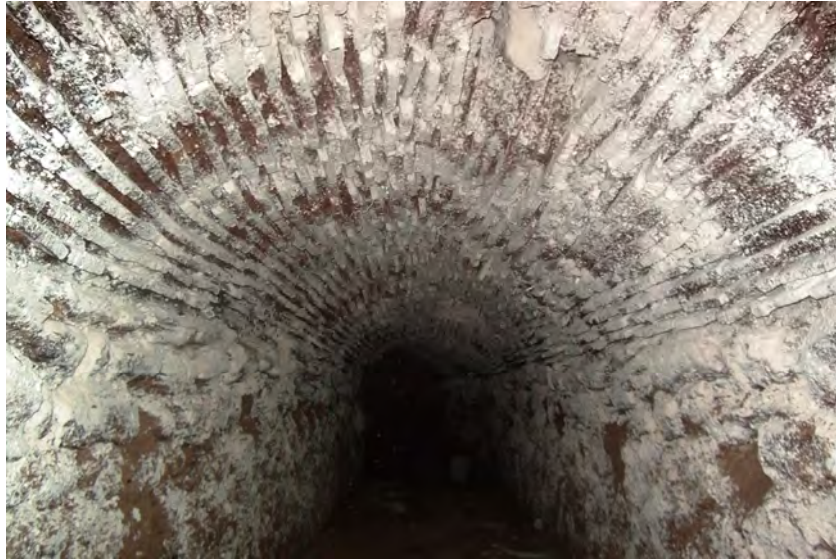
Figure 3

One of the most important findings in the area is what is thought to be a Potern from the 4th century BC (Figure 3). A large number of oil lamps were found in this arched brick structure of which 11 meters are visible. Although some researchers believe that it could be a waste water canal, the presence of oil lamps makes it more likely to be a Potern. The structure dates from the same period as the city walls presumed to be from the Constantine period, and a connection needs to be established between these two structures.

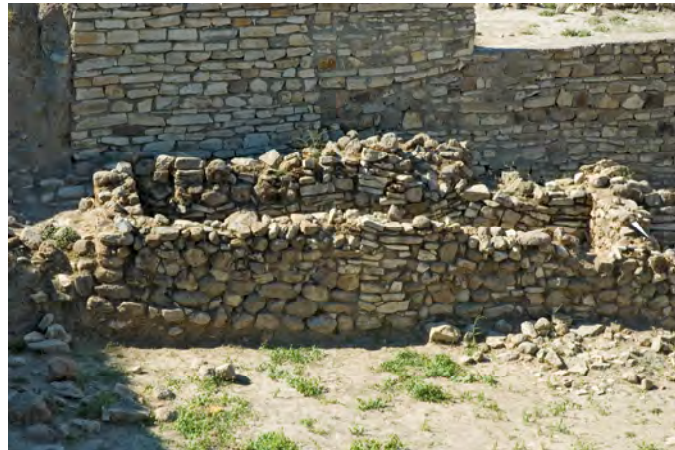
It was decided that the site conservation work should begin on two sectors of the settlement selected by the archaeologists for their historical importance as well as for the frailty of their condition. One section consisted of the EBAI fortification walls. The other section consisted of the storage compartments of an administrative complex (Figures: 1 and 2) and a staircase from the Late EBAIL.

Figure 1: Storage compartments before conservation.

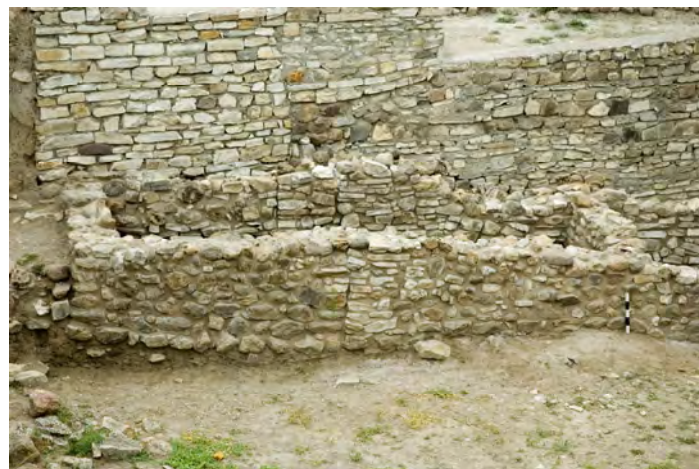
Figure 2: After conservation.

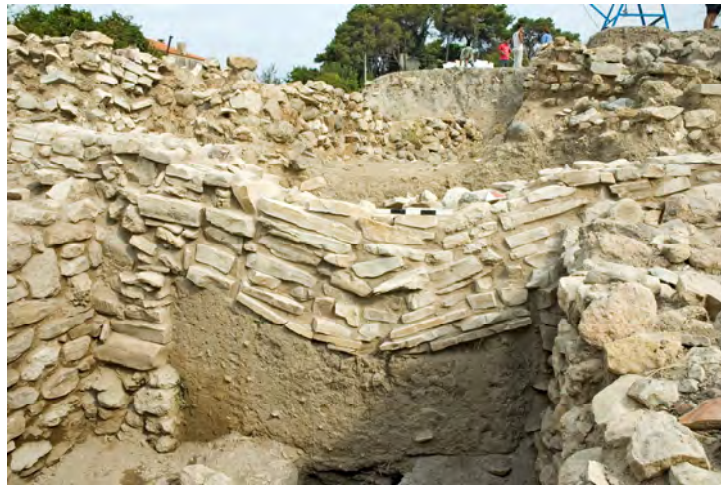
Conservation, as was applied at Liman Tepe, is meant mainly to support excavated walls and other constructions in the positions in which they were found (Figure: 3), starting with the ones that were the most endangered. The goal should be to maintain the character of the site aesthetically and architecturally.

Figure 3: After conservation, left in position as found.

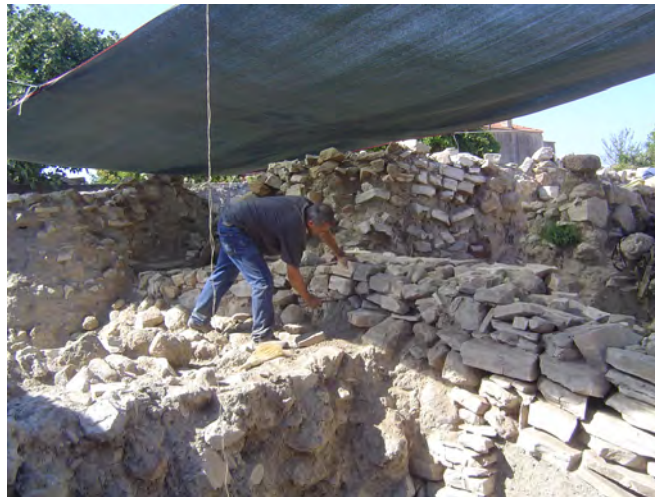
The cleaning of the old mortar – or soil, in the case of Liman Tepe -- is important and time-consuming work. Small picks, but also specially made hooks, were used in order to scrape away the soil between the stones (Figure: 4). Next, the walls were thoroughly hosed with water, removing any last remaining soil, and preparing the surface for the new mortar.

Figure 4: Cleaning of the old mortar

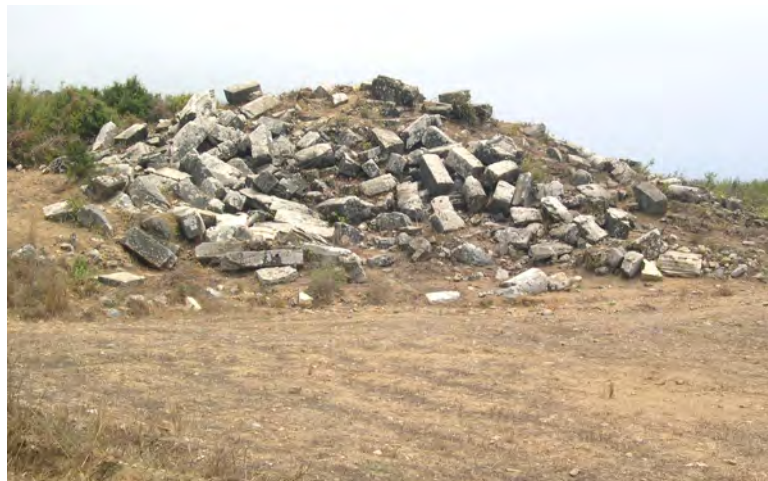
Figure 1. Architectural Remains of collapsed Temple at Antiocheia ad Kragos

Once the debris mound was fully cleared, each block was catalogued, sketched, photographed and surveyed with a Total Station in order to create an actual state plan of the structure (Figures: 1 and 2). In that initial field season over 270 blocks were catalogued and brought into the state plan. Additional blocks lie below the top layer and are therefore not yet catalogued. Atop the mound several blocks that constitute a remnant of the wall foundations can be observed still in situ, but for the most part the outline of the walls is still obscured by earth and debris.

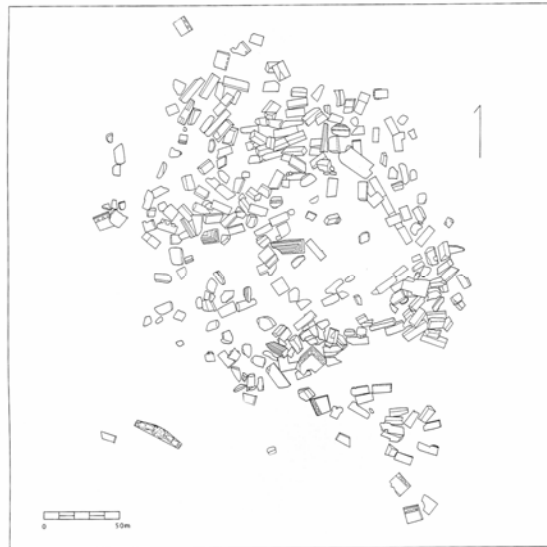
Figure 2. Antiocheia ad Kragos. Temple state plan

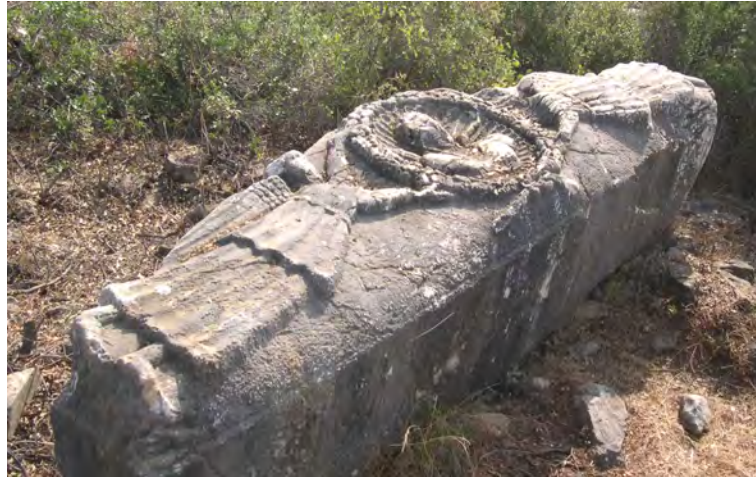
The labor in moving over 270 blocks, plus documentation, will require two seasons of approximately four to five weeks each. The primary research envisioned for each season involves the removal of blocks from the mound to an adjacent field for study and the excavation of the podium. In order to study the blocks completely, it is necessary to lift them from their fallen position. In many cases the blocks are upside down or their decorated faces are obscured. Other blocks are partially buried in the ground thus requiring some excavation to dislodge them. There is also a conservation issue that needs addressing. As they are currently situated one on top of the other, the blocks are breaking along stress points due to their own weight. In addition, shrubs and bushes with deep root

systems are pushing against the blocks, in some cases causing damage to the stone.

Figure 3. Antiocheia ad Kragos. Temple pediment

This is particularly a problem with the podium blocks as roots are pushing the blocks out of place or damaging them. Moving the blocks to the adjacent field will provide them protection as they will be arranged upon wood skids keeping them off the ground and affording minimal contact with each other. One other problem has emerged in recent years, namely looting. Looters have broken blocks while digging into the ground in an effort to find antiquities. The project hopes to avoid looting incidents in the future by educating the local villagers about the project's activities and to press upon them that protecting their heritage is in their best interests.
