# SHH07

## STUDIES on HISTORICAL HERITAGE

Proceedings  
of the  
International  
Symposium

Antalya, Turkey  
September 17-21, 2007

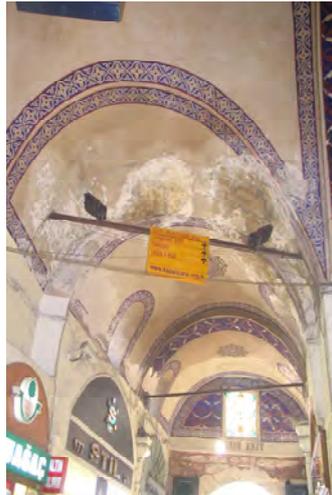
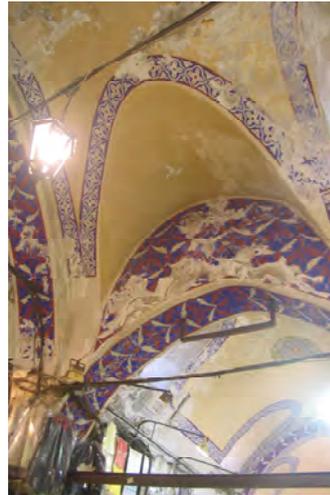
Figure 1. Humidity problems on the walls (Photos: Ö. Şenyiğit)

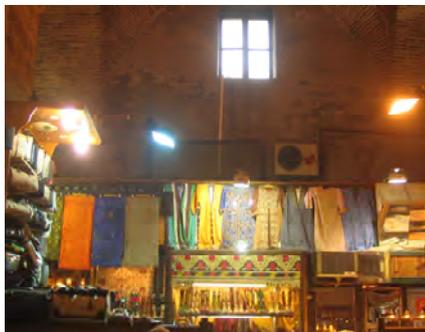
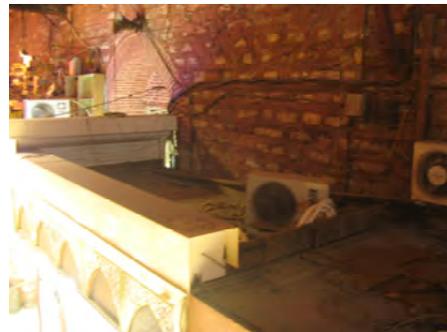
Figure 2. Ventilation problems of Bedestens (Photos: Ö. Şenyiğit)

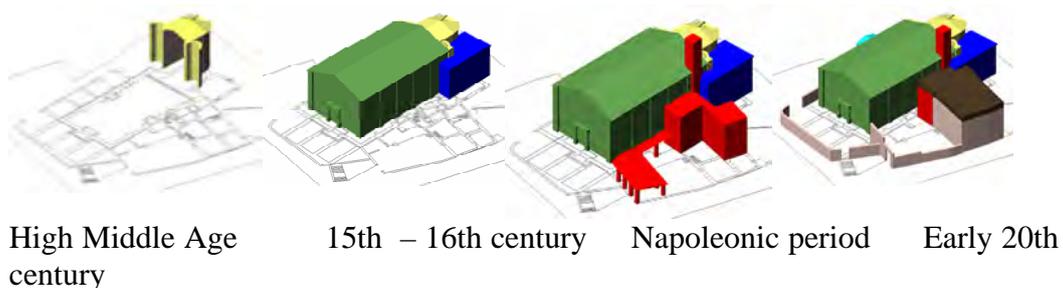
Figure 5: Construction phases of a church (S. Michele Arcangelo at Sabbio Chiese, Italy)

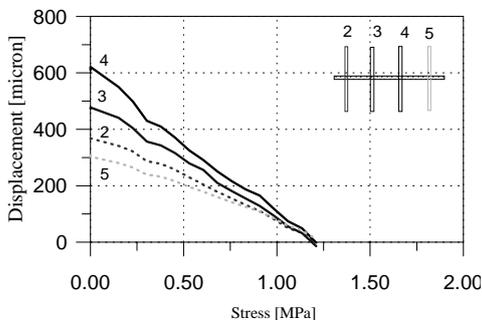
Figure 9: Single flat-jack tests carried out at the Monza Tower

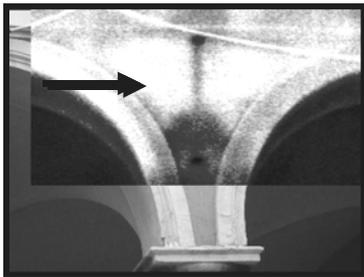
Figure 11: Investigation on hidden steel tie rods

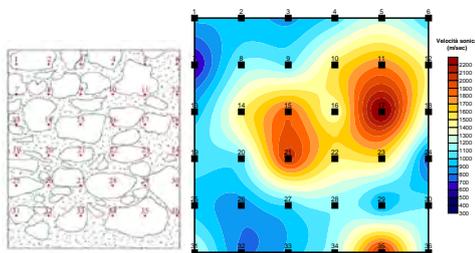
Figure 12: Distribution of sonic velocities in a wall

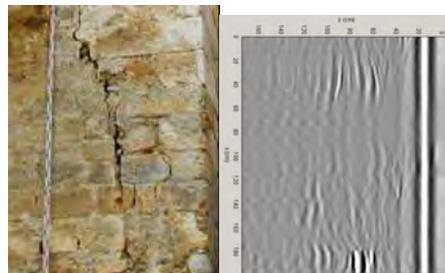
Figure 13: Localisation of cracks by radar

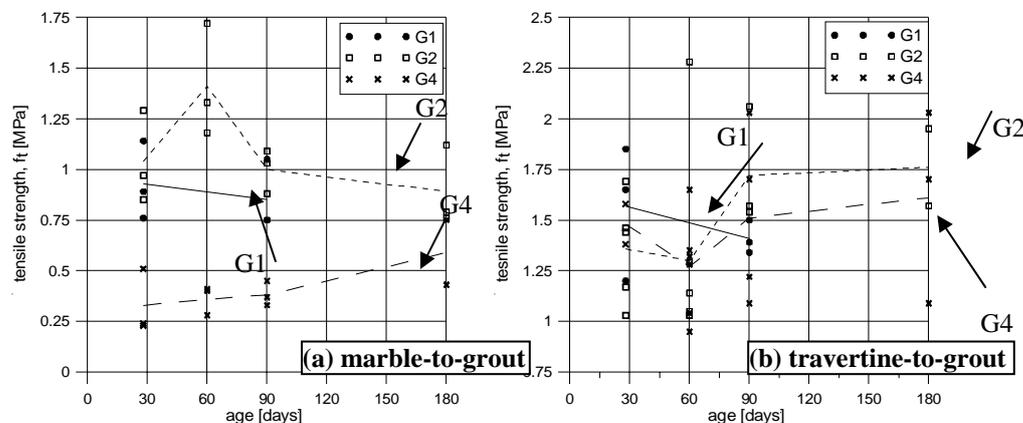
Figure 3. In-time development of bond tensile strength

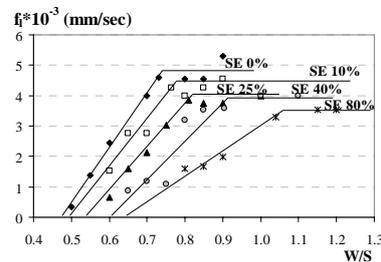
Figure 3: Fluidity factor measurements (ACT method) for several cement-and-Santorini Earth compositions (SP% = 0).

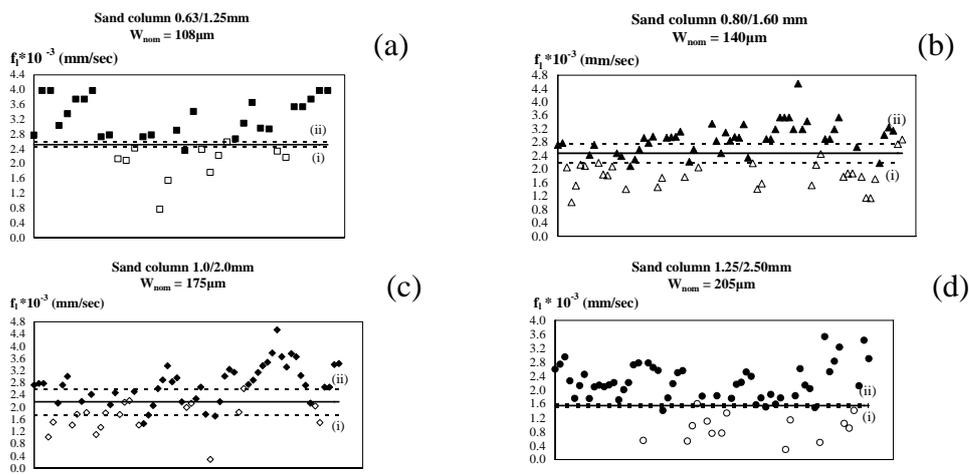
Figures 6: There is a lower fluidity-index-value approximately equal to (a)  $2.50 \cdot 10^3$  mm/s, (b)  $2.45 \cdot 10^3$  mm/s, (c)  $2.20 \cdot 10^3$  mm/s and (d)  $1.58 \cdot 10^3$  mm/s for grout mixes to be injectable through a sand column with nominal value of crack widths equal to (a)  $108\mu\text{m}$ , (b)  $140\mu\text{m}$ , (c)  $175\mu\text{m}$  and (d)  $205\mu\text{m}$ .

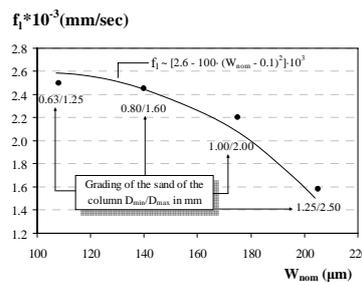
Figure 7: Lower fluidity factor values, for grouts to be injectable through sand - columns of several nominal values of crack widths,  $W_{nom}$ .

combinations of cement/hydraulic limes with lime or/and pozzolans. The grouts have been classified in two categories: those that are injectable into the sand columns without difficulties, and those that are not injectable at all. The  $f_i$  – threshold is defined as the average of (i) a 5%-fractile level of “injectable” (sand column test) and of (ii) a 5%-fractile level of “non injectable” grouts. From these experimental results, an indicative lower value of the fluidity factor can be derived for each  $W_{nom}$ , as presented in Figure 7.

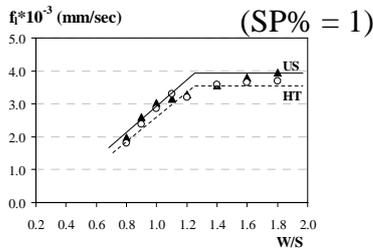
Figure 10:  $F_1$  values of lime/pozzolan/cement (25/45/30) grouts. (SP% = 1)

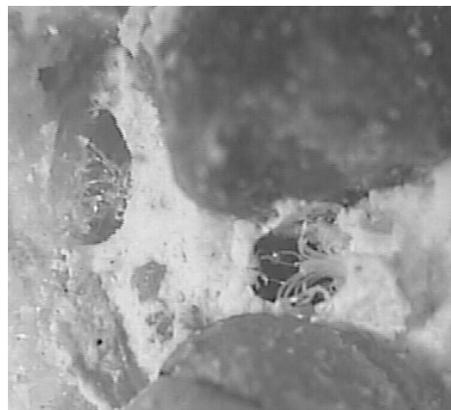
Figure 2. Crystals of salts into the pores of an old mortar (Stereoscope x25).

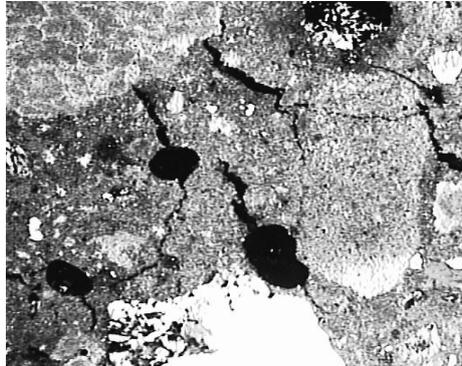
Figure 3. Structure of an old lime mortar (Polarized microscope x65)

The microstructure analysis of the untreated samples showed a loose structure for the lime mortar. Many spherical pores of mean diameter 500µm and open cracks (mean width 20µm) were present. In the case of pozolanic mortars, small pores of mean diameter 300µm were present into the binder and the binder matrix was dense. The difference is due to the crystals that were formed in both cases. As explained in literature in the case of pure lime mortars calcitic plate-like crystals are formed having a loose contact with each other (figure3).

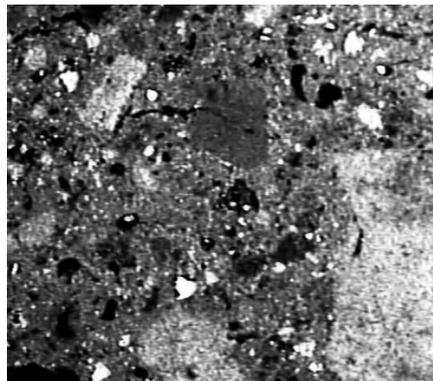
Figure 4. Structure of an old pozolanic mortar (Polarized microscope x65)

On the contrary, in the case of pozolanic mortars a combination of needle-like and plate like crystals is existing in the matrix and a strong cohesion between them is achieved (figure4) [9].

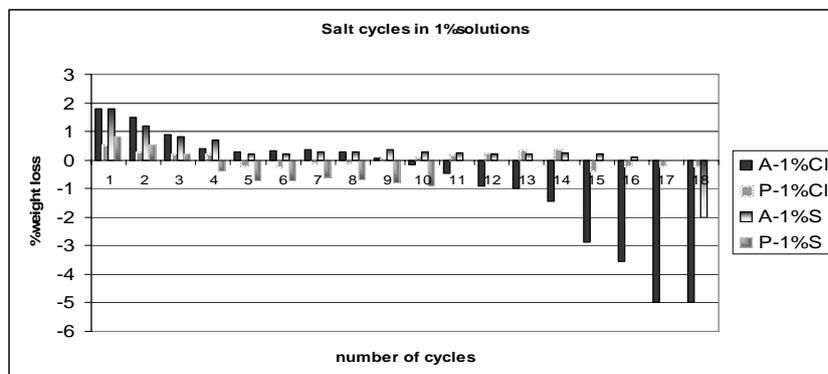
Figure 5. Weight difference in mortars subjected to salt cycles 1% solutions

Three specimens 4x4x8cm from each mortar type were tested in each case. During each salt cycle, the dry weight of the samples was measured and a photographic documentation was performed. The experiments were ended when the samples collapsed. Diagrams were produced showing the durability of each sample while the type and extent of damage was recorded (figures 5, 6, 7).

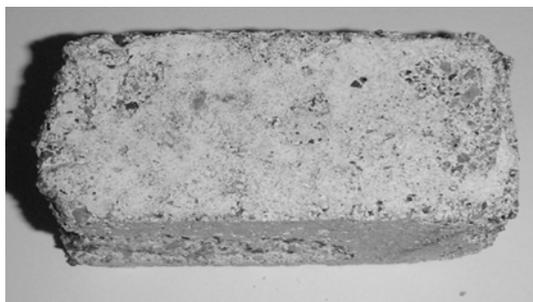
Figure 8. Lime mortar after 10cycles in NaCl solution

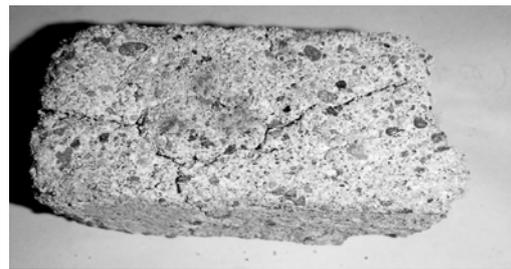
Figure 11. Pozolanic mortar after the 10th cycle in NaCl solution

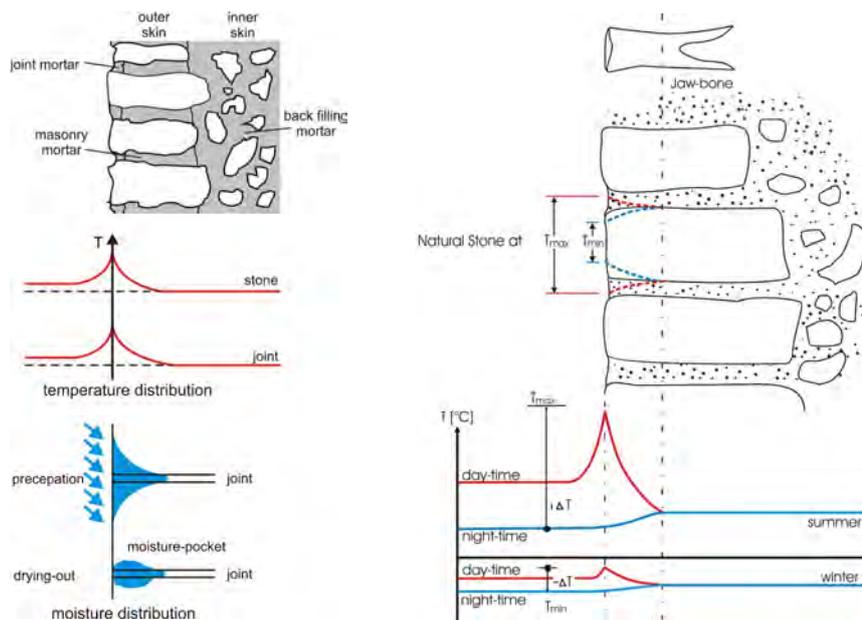
Figure 1: Thermal and hygric Deformation of natural stones in histo-exposure of historical masonry as a result of thermal elongation

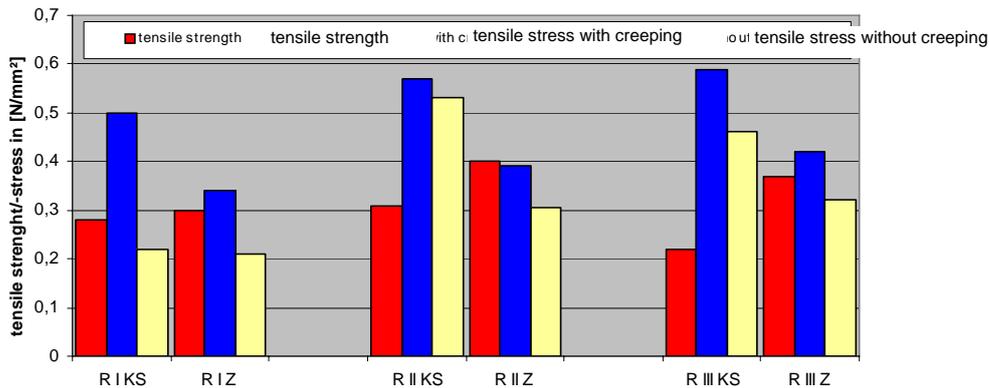
Figure 5: Calculation of flank cracking of three different gypsum-lime-mortars and two different bricks (results) Fig. 5 shows the results of comparative calculations using the engineering model for flank failure due to the temperature load case  $\Delta T=5K$ . In this case, the bond between three different gypsum-lime mortars and calcareous sandstone or highly absorbent bricks is considered. Once the maximum stresses exceed the measured bond strength, the flanks will fail. It is evident that the stress-reducing effect of the creep deformation of gypsum mortar has been considered in a very realistic manner. Masonry samples exposed to this temperature load case showed flank failure in the same specimens as it had been forecasted in the model.

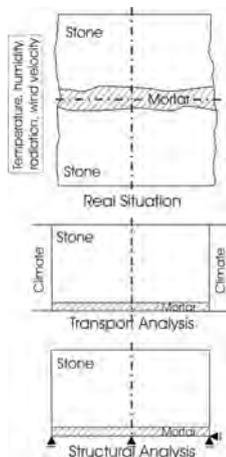
Figure 6:  
Geometric model and deformation conditions in the research model

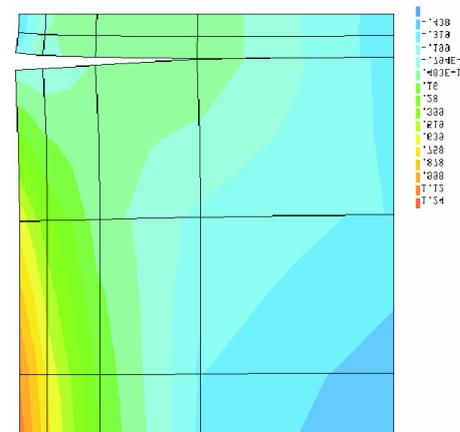
Figure 8:  
Detail stone-joint: resulting stress in y-direction and deformation pattern

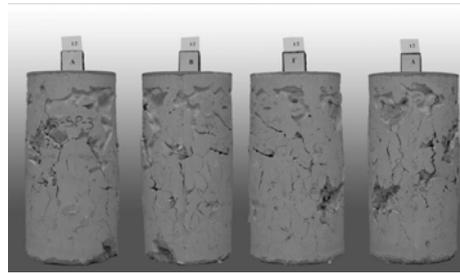
Figure 4: Typical failure mode

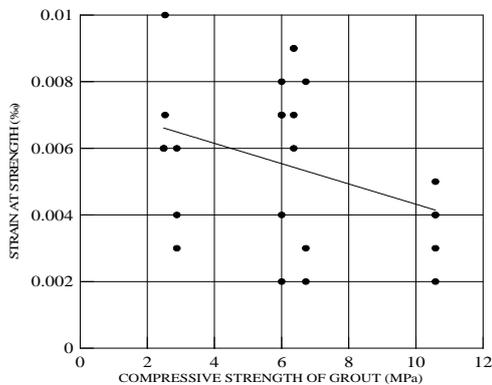
Figure 5: Relationship between the strain at strength and the compressive strength of the grout

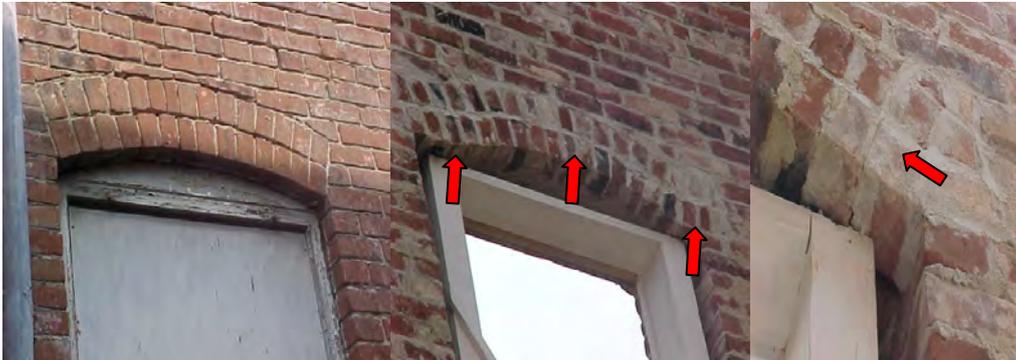
Figure 2: Construction of arches and cracking in area of double curvature

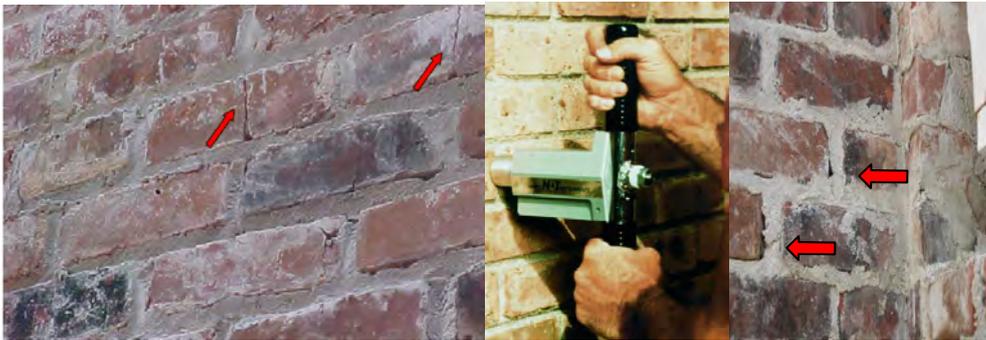
Figure 3: Cracking in brick, Windsor probes and separation in new joints

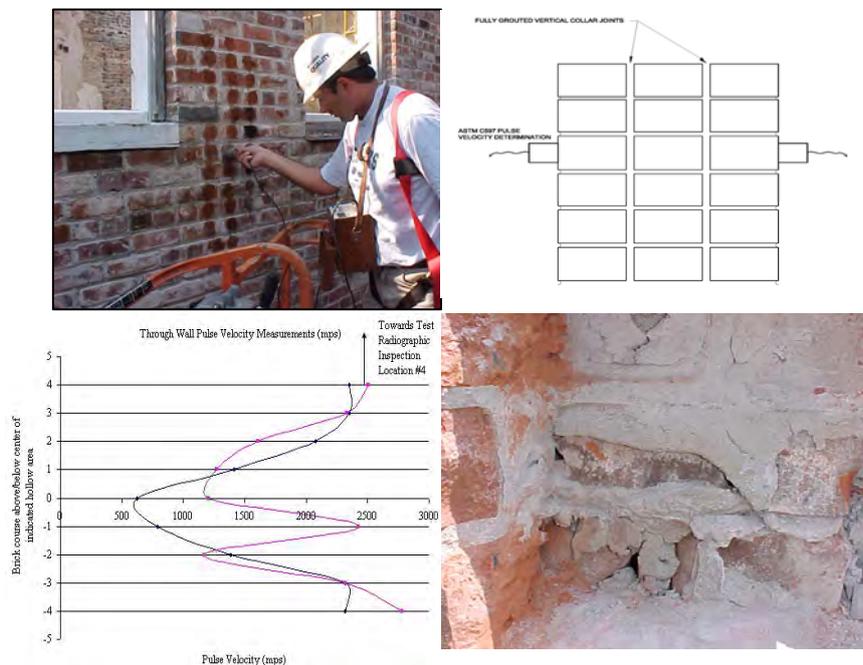
Figure 4: NDE of hollow collar joints and demo verification of findings  
Based on the findings of the evaluation, the defective areas of rehabilitation were removed and reconstructed

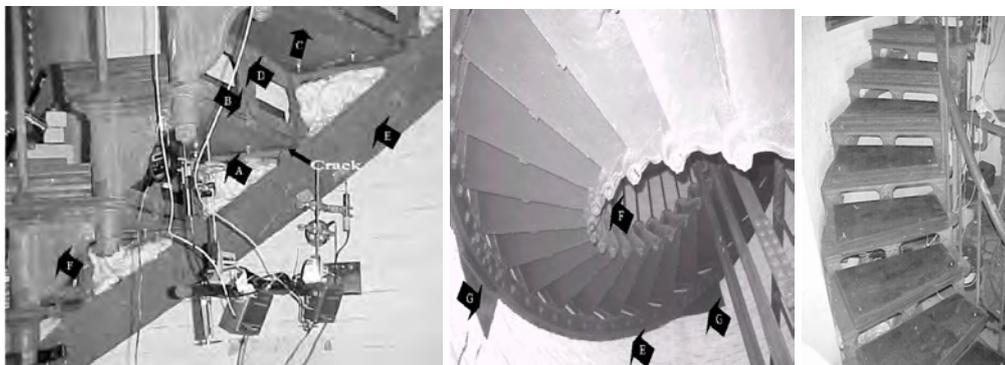
Figure 6. Monitoring Gages, Structural Configuration of Stairs and Load Plates.  
*A Bracket, B Tongue/Tab, C Tread, D Riser, E Ext. Stringer, F Int. Stringer*

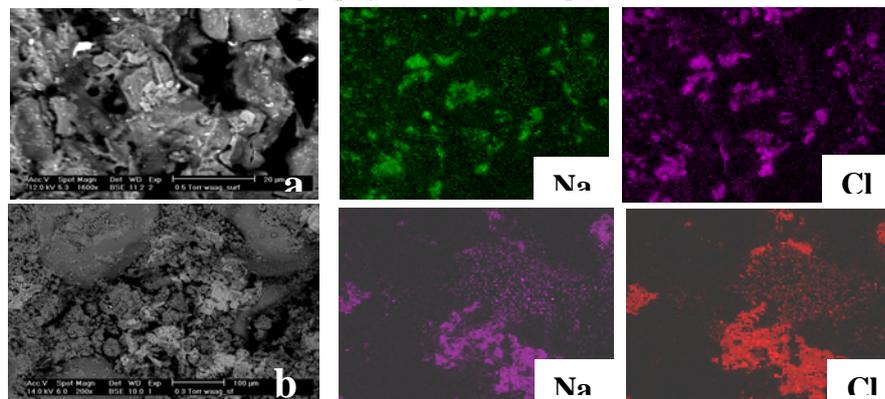
Figure 4 Na and Cl mapping performed by EDX on brick (a) and mortar (b) samples

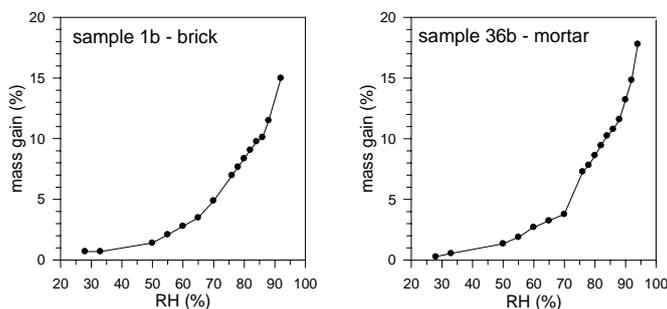
Figure 6 Adsorption curves of sample 1b (left) and 36b (right)

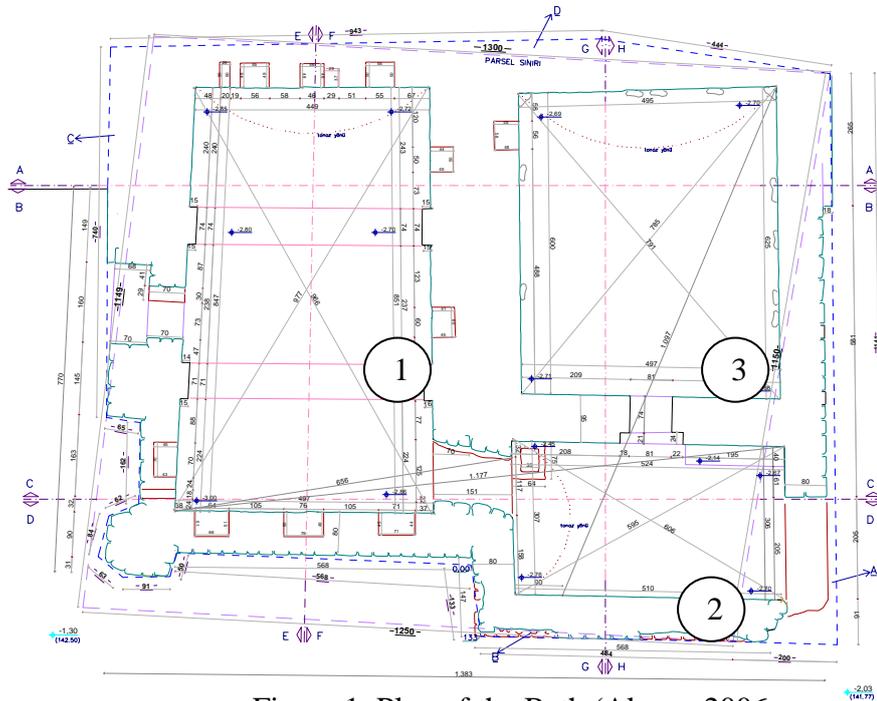
Figure 1. Plan of the Bath (Aksoy, 2006)

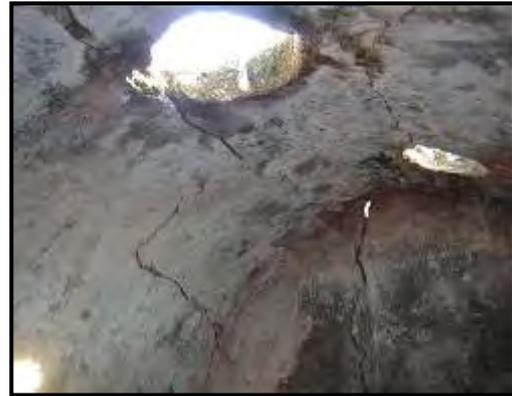
Figure 7. Cracks on the vaults and lightning holes (Space No:2)

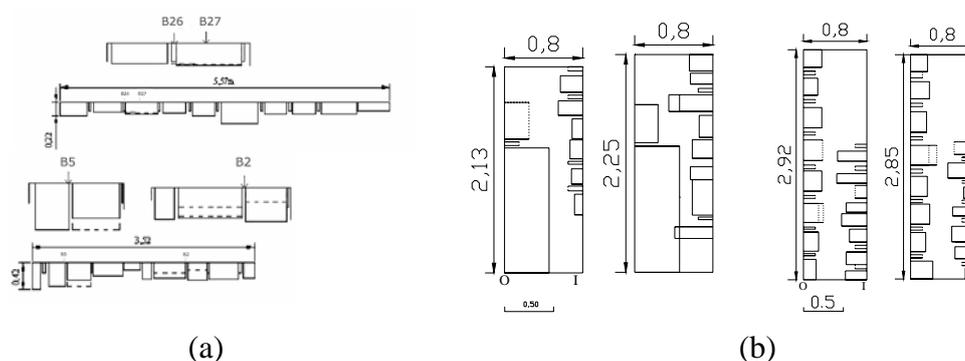
Figure 4: (a) Comparison of results obtained by radar and boroscopy. Dotted lines indicate the results of boroscopy. (b) Vertical sections of masonry.

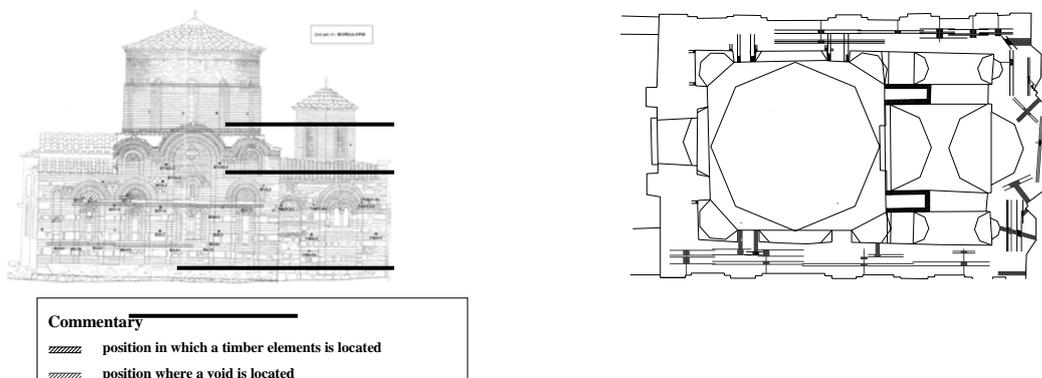
Figure 5: Mapping of the timber ties system (north face and first level plan).

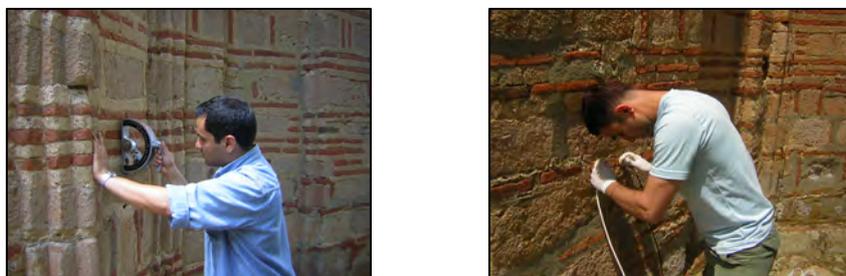
Figure 15. P type Schmidt hammer test and ultrasonic pulse time measurement

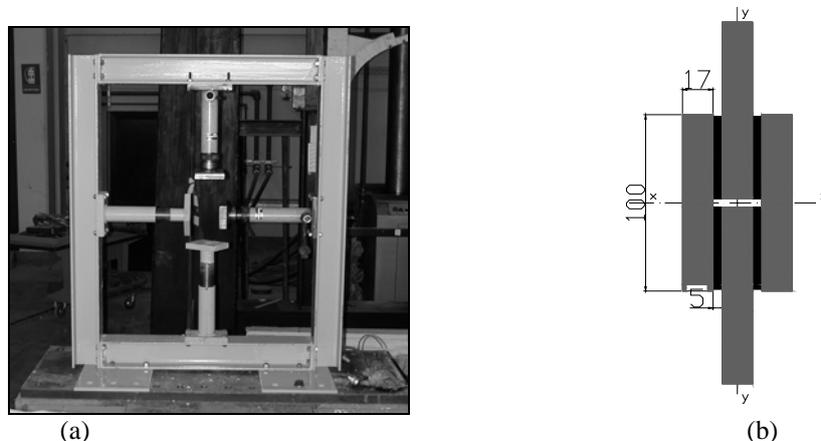
Figure 1 – (a) Experimental apparatus; (b) triplet specimen

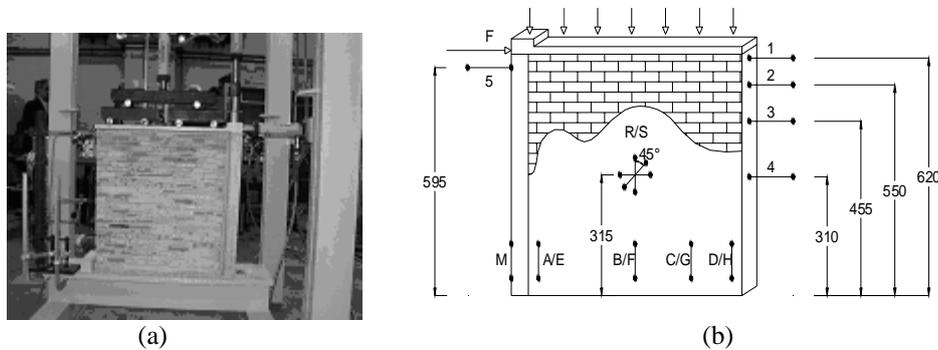
Figure 2 – (a) Wall model and apparatus; (b) dimensions and point of measure.

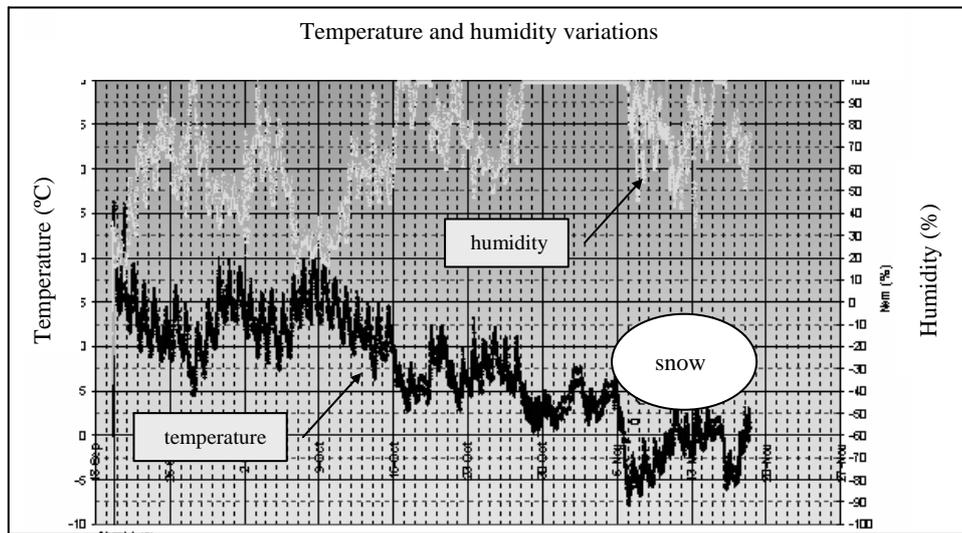
Figure 1: Typical temperature-humidity data belonging to one and a half months

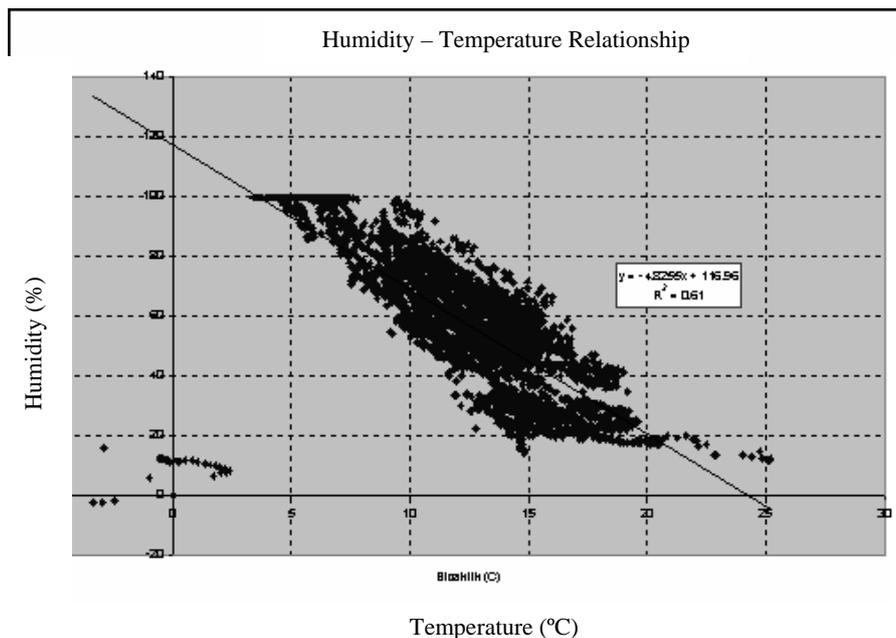
Figure 2: Humidity – temperature relationship derived by humidity and temperature data of approximately a month

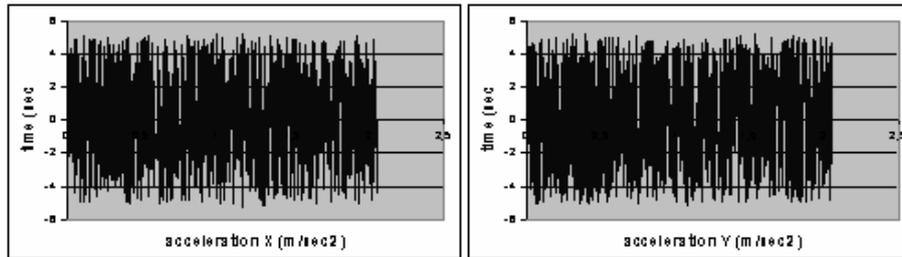
Figure 5: The synthetic EQ data in the x and y directions, respectively.
