STUDIES on HISTORICAL HERITAGE

Proceedings
of the
International
Symposium

Antalya, Turkey
September 17-21, 2007

Organized by
YILDIZ TECHNICAL UNIVERSITY
RESEARCH CENTER for PRESERVATION of
HISTORICAL HERITAGE

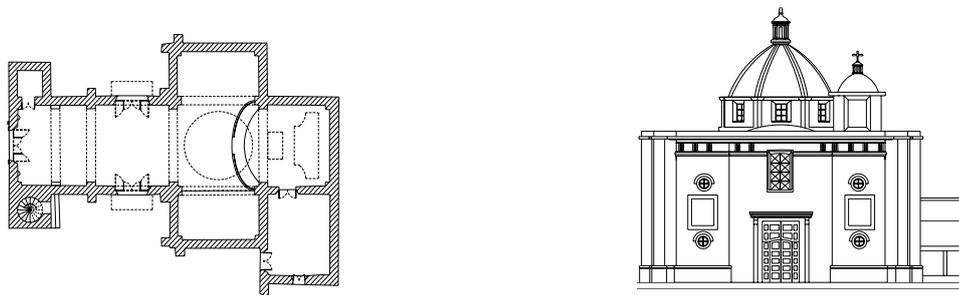
Figure 1. Plan view and façade of a typical Colima church

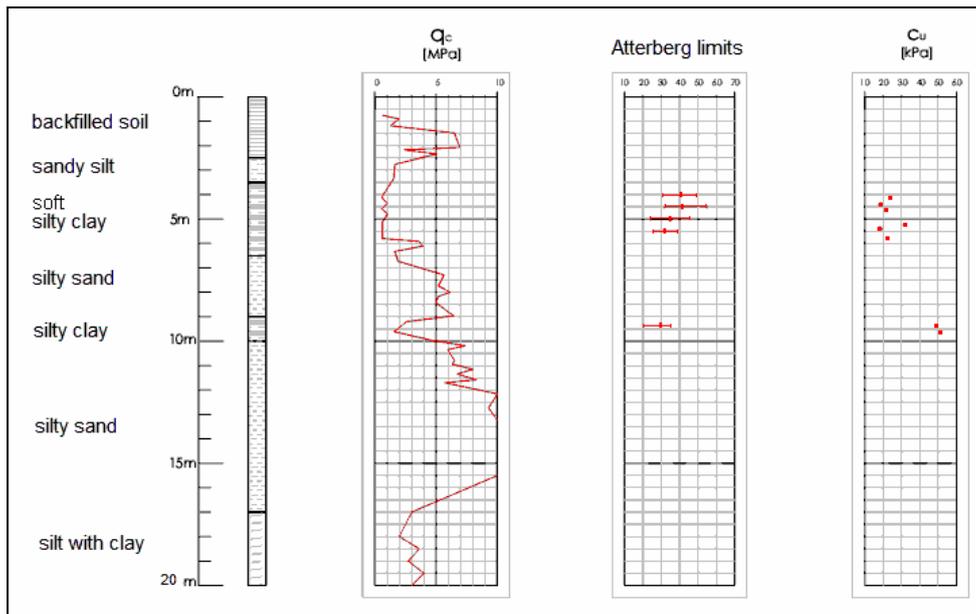
Figure 4 - Soil profile of the Rialto Bridge site.

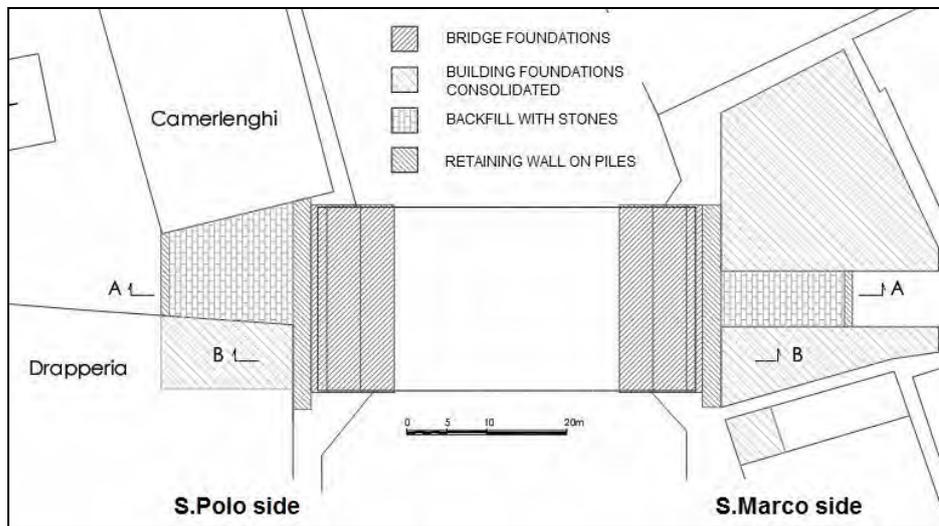
Figure 5 – Plane view of the Rialto Bridge foundations.

The minutes of the commission of inquiry of 1588 were analysed, so that a detailed reconstruction of the Ponte di Rialto foundations could be made. In particular, operations to consolidate the soil near the abutments and reinforcements of the foundations of nearby buildings such as the Palazzo dei Camerlenghi and the Drapperia, to contrast the horizontal thrust of the bridge (figures 5, 6, 7), were highlighted. The same constructive criterion was also adopted for the foundations on the San Marco side.

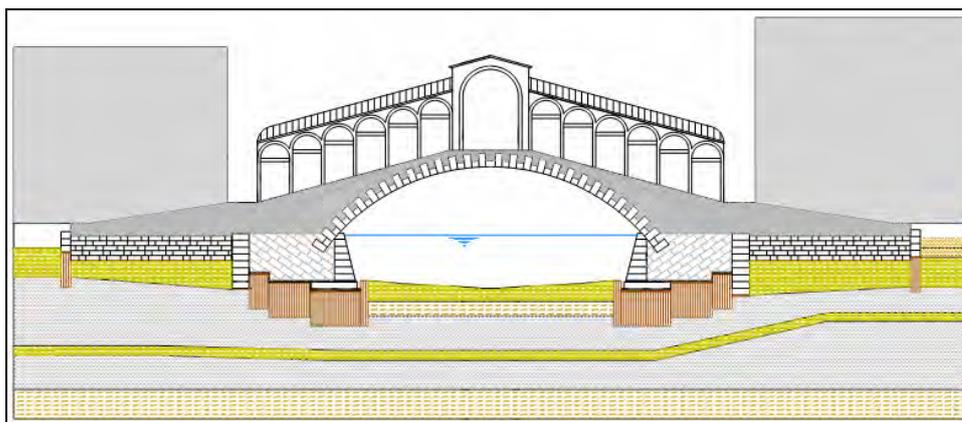
Figure 6 – Section view A-A.

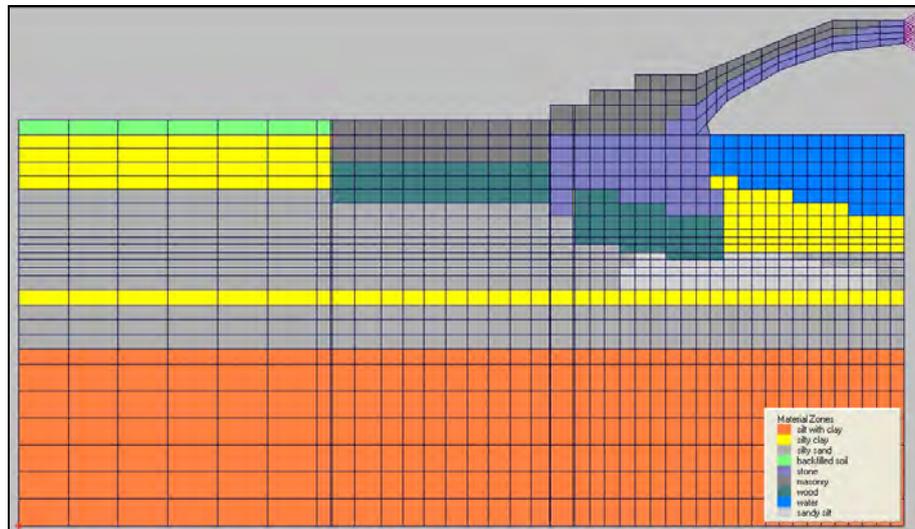
Figure 7 – Mesh detail of sectional view B-B (elements: quadrilateral 8 nodes).

Finite-element simulation of soil-structure interactions was used to analyse the evolution of settlements undergone by the bridge in time, and it was found that deformation were totally absorbed by the foundations, considered as a whole [1].

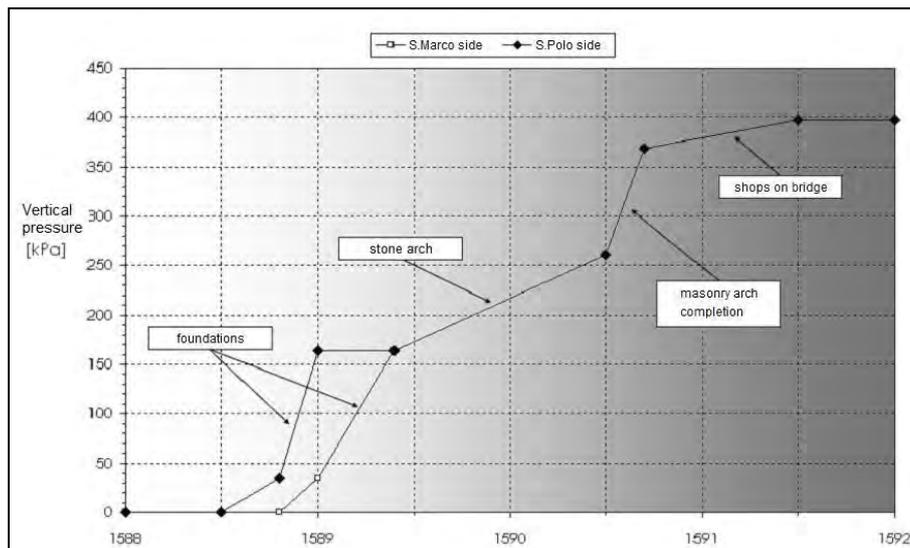
Figure 8 - Reconstruction of load history on the foundation base.

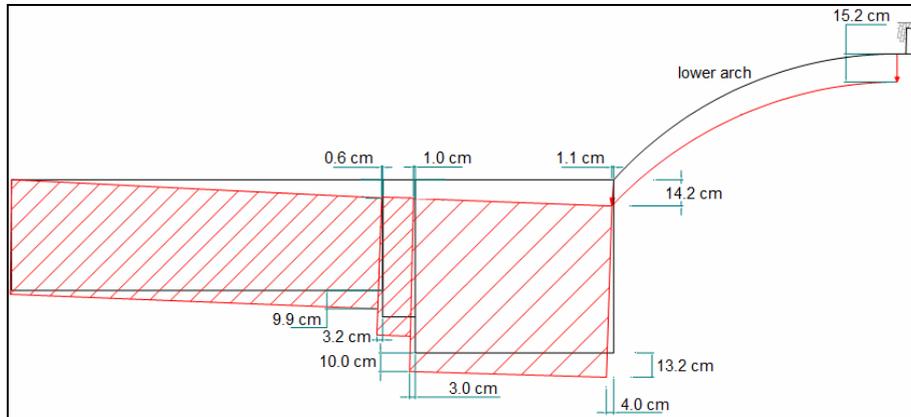
Figure 9 – Settlement values of bridge and nearby buildings.

Results of analysis show how the structure chosen by Da Ponte was kinematically capable of associating the vertical movements of the abutments with slight rotations, thus maintaining the arch under compression and avoiding the dangerous horizontal displacements foreseen by some technicians of the time.

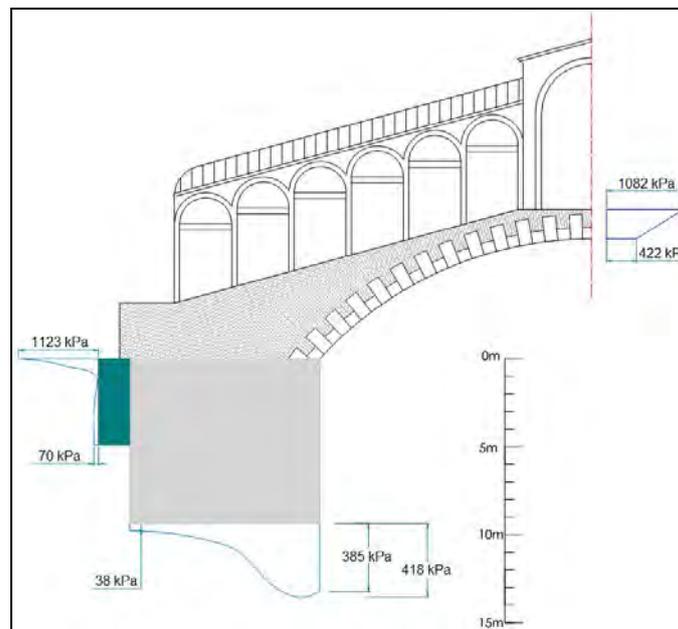
Figure 10 – Stresses on the foundation base, foundation buttress and bridge vault.

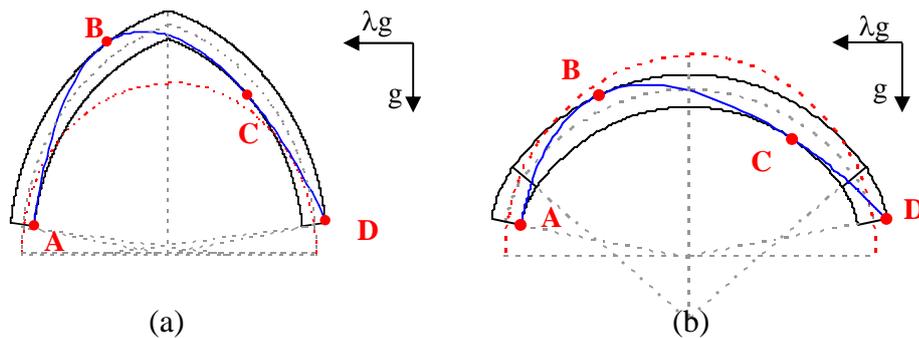
Figure 2 – Example of hinge formation and line of thrust at collapse in the pointed arch (a), and in the basket-handle arch (b)

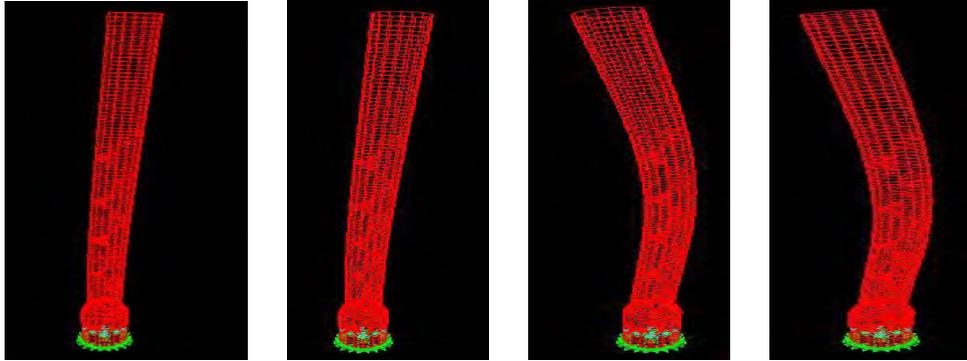
Figure 4. The main mode shapes of the analyzed minaret

The first natural frequency obtained from these calculations is 0.87 Hz, i.e. the first period of the structure is 1.15 sec. This value also can be easily observed on the response spectrum presented in Figure 6, which is extracted from Figure 5 for a particular time range. The differences between the occurrences of peak displacements are about 1.15 sec.

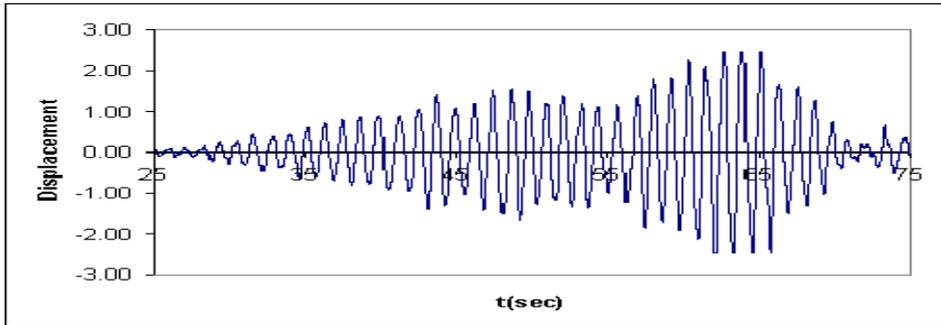
Figure 5. Sample Fourier spectra on N-S direction

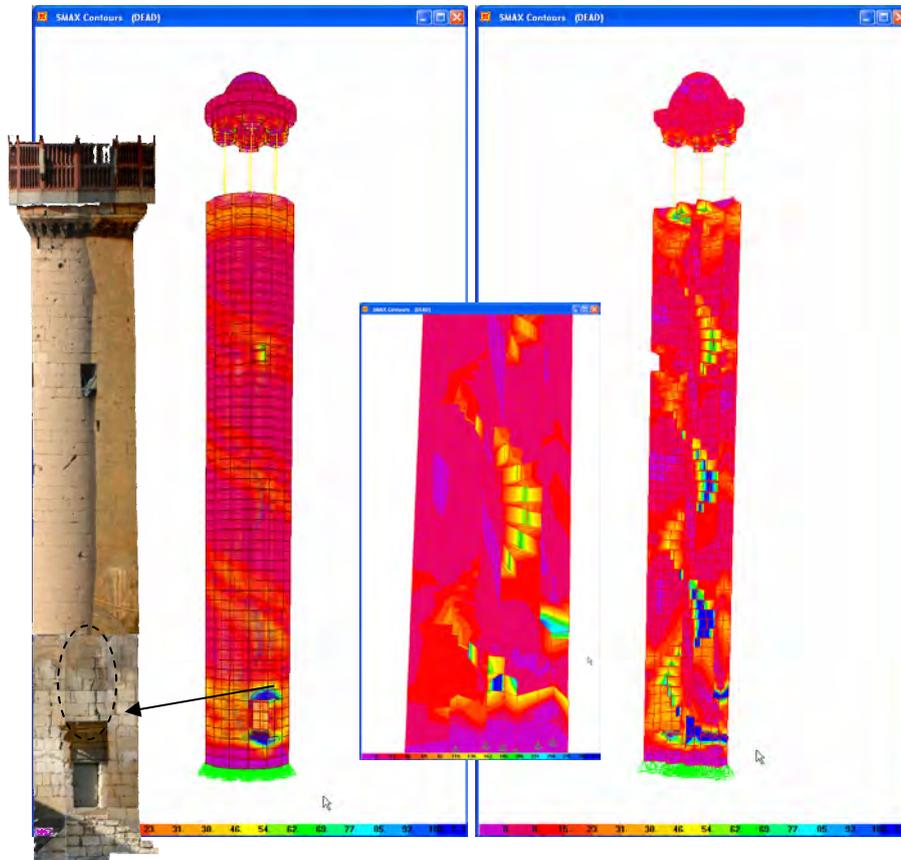
Figure 3: Dead load analysis results indicating stress concentration locations.

The tilt of the minaret is thought to be due to foundation – soil interaction since the minaret has a symmetric geometry. Considering more than 500 years of service life, the base rotation might be due to recent changes in the ground water levels such as draught or expanding soil due to a nearby water leakage from a pipe.

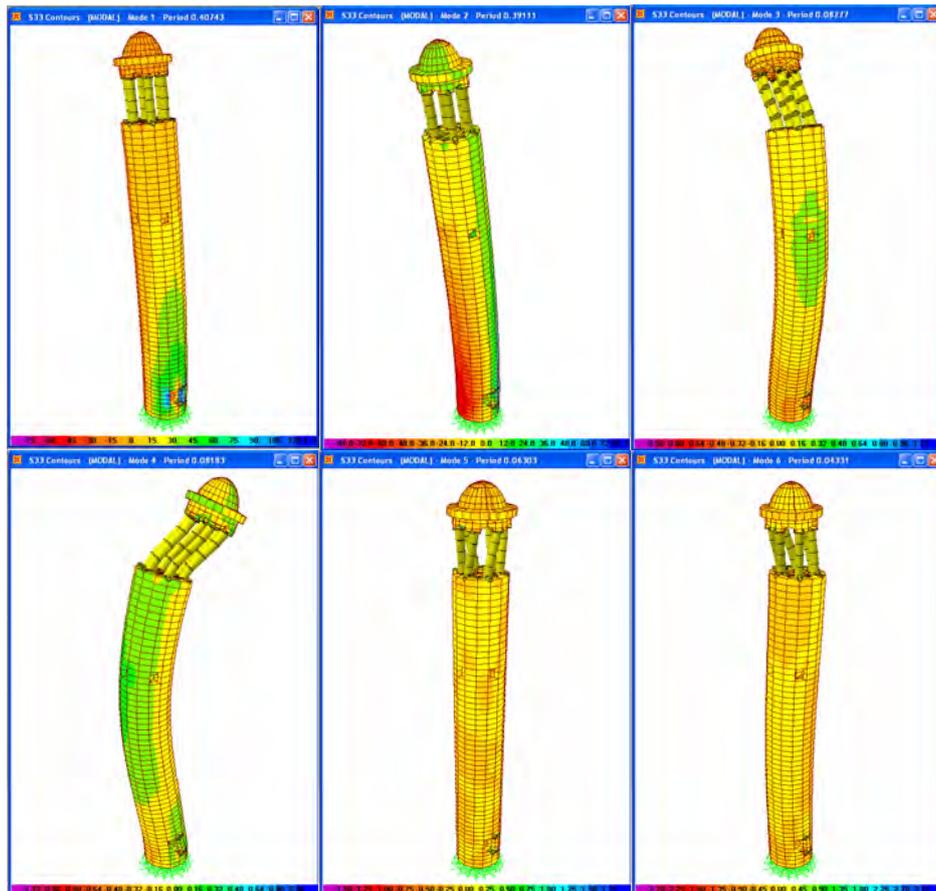
Figure 4: First six vibration mode shapes of the minaret.

The earthquake analysis was conducted using response spectrum approach. The minaret is located on earthquake Zone 3 based on Turkish Earthquake Zoning Map, where Zone 1 is the most seismically active and risky region; therefore, ground spectral acceleration coefficient was taken as 0.2. The soil conditions were determined to be silty clay material (Type C according to Turkish specification for structures to be built in disaster areas, Part III - Earthquake disaster prevention), which refers to ground type Z2 having characteristic spectrum periods of $T_A=0.15$ sec and $T_B=0.40$ sec. The structural analysis of the minaret indicated that the first natural vibration period starts from 0.41 second and higher modes have shorter periods. Therefore, considering a Z3 type soil with $T_A=0.15$ sec and $T_B=0.6$ sec has no immediate effects on the linear response spectrum earthquake analysis results. The first six mode shapes obtained from the modal analysis are the two bending modes in x and y directions followed by torsional modes (Figure 4). The corresponding periods and frequencies of the modes are listed in Table 1. Although the first 30 modes were used for the earthquake analysis, only a limited number of the modes are presented here due to space limitations.

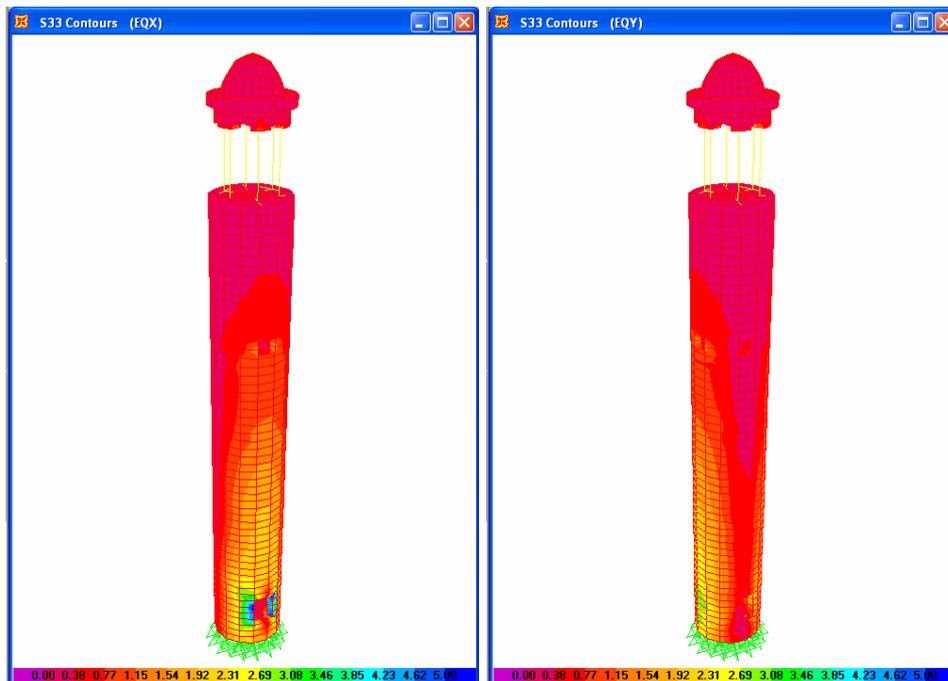
Figure 5: EQ analysis results showing vertical stresses.

The earthquake response spectrum analysis results show that tensile stresses are in the range of 3 MPa to 5 MPa developing at the base of the minaret in x and y directions (Figure 5). The level of vertical compressive stresses at the same locations change between 0.3 MPa and 0.7 MPa which are too low to counterweight the tensile stresses generated by the earthquake forces. The superimposed dead load and earthquake analysis yields tensile stresses in the range of 4 MPa which are beyond the capacity of stone blocks and connections between blocks.

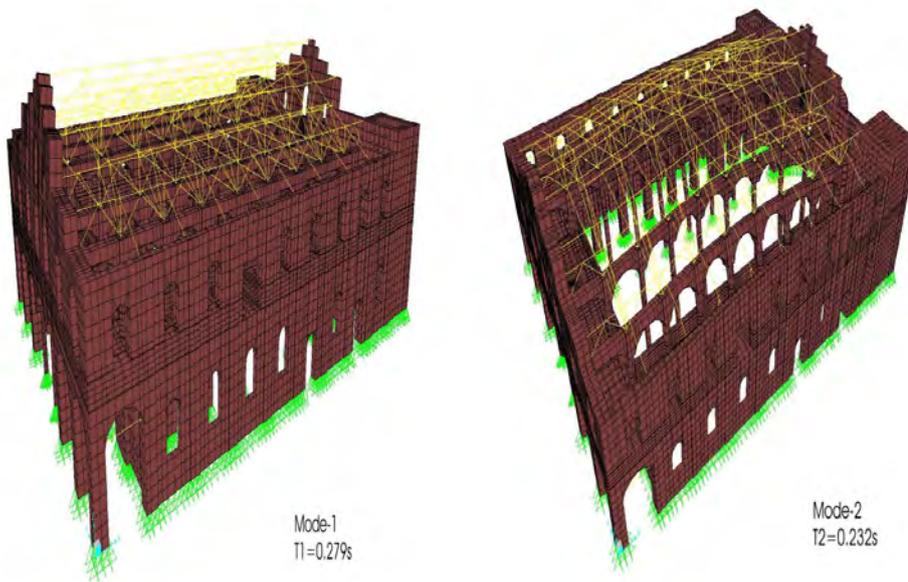
Figure 4 Mode shapes of the church

Turkish Earthquake Code requires shear stress control under earthquake loading in the masonry buildings due to the shearing is being the most critical stress situation. The periods of the building in x-direction (the movement of triangular walls rising up to the roof in the front and back façades) and y-direction (the movements of the square piers and the vaults connecting the 30x30 cm. square columns) are found as $T_x=0.279$ seconds and $T_y=0.232$ seconds, by dynamic calculation (modal analysis). In determining the earthquake loads, “Turkish Earthquake Code, 2007, Section 5” [5] is used; accordingly the static earthquake load coefficients in x and y directions are taken as 0.375. $A_o=0.30$, $S(T_1)=2.50$, $I=1$ and $R_a(T_1)=2$ are used in the calculations. The self-weight load of the building is calculated as 23018 KN. Hence, the equivalent static base shear force is found as 8632 KN by using the concepts in “Turkish Earthquake Code, 2007” [5]. The mode shapes of the building obtained by modal analysis are given in Figure 4.

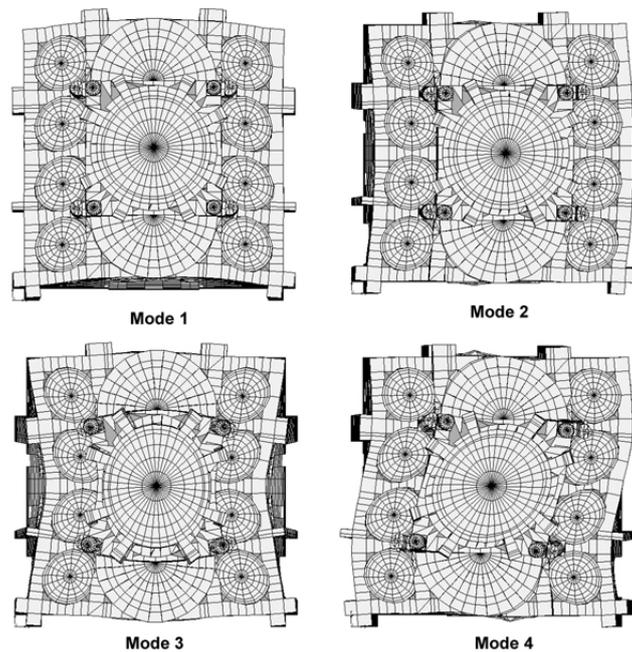
Figure 5

There is a general decrease of periods after retrofitting, except the first period in the perpendicular direction to the retrofitted arch (Figure: 5). This phenomenon appears because of the difference between the increase of total mass and the increase of rigidity in the direction of the first mode. Since the first mode direction is the out-of-plane direction of the retrofitted arch, it has mass contribution more than rigidity contribution. Another observation about the periods is that the third period, which refers to the lateral squeezing, decreased 15%, since that movement is strongly related to arch rigidities. It is also found that the analytical periods are slightly lower than the experimental ones. The reason behind that might be the existence of cracks and the soil-structure interaction which have not been included in the model.

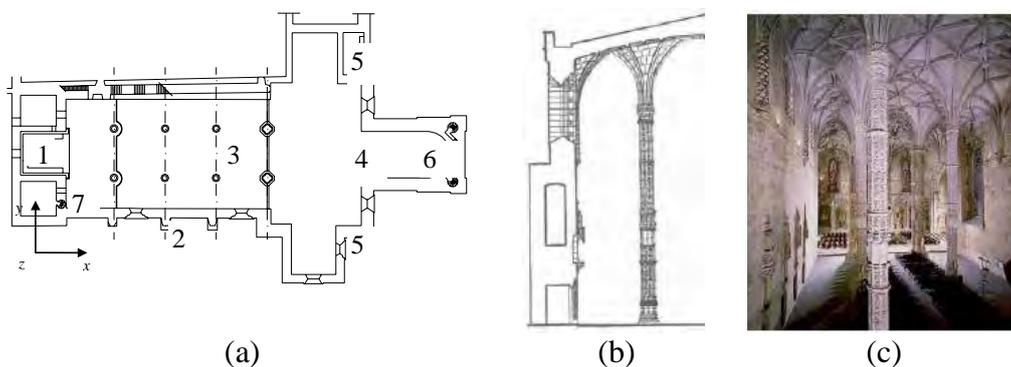
Figure 1. Santa Maria of Belém Church: (a) plan (1-axial doorway, 2-lateral doorway, 3-nave, 4-transept, 5-side chapels, 6-chancel; 7-South bell-tower); (b) half of transversal cross-section; (c) view of the three naves.

The main nave is divided by two rows of slender columns, with a free height of about 16.0 m. The transverse sections of the octagonal columns in the nave have a radius of 1.04 m with top fan capitals that reduce the effective free spans of the slightly curved vault, see Figure. For additional information see reference [3].

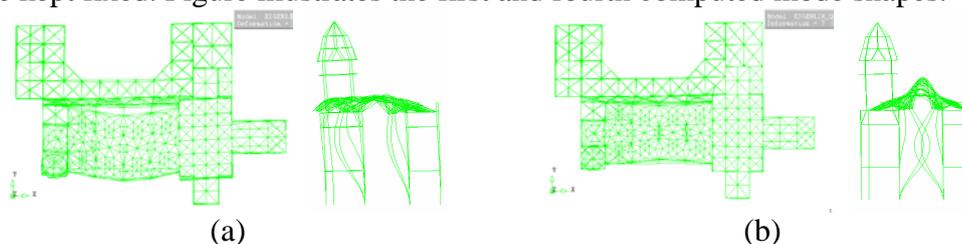
Figure 3. Numerical mode shapes: (a) 1st mode at 3.8 Hz; (b) 4th mode at 5.34 Hz.

the global model was performed in two phases. First, a preliminary comparison against an existing detailed numerical analysis of the vault under its self-weight was performed [7]. A second calibration was based on experimental existing results obtained from the dynamic identification and laboratory tests, presented above. In this way, the Young modulus was assumed to be equal to 30 GPa for the columns and 12 GPa for the other structural elements. The foundation boundaries were kept fixed. Figure illustrates the first and fourth computed mode shapes.

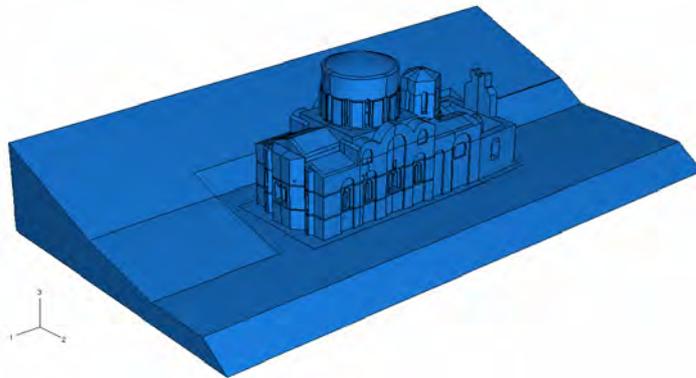
Figure 2: General view of the numerical model.

The numerical analysis was performed with the code ABAQUS [1] using 3-dimensional, tetrahedral finite elements. For the structure, the maximum dimension of the finite elements was 0.30 m and for the soil 1.50 m. All the walls were modeled with at least two elements along their width. In total, the model consisted of $44,282$ nodes and $190,597$ elements with $132,348$ degrees of freedom. A general view of the model is shown in Figure 2, while in Figure 3 the longitudinal section of the model of the building is depicted.

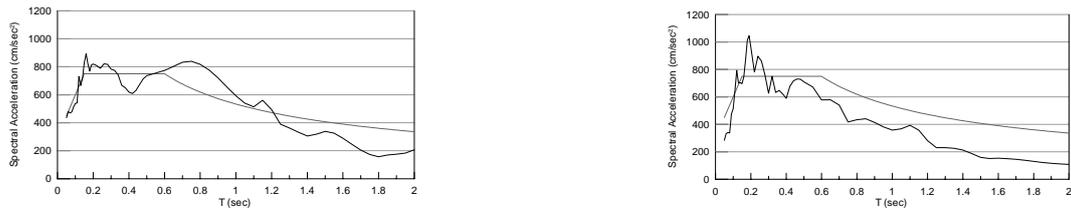
Figure 5: Corresponding elastic response spectra for 5% damping.

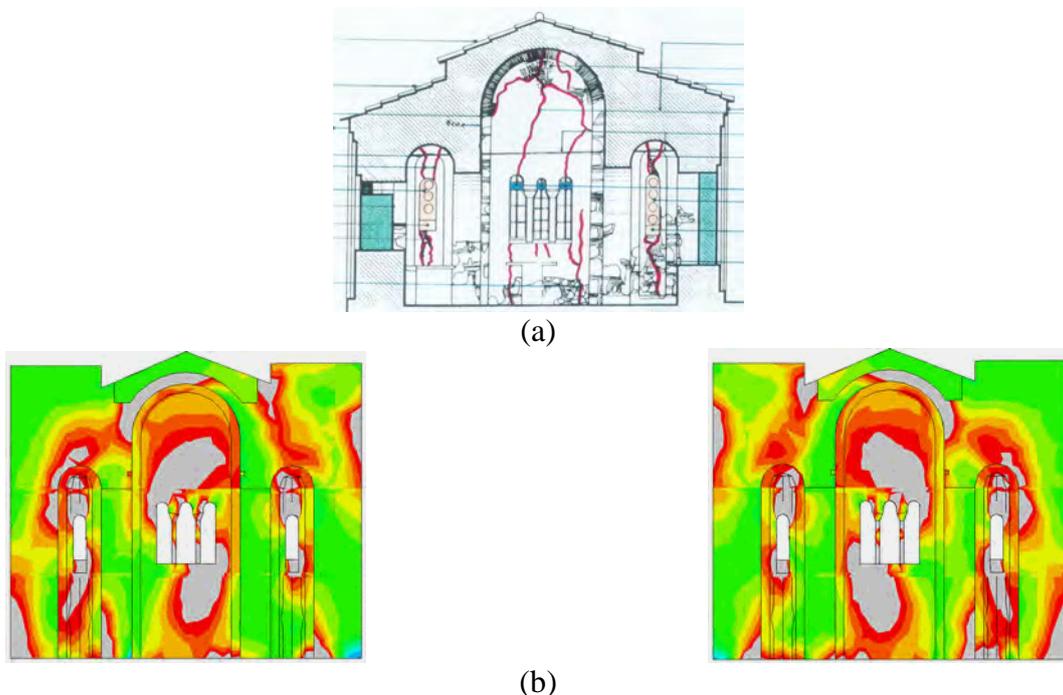
Figure 6: E wall (sanctum): (a) existing crack pattern; (b) principal tensile stresses at time steps 240 and 284.

From the results of the numerical analysis, the regions of the structure, at which the maximum principal tensile stress was developed for the combined effect of gravity and earthquake loads, were determined. These regions were compared to the existing crack pattern of the church. Such a comparison is shown in Figure 6 for the E wall of the main church (sanctum). In Figure 6a, the existing cracks are shown, while in Figure 6b, the principal tensile stresses are plotted for two different time instances. With gray colour are shown the areas with stresses larger than 350 KPa, a value that is significantly larger than the tensile strength of the masonry in its present condition (estimated to 150 KPa, at the most). Therefore, cracks should appear at these regions. Comparison of the gray areas of Figure 6b with the crack pattern of Figure 6a shows that the existing cracks are in agreement with the ones that would occur during the earthquake. Typical results concerning the vaulted roof are presented in Figure 7. Again, the gray areas correspond to tensile stresses larger than 350 KPa. Note that cracks do not exist at the roof of the narthex, because this part of the building was restored after the 1881 earthquake. Similar results were obtained for the other walls of the building. In general, the areas of large tensile stresses were in accordance with the existing cracks in all walls, except for a vertical crack at the upper part of the S wall of the main church, which could not be explained. This crack, however, could be the result of

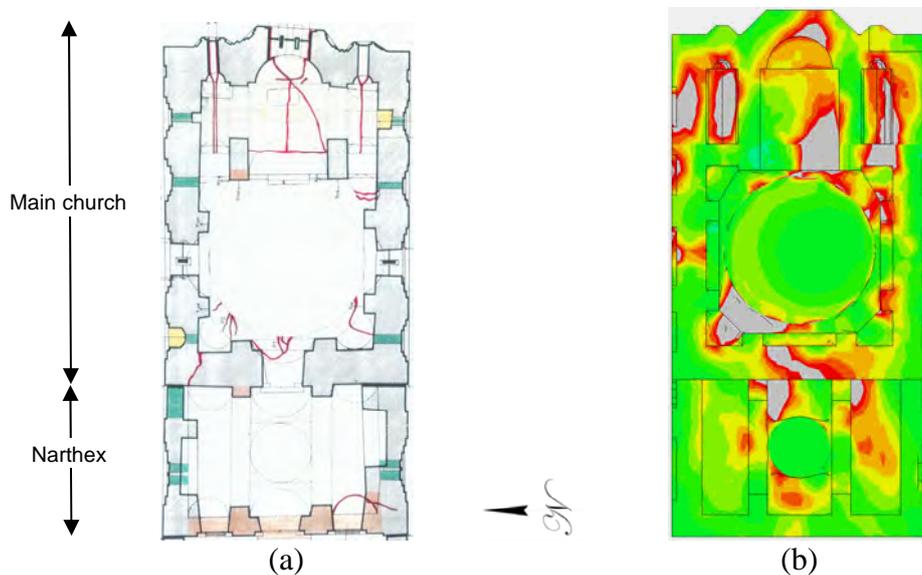
Figure 7: View of the roof (from below): (a) existing crack pattern; (b) principal tensile stresses at time step 278.

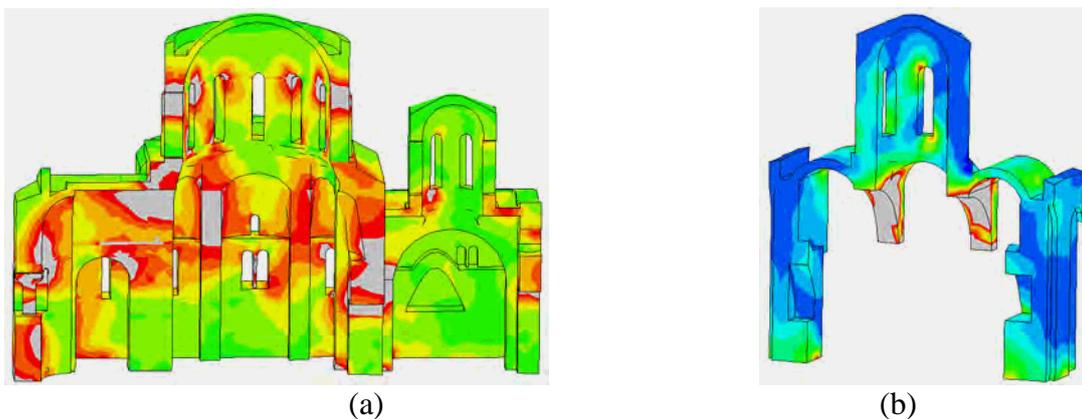
Figure 8: (a) Longitudinal section of the main church and the narthex (S view); (b) Transverse section of the narthex (W view).

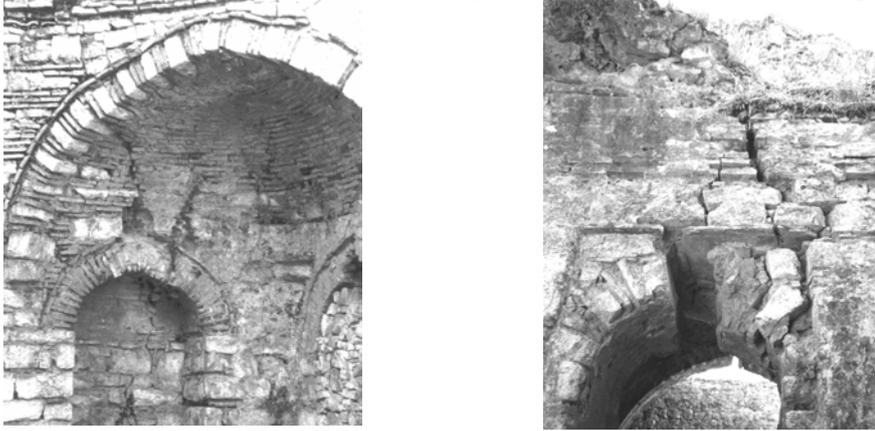
Figures 2a, 2b. Damages at domes and arches.

inspection, carried out by the authors, the pathology was recorded. Structural damages can be divided into two categories: (1) damages of general nature, concerning the disruption of continuity and shape of the structural system (partial

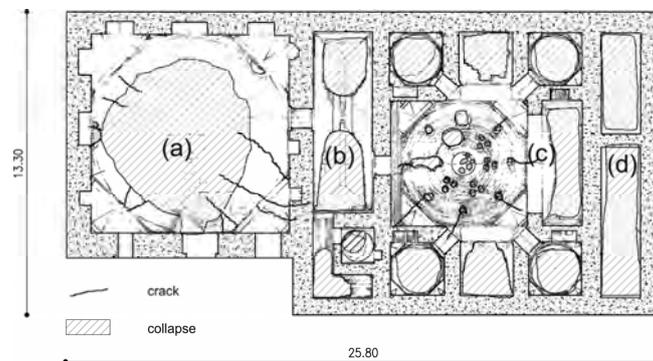
Figure 3. Ceiling plan: cracks and collapses are denoted.

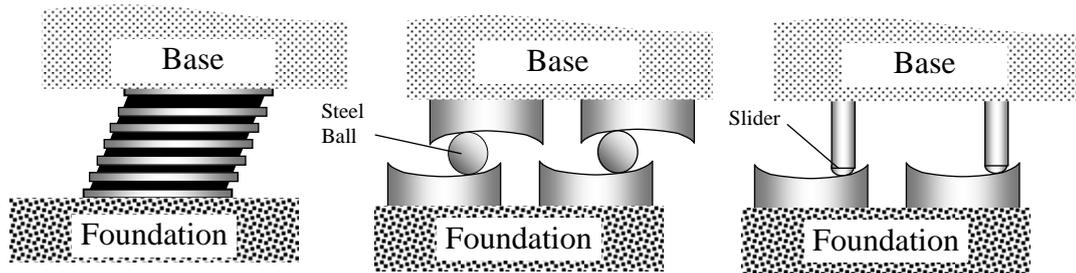
(a) Rubber Bearing (b) Friction Pendulum 1 (c) Friction Pendulum 2
Figure 4: Typical Base-isolation devices with recovering mechanisms

Base-isolation systems are the structural systems that isolate the super structures, using special bearing devices (fig.4), from the ground motion during earthquakes. Base-isolation systems make it possible to drastically reduce the seismic loads and deformations induced to both the structural components and non-structural components. In this paper a new base-isolation system for timber structures is proposed and the results of its real scale shaking table tests are reported.

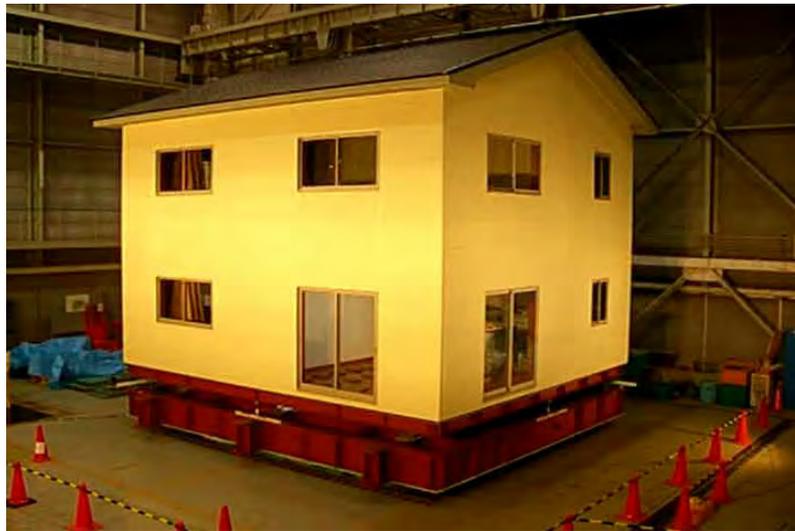
Figure 6: General view of the full scale shaking table test.

In order to check the performance of this base-isolation system a series of full scale shaking table test using real wooden house was carried out. The size of the base of the house was 6.37(m) x 7.28(m) = 46.37 (m²) and the height of the house was 7.4m. Total weight of the house was 240kN. Six VP-isolators and four hydraulic dumpers are installed and connected between the base and the foundation of the house. After the tests of base-isolated house the same house was directly connected to the foundation without base-isolation system and another series of shaking table tests were carried out to investigate the behavior of “earthquake resistant” house.

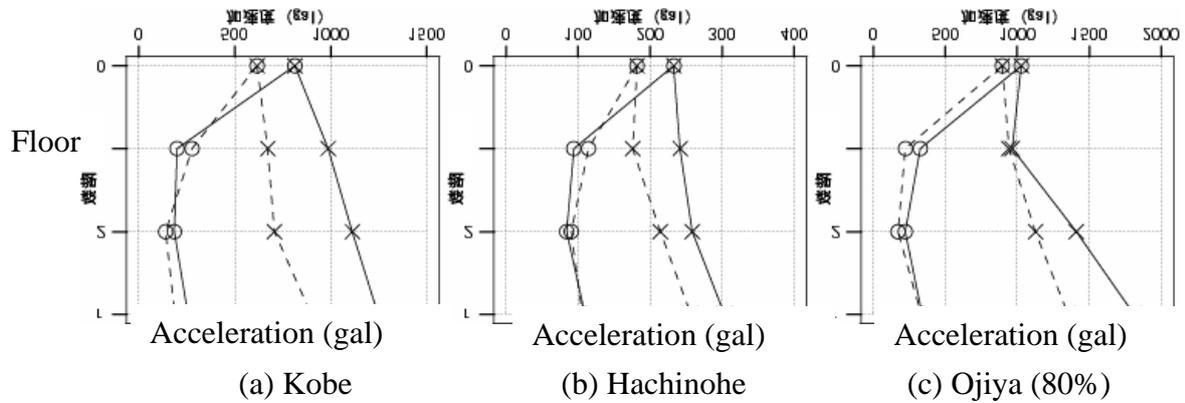
Figure 7: Response acceleration

Several real earthquake ground motions recorded, Kobe 1995 (max. 818gal), Hachinohe 1968 (max. 233gal) and Ojiya 2004 80%(max. 1046gal), were reproduced by the shaking table. Some results of the tests are shown in figs.7 and 8. In the figs. the crosses show the results of base-isolated house and the circles show the results of the earthquake resistant house. With base-isolation system acceleration level was reduced to about one-fifth of the that of earthquake resistant house. Contrarily, relative displacement between the base and the foundation became much larger. This large displacement absorbed the large ground motions. For the base-isolated house structural components and non-structural components remained perfectly safe while in the earthquake resistant house structural components, especially timber braces, and non-structural components, such as wall panels and furniture were heavily damaged.

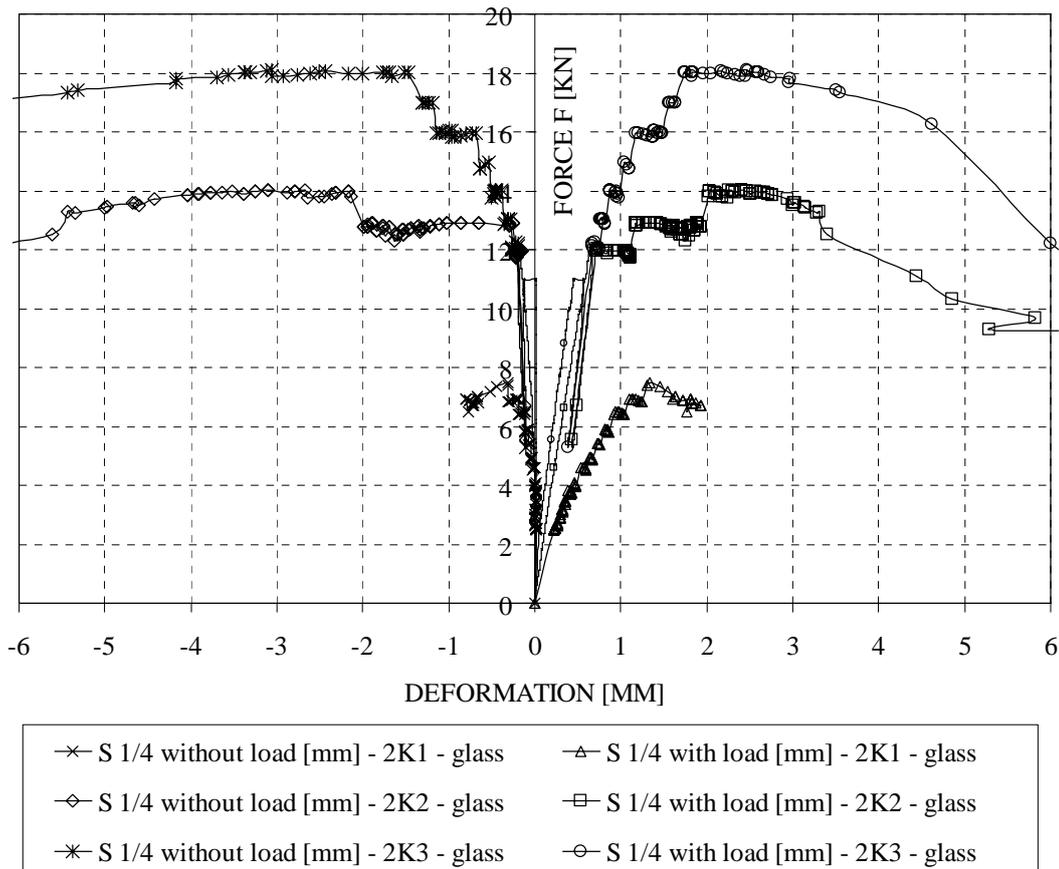
Figure 4 Comparison of deformations on vaults loaded in 1/4 of the span strengthened with GFRP reinforcement – dynamical test

Dynamical tests were performed on vaults loaded asymmetrically in 1/4 of the span and reinforced with glass reinforcement (GFRP). From results of first dynamical tests is again visible increasing of load-bearing capacity of reinforced vaults (2K2, 2K3) compared to vault unreinforced (2K1) (Figure 4). But low set of tested specimen prohibited comparison with test data from statical experiments and it also in connection with big nonhomogeneity of masonry constructions. As well a fracture mode, failure of vault by opening of tension cracks in bed joint, is not uniform and position of crack can influence final load bearing capacity. Especially load-bearing capacity of unreinforced vault loaded by dynamical loading is higher in comparison with statical examination. Strengthened vaults can be partially compared by relation of their load-bearing capacity. Ratio of load-bearing capacity of vaults with three reinforcing chases and with two chases (2K3/2K2) at statical examination is 1,33 and at dynamical examination is 1,29.

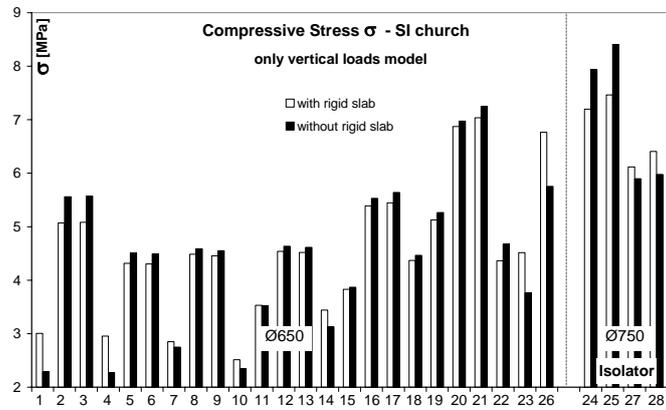
Figure 4. Compressive stresses due to vertical load.

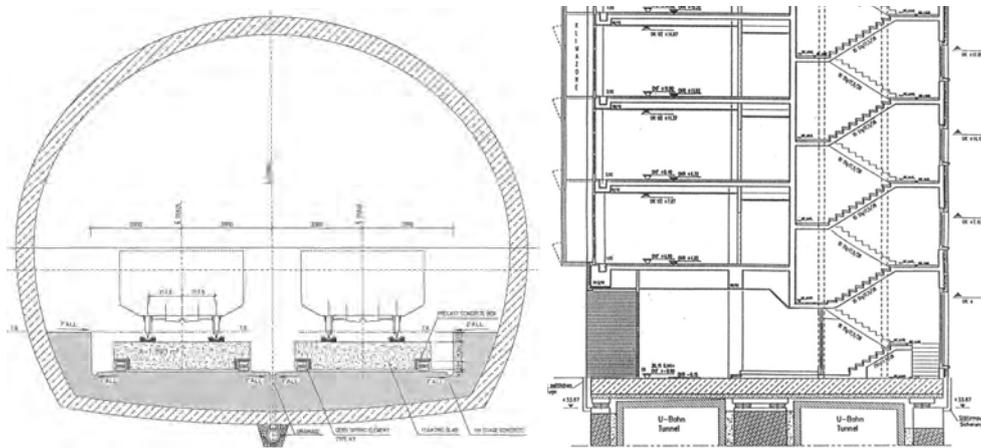
Figure 2 – Floating Trackbed and Typical Isolated Building

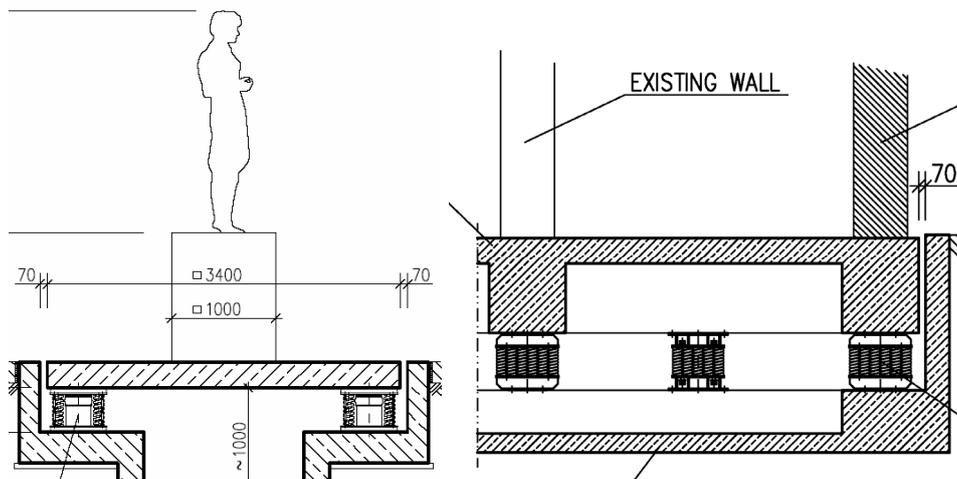
Figure 4 – Base-Control Systems for Statues / Retrofit of Historical Buildings

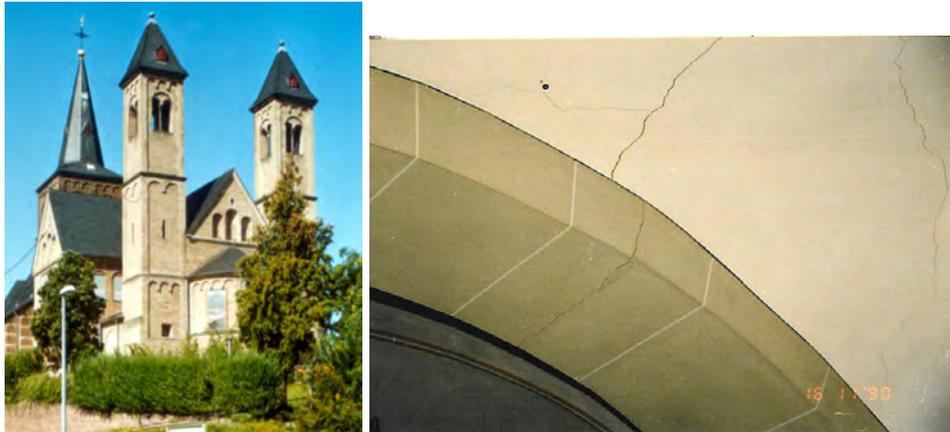
Figure 6 – St. Remigius Church in Bergheim, Germany, Observed Cracks

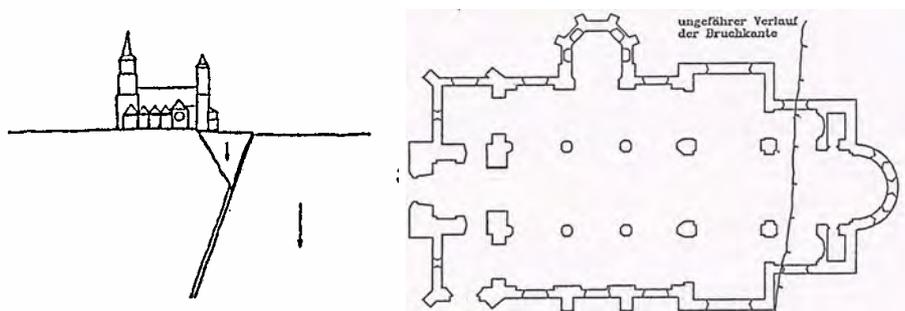
Figure 7 – Geological Fault Line in the Section and in the Plan

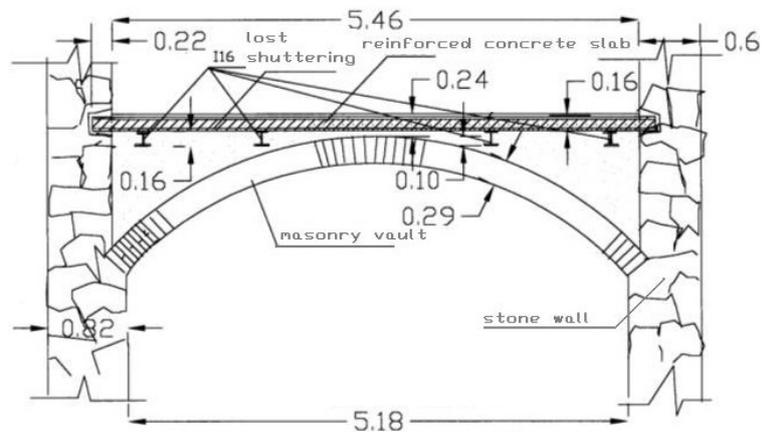
Figure 4 Consolidation of the slab system over the basement

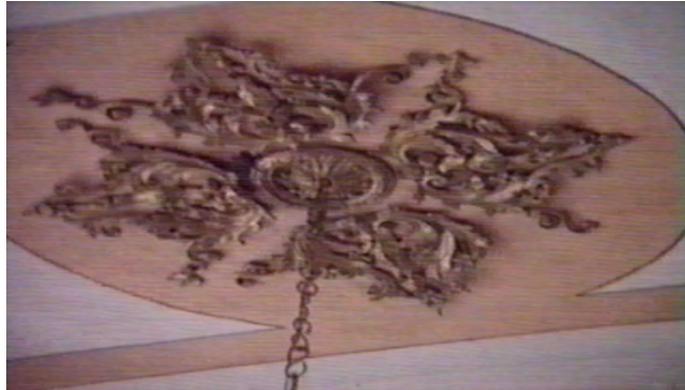
Figure 5 Plastering in stucco of the ceiling

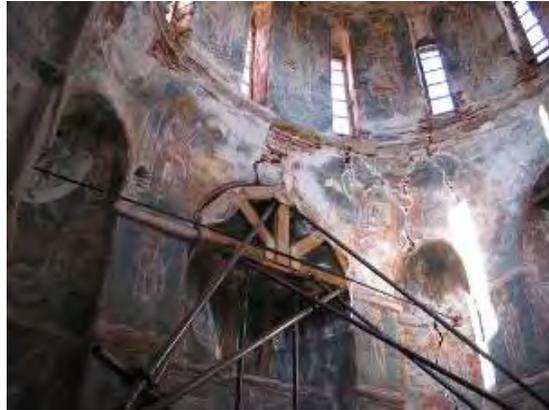
Figure 3: View of the West wall of the main church

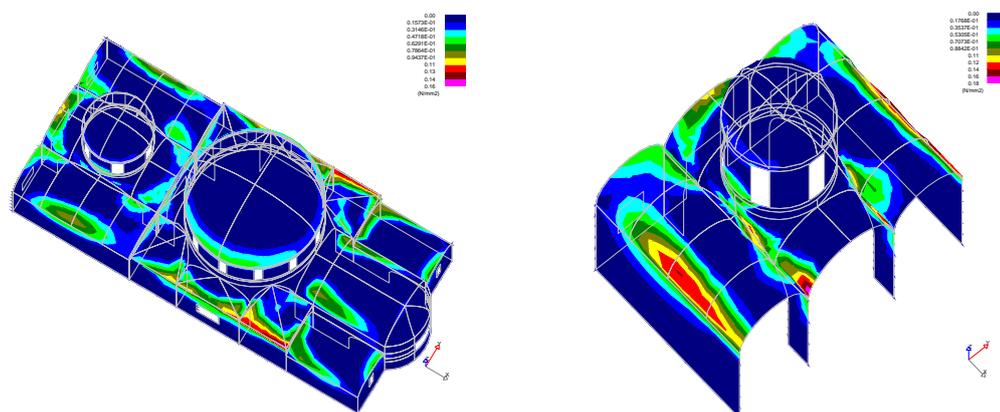
Figure 4: Tensile stress isocurves in the surface FEM model for the connected structure, and the separate narthex

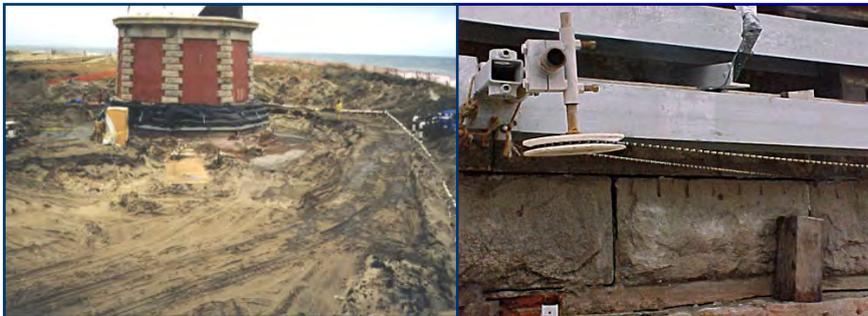
Figure 2 Dewatering around the foundation and cable sawing of the base

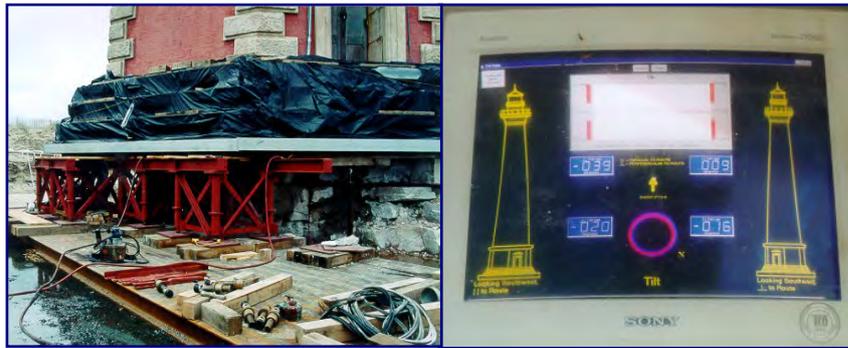
Figure 3 Underpinning of the base and monitoring system against tilt

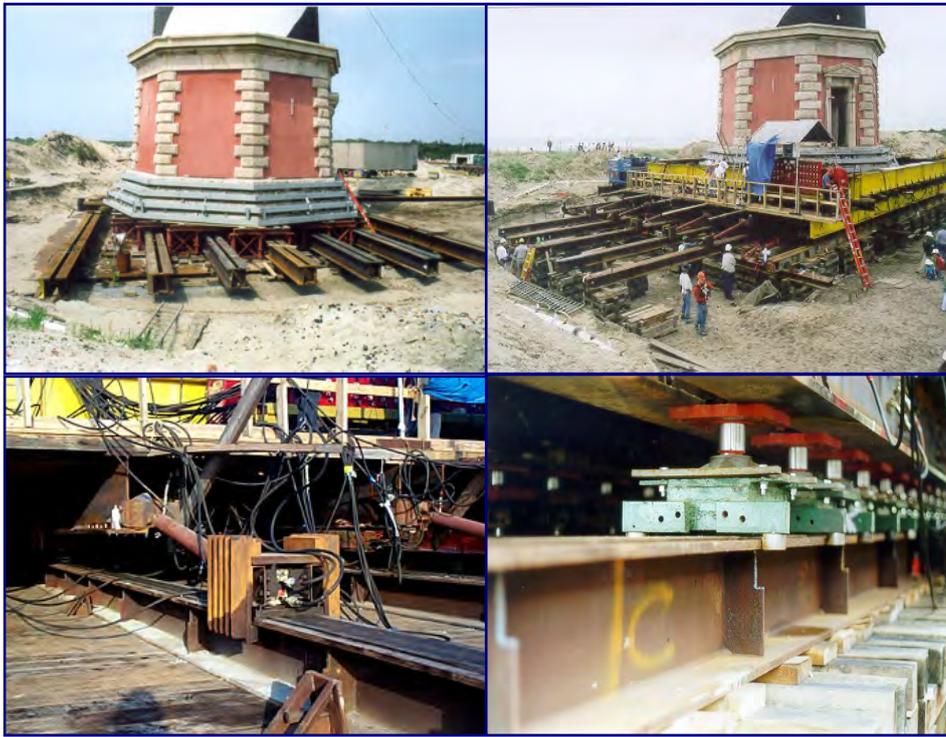
Figure 4 Seven Rails, Support Frame, Jacks and Rollers for the Lighthouse

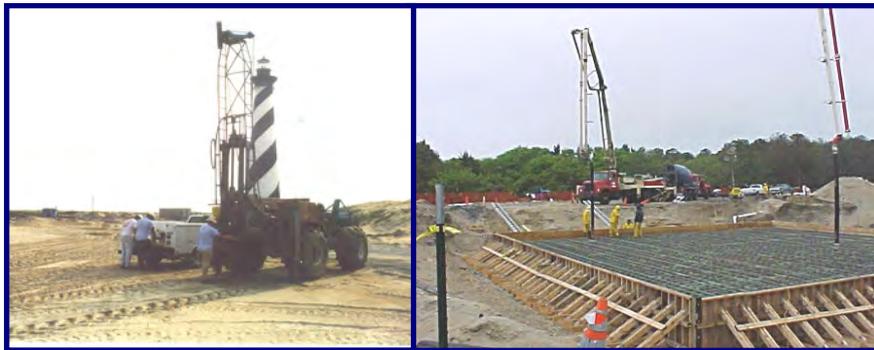
Figure 5 Geotechnical Study Along the Move Route and New Foundation

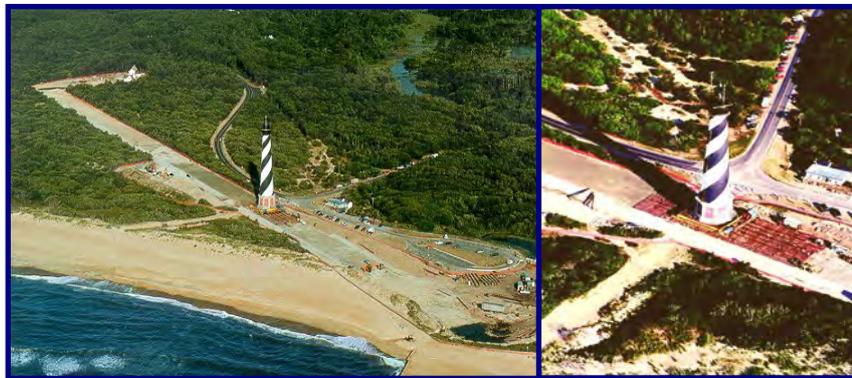
Figure 6 Moving of the Lighthouse
