STUDIES on HISTORICAL HERITAGE

Proceedings
of the
International
Symposium

Antalya, Turkey
September 17-21, 2007

Organized by
YILDIZ TECHNICAL UNIVERSITY
RESEARCH CENTER for PRESERVATION of
HISTORICAL HERITAGE

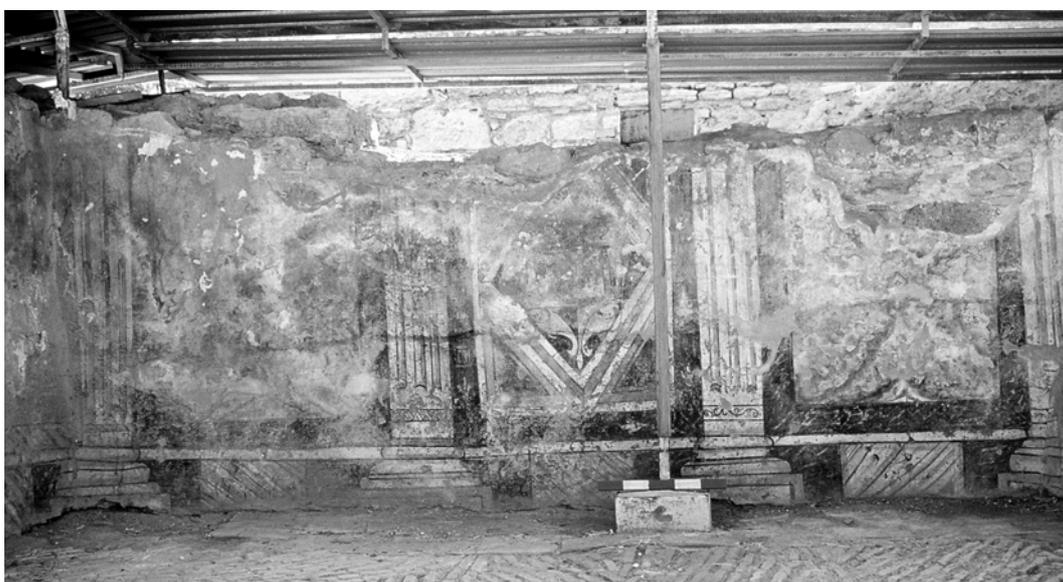
Figure 1 Effloresces hiding the patterns and the colors and the white colored plaster pointings (on the upper part on the left side).

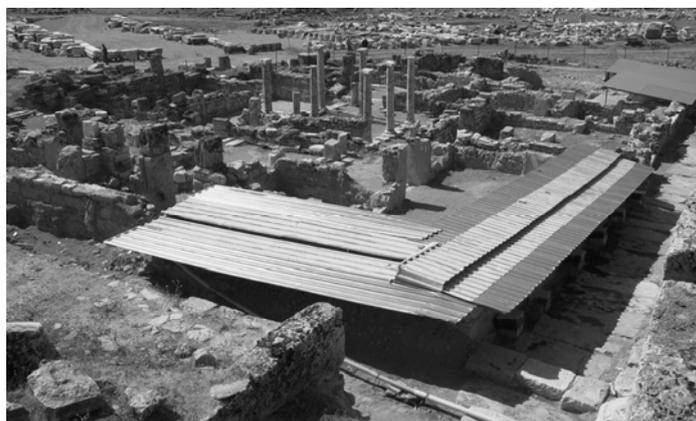
Figure 5. The modified roof.

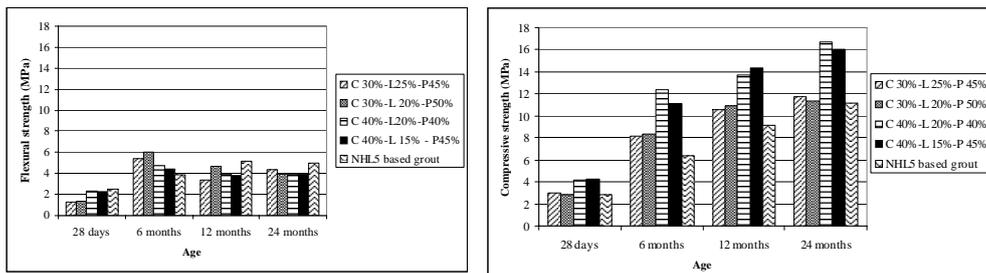
Figure 1: Evolution of strength of grouts injectable through sand column 1.25/2.5mm ($T_{36}<50\text{sec}$) which simulates voids and cracks of 0.2-0.4mm ($W_{nom}\sim 200\mu\text{m}$). Water /Solids= 0.8, Superplastizer 1% of the solid phase. (C=white cement, L=lime, P=Pozzolan, NHL5=natural hydraulic lime), (DTRR)

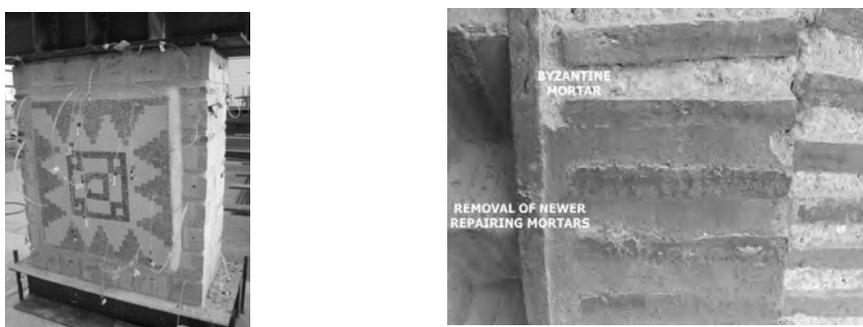
Figure 2: Wallette preparation for grouting (left). Removal of the recent repairing mortars in order to reveal the underlying byzantine mortars of the Katholikon masonry (right)

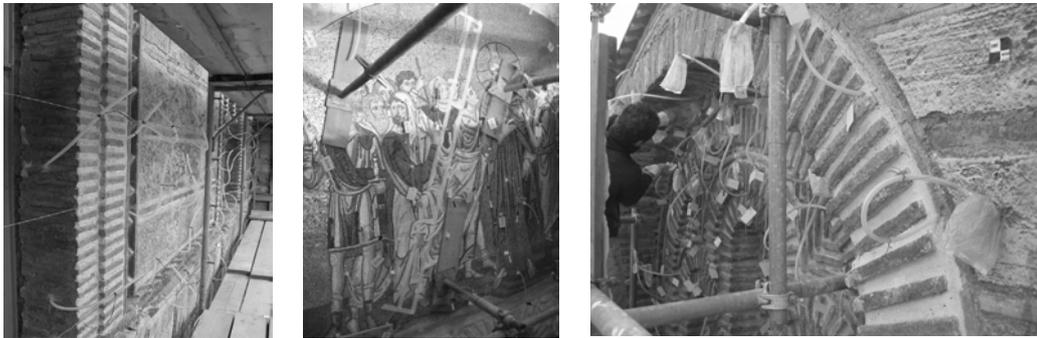
Figure 3: Preparation of the Katholikon masonry and its mosaics before grouting

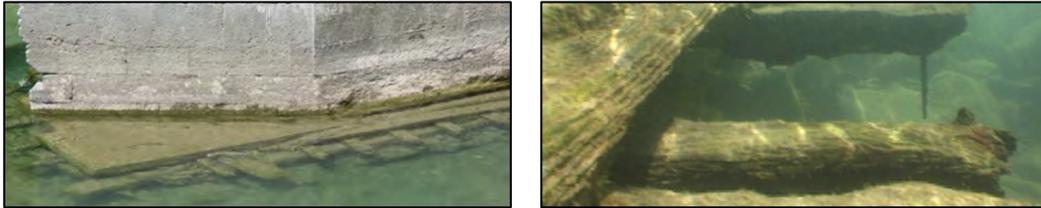
Figure 3: The wooden grates forming the foundation of the bridge abutments.

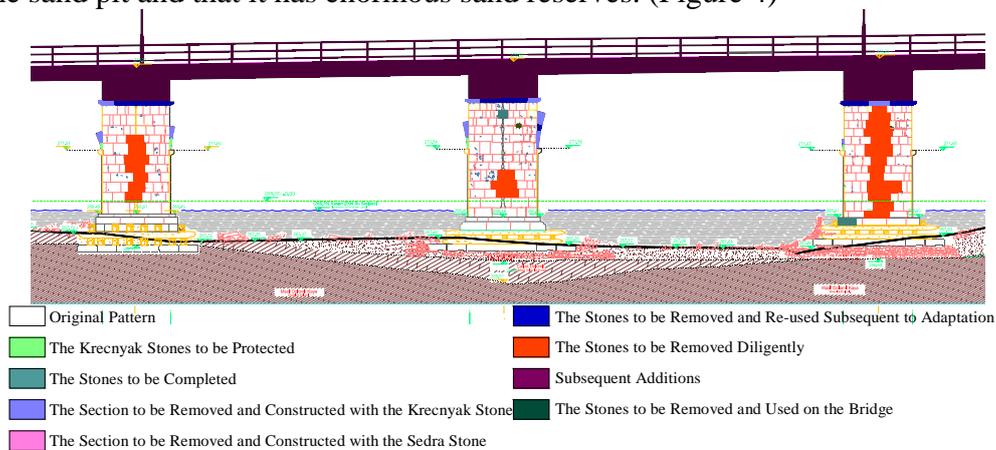
Figure 4: Upstream – Measured Drawing Analysis

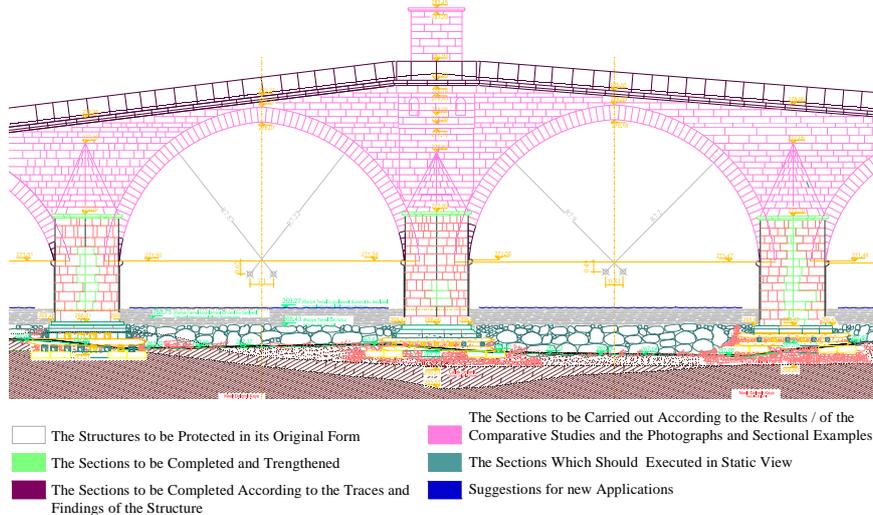
Figure 6: Upstream- Restoration Analysis

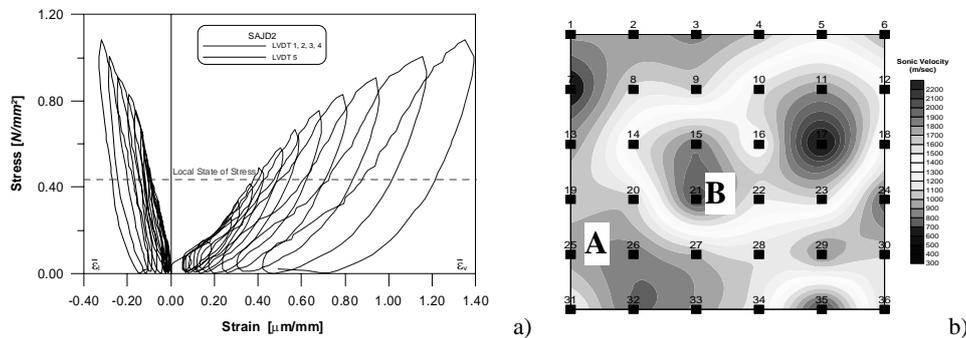
Figure 2. a) Result of flat jack-tests, b) Sonic velocity distribution

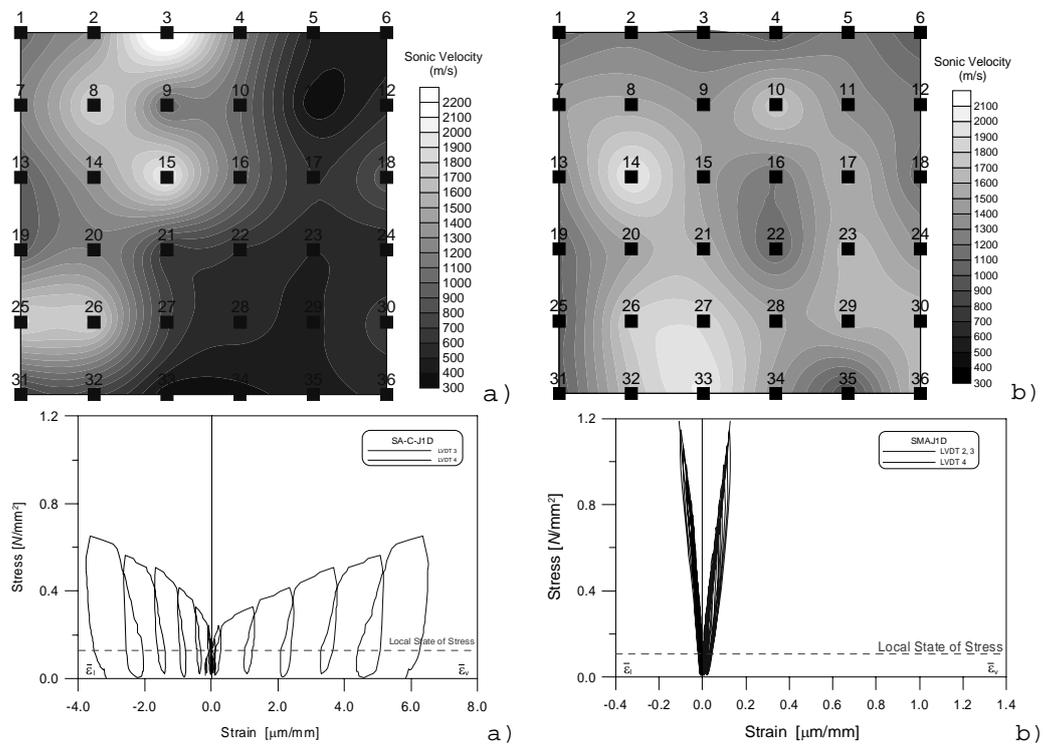
Figure 3 a,b, Results of sonic and flat-jack tests on the masonry of two churches in Lombardia [10].

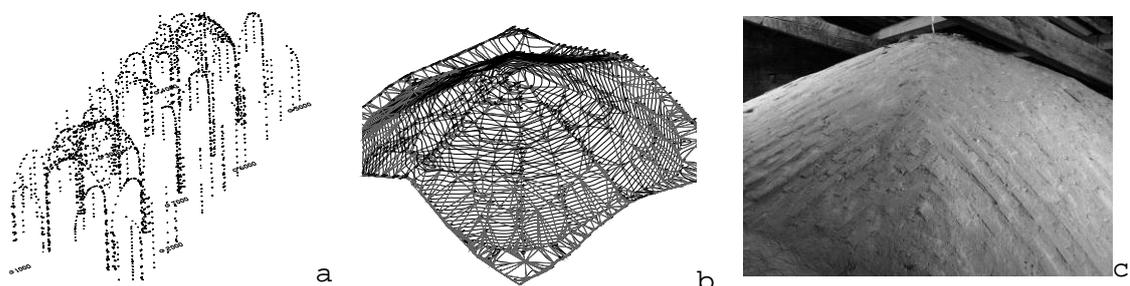
Figure 3. Topographic survey of the profile of the pillars and of the intrados of the vaults (a); 3D reconstruction of the vault extrados (b); view of the details of the extrados of a vault (c)

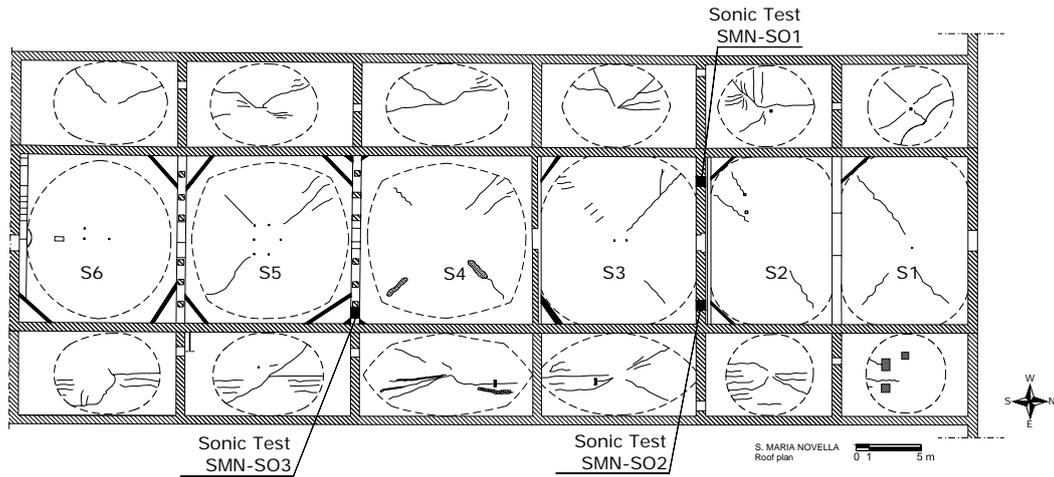
Figure 4. localization of the sonic tests performed in the roof level

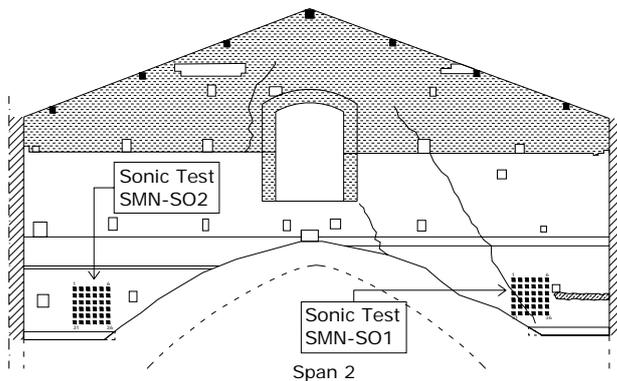
Figure 5. Sonic tests in the transversal wall between span 2 and span 3

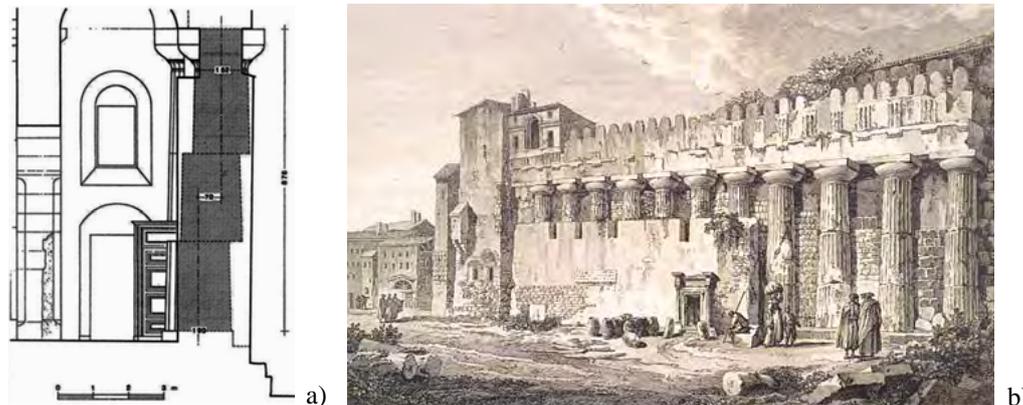
Figure 5. Detail of a damaged column (a) and view of the intervention following the earthquake in a picture of the XVIIIth century (b).

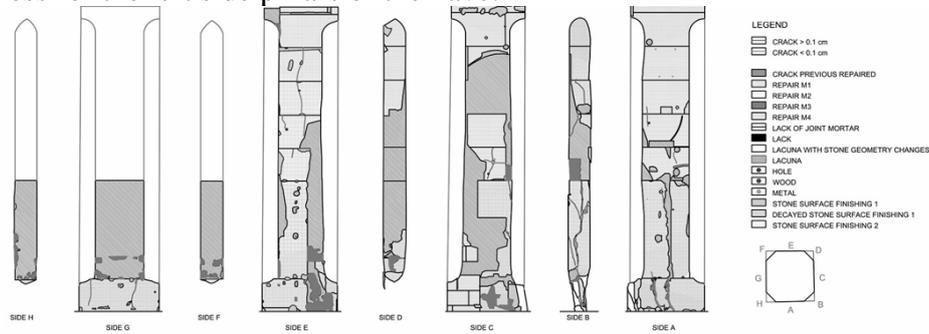
Figure 6. Survey of the pillar 19.

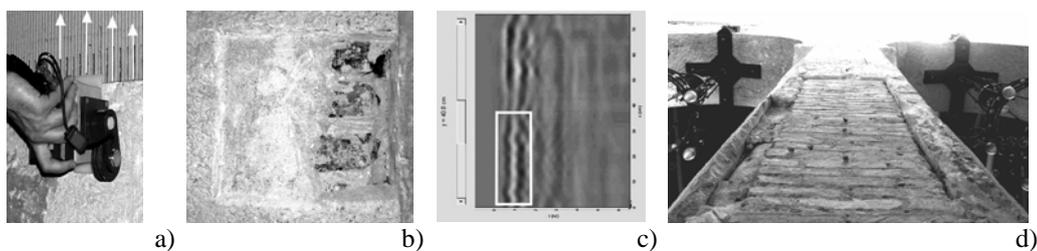
Figure 10. The radargram shows the presence of regularly spaced diffractions (about every 5-6 cm) at a depth of about 3-4 cm. The inspection proved that these pillars were sometimes repaired with bricks
